Sediment Management Plan For the Watersheds of Clearwater Harbor and Saint Joseph Sound

Prepared for:
Pinellas County
Department of Environment
and Infrastructure

April, 2012

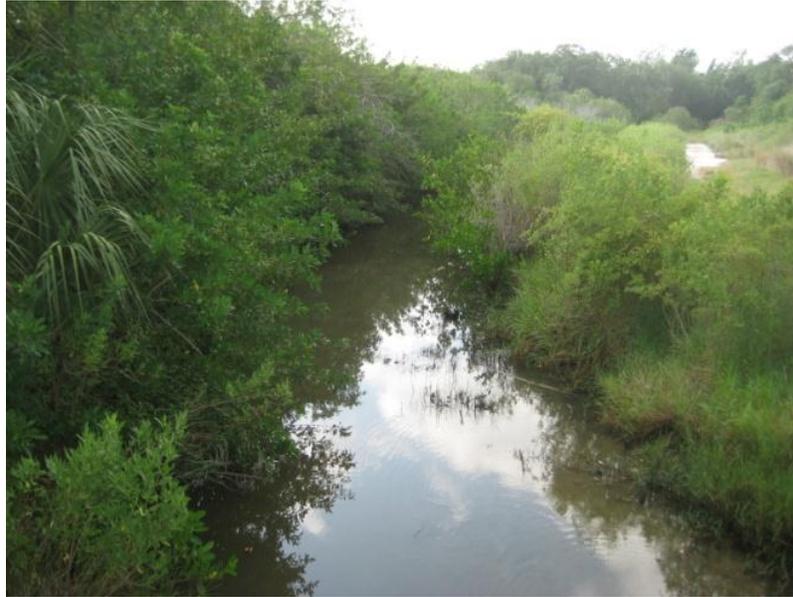
Figure 4-2. Site Klosterman 1 looking upstream.

Site “Klosterman 1” is located just upstream of the stream crossing at Alternate US 19 (Figure 4-2). The reach is tidally influenced and has very little topographic relief. Water quality data indicate that the stream is brackish from its mouth to upstream of US 19 at the discharge point of the Innisbrook Resort lake system (Pinellas County, 2010; FDEP, 2008a). Much of the upstream drainage area is contained within the Innisbrook Resort water management system and very high flows at this site are not expected. The sediment probe was used to estimate fine-grained material and loose soft sand layers. Loose sediment layer depths ranged from 6 to 12 inches at the site.

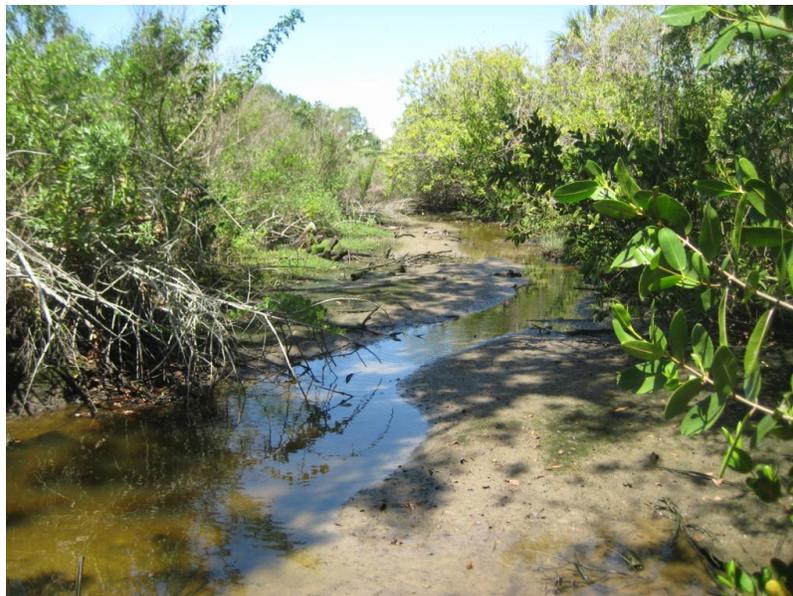
Figure 4-3. Site Klosterman 2 looking downstream.

Site Klosterman 2 (Figures 4-3 and 4-4) is located just upstream of the Pinellas Trail approximately 0.1 mile upstream of Alternate US 19. The terrain is relatively flat and the channel slope is low.

Figure 4-3 shows the stream downstream of the trail. The stream reach is tidal and supports mangroves along the banks. Figure 4-4 shows the upstream reach to be overgrown, with significant amounts of detritus in the channel. However only a thin (1-inch) layer of silty/mucky sand sediment was observed. Although the channel banks were overgrown it appeared that the channel had been excavated at one time.

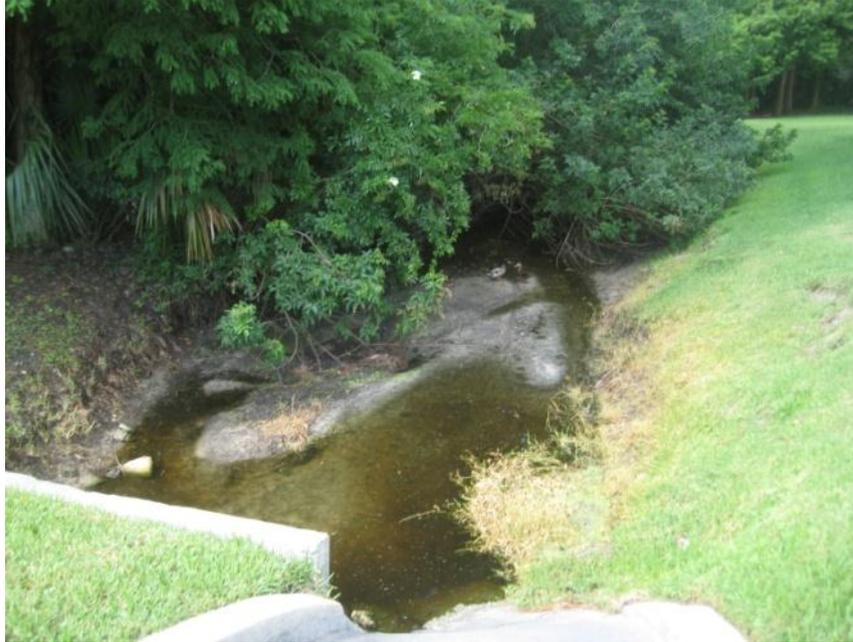
Figure 4-5. Site Klosterman 3 looking downstream.

Site Klosterman 3 was on the Innisbrook Resort grounds near the stream headwaters. The stream was channelized with grassed side slopes (Figures 4-5 and 4-6). Soft sand with fine-grained material had accumulated to a depth of 10 inches upstream of the road crossing and had shoaled to 14 inches deep downstream of the Old Post Road culvert. Although potential issues with sediment accumulation were noted, the stream was on private property and its maintenance may not be a County responsibility

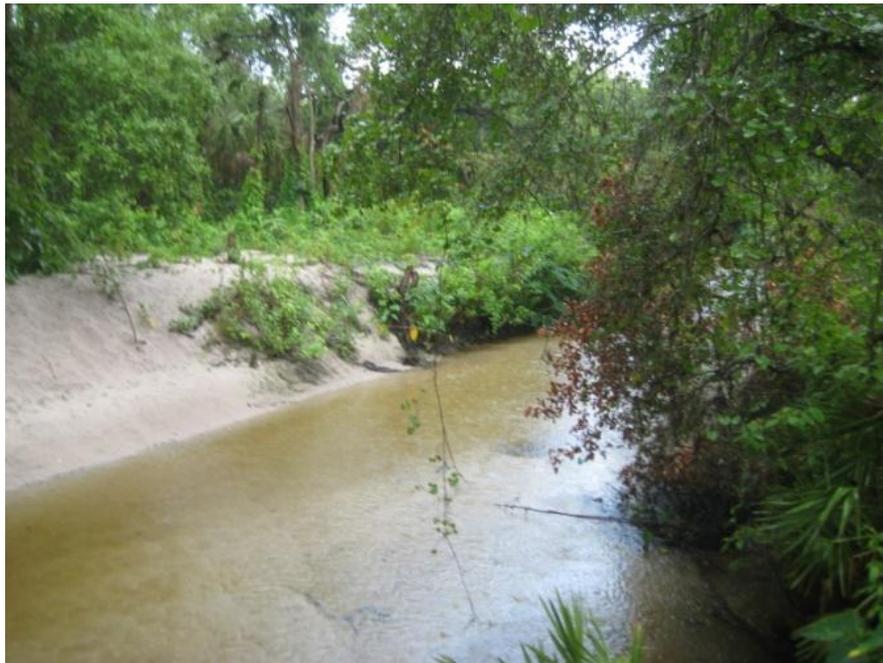
Figure 4-17. Site Curlew 2 looking downstream.

Site Curlew 2 is located in Curlew Creek Park about 0.2 miles upstream of Curlew 1. The channel is sinuous but the bed material is similar to that at Curlew 1 (about 2 – 3 inches of loose sand). There was virtually no fine-grained sediment visible in the channel. Figure 4-17 shows unstable loose sand banks, making this area susceptible to bank erosion.

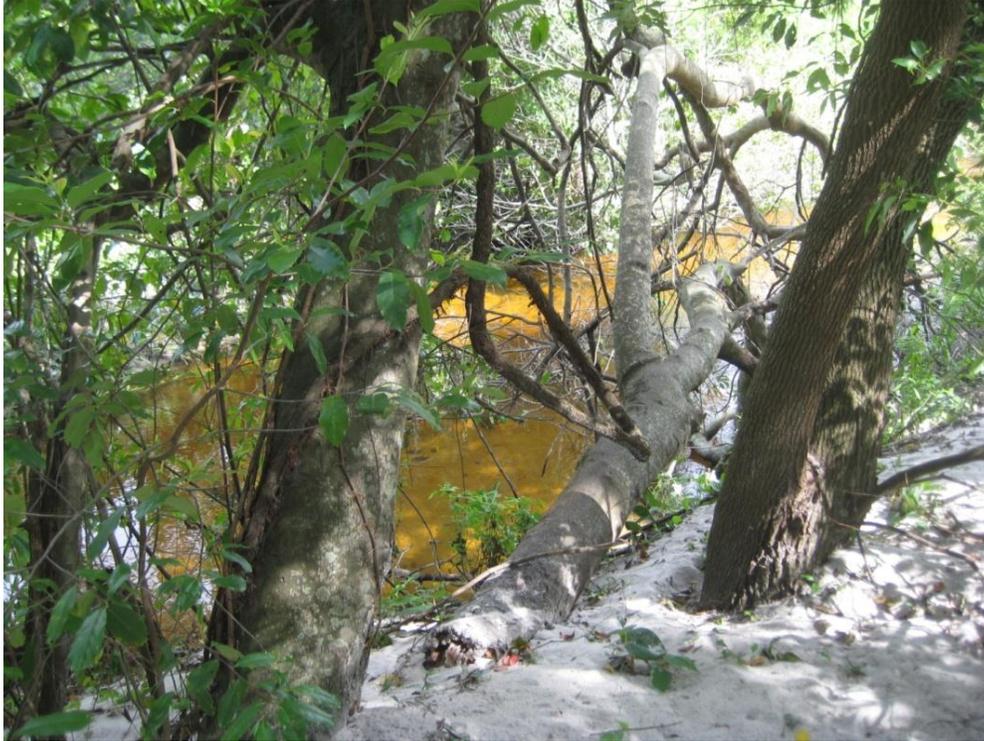
Site Curlew 3 is approximately 0.7 miles upstream of Curlew 2, 100 feet downstream of County Road 1. The channel is narrower than downstream reaches but the bed material appeared to be similar to Curlew 2, with about 2 inches of soft sand. Figure 4-18 shows tree damage caused by bank erosion. Figure 4-19 illustrates overbank shoaling at a residential lot caused by recent high flows in the stream.

Figure 4-18. Site Curlew 3 looking downstream showing tree downed during high flows.

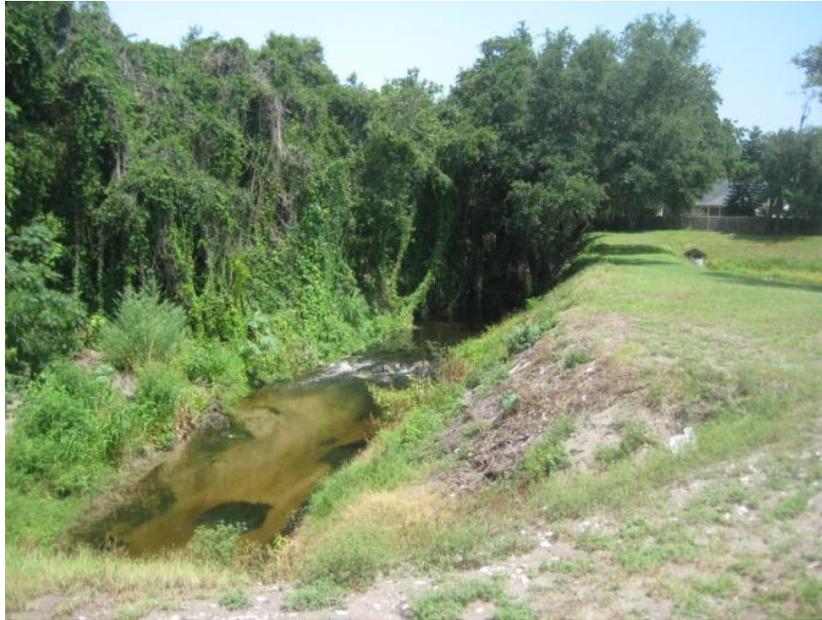
Figure 4-20. Site Curlew 4 looking upstream.

retention pond that was constructed in association with County Road 1 improvements. It is likely that the relatively steep south channel bank contributes material to the creek during rainfall events. Downstream, the bottom was generally clean with 2 – 3 inches of loose sand. Patches of fine-grained material and bottom algae were observed, but no major accumulations were noted.

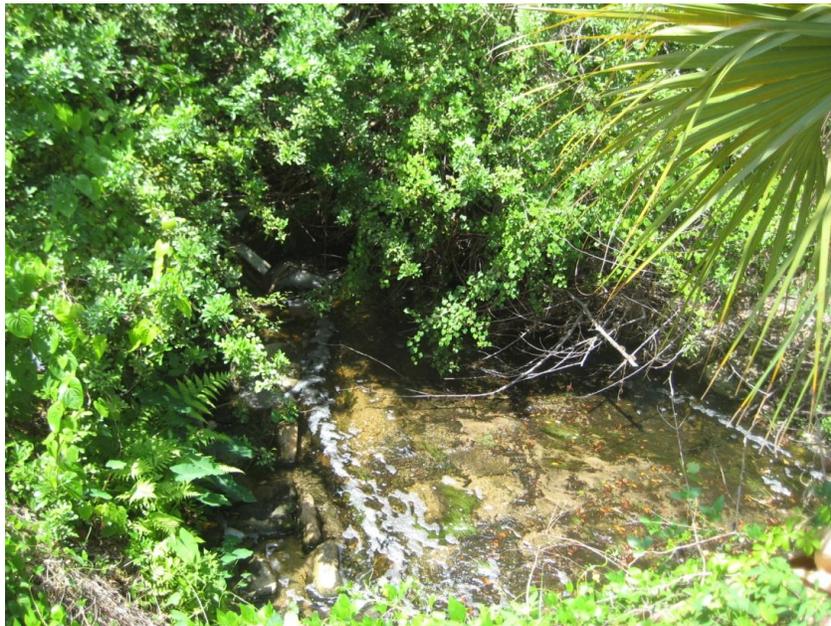
Figure 4-21. Site Curlew 5 looking downstream.

Site Curlew 5 is on the main stem at Estancia Blvd east of US 19. The channel was overgrown and had a sand bottom with 2 – 3 inches of loose sand. Figure 4-21 shows site conditions.

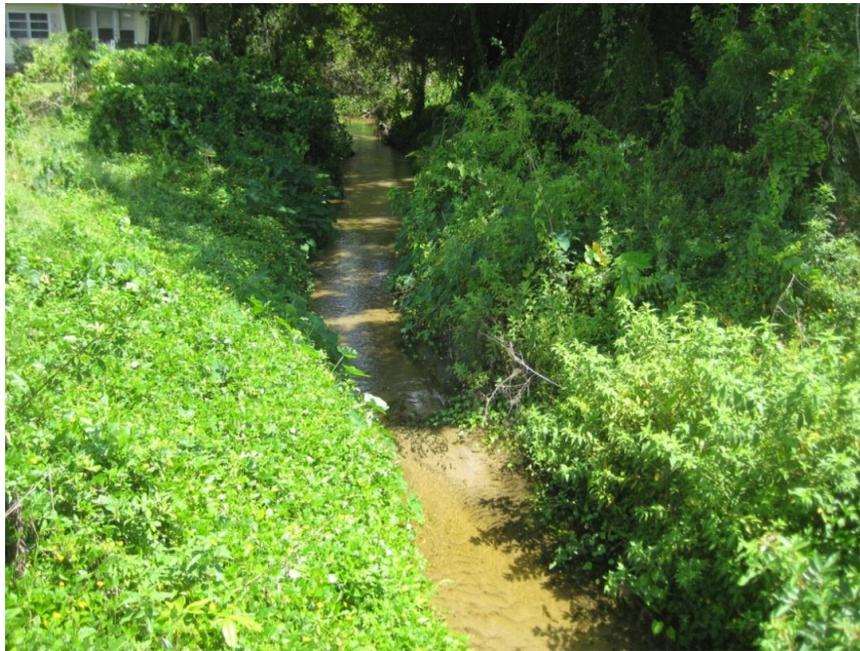
Figure 4-22. Site Curlew 6 looking upstream.

Site Curlew 6 is west of US 19 in Birch Court in the Silk Oak Trailer Park (Figure 4-22). The channel bottom is bare clean sand with some rocks with some shoaling and 3 – 4 inches of loose sand.

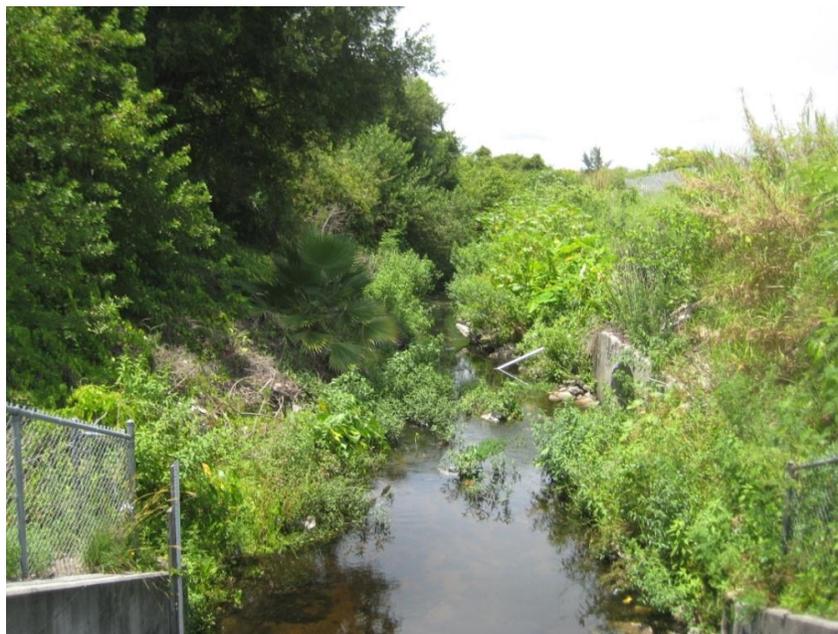
Figure 4-23. Site Curlew 7 looking downstream.

Site Curlew 7 is west of US 19 and north of Evans Road (Figure 4-23). The channel bottom was composed of coarse sand with silt and about 2 inches of loose sand. There is substantial debris in the channel, which receives runoff from an adjacent shopping center parking lot.

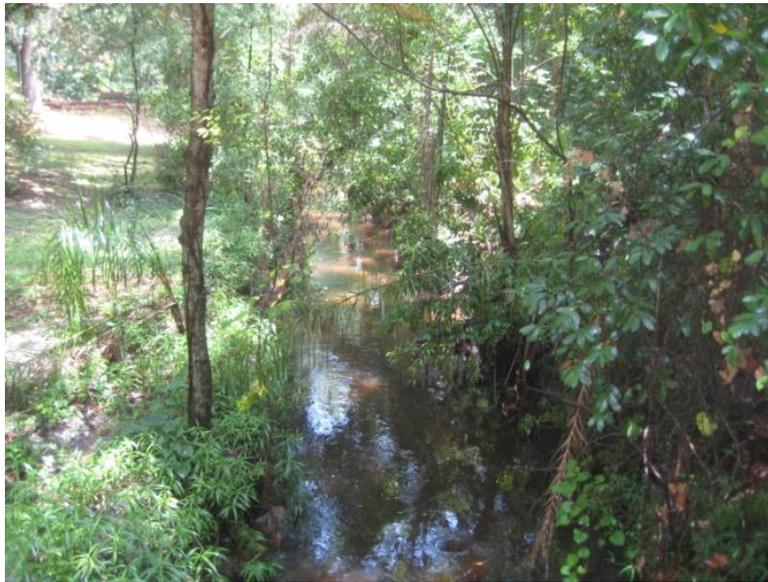
Figure 4-24. Site Curlew 8 looking upstream.

Site Curlew 8 is located on Brady Drive east of County Road 1 and is on Jerry Branch, a tributary of Curlew Creek. This is at one of the reaches within the Curlew Creek system with a higher channel slope. Figure 4-24 shows fairly incised banks.

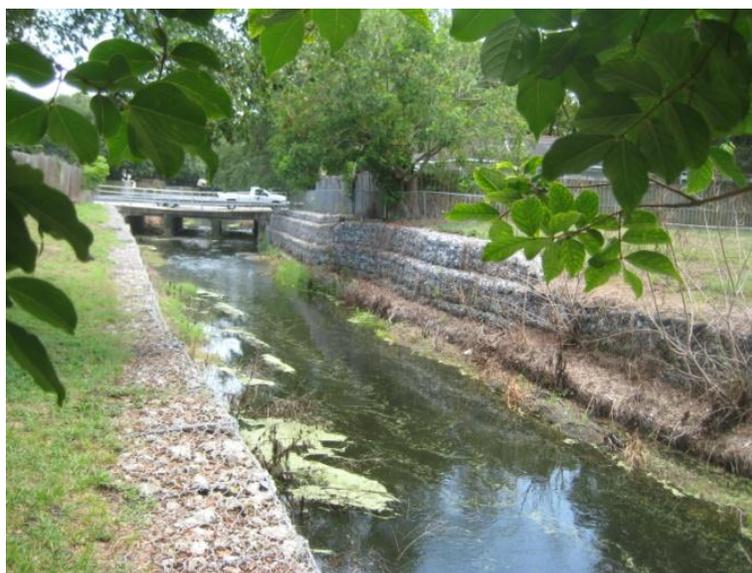
Figure 4-25. Site Curlew 9 looking upstream.

Site Curlew 9 is located at Laurelwood Lane west of Belcher Road. The channel is lined with gabions and is 7 – 8 feet deep as shown in Figure 4-25. There was mainly gravel on the gabion channel bottom.

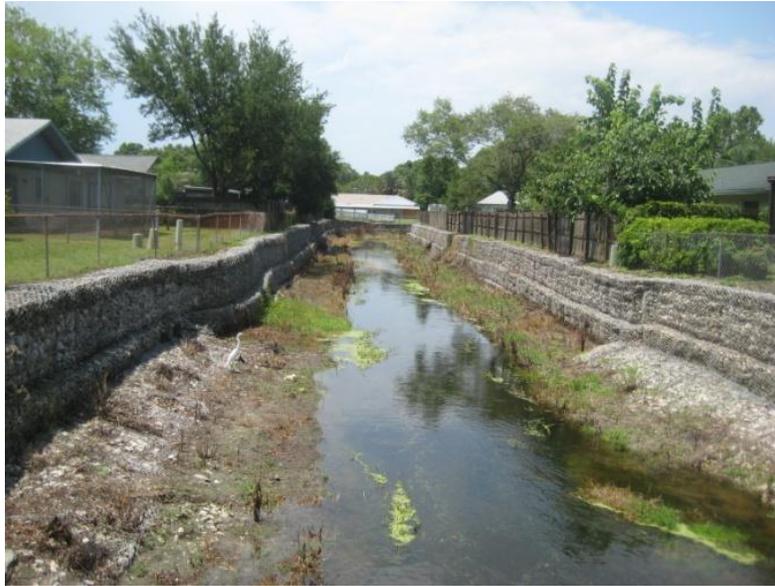
Figure 4-26. Site Curlew 10 looking downstream.

Site Curlew 10 is located at Solon east of Cottonwood Terrace. The channel is lined with gabions as shown in Figure 4-26, however there was a 3 – 4 inch layer of loose sand on the bottom at this site.

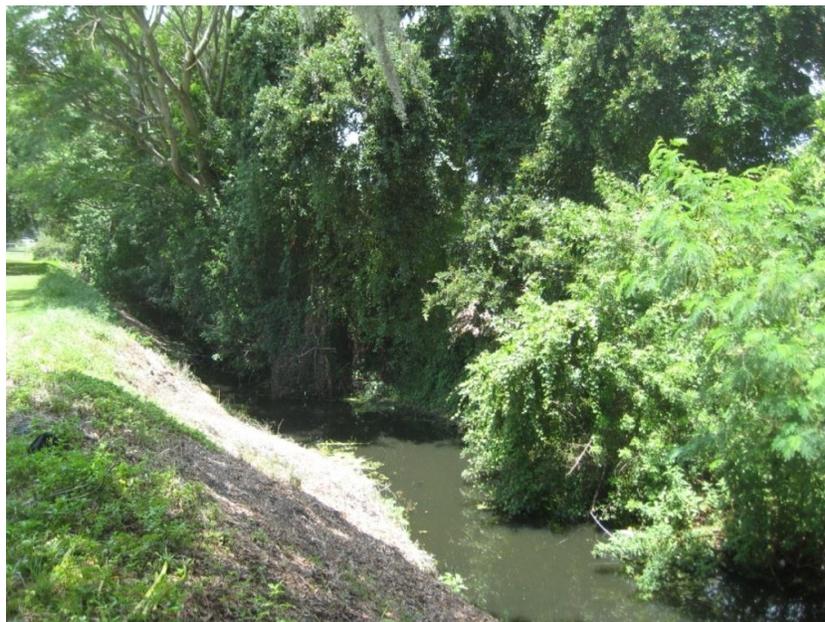
Figure 4-27. Site Curlew 11 looking upstream.

Site Curlew 11 is on Jerry Branch located south of Main Street and east of Creek Park Drive, and is shown in Figure 4-27. The west bank was maintained but the east bank was thickly overgrown. The channel bottom was composed of thick mucky fine-grained material. The 8 – 10 inch thick layer gave off sulfur smell and profuse bubbles when probed. There was limited bank erosion.

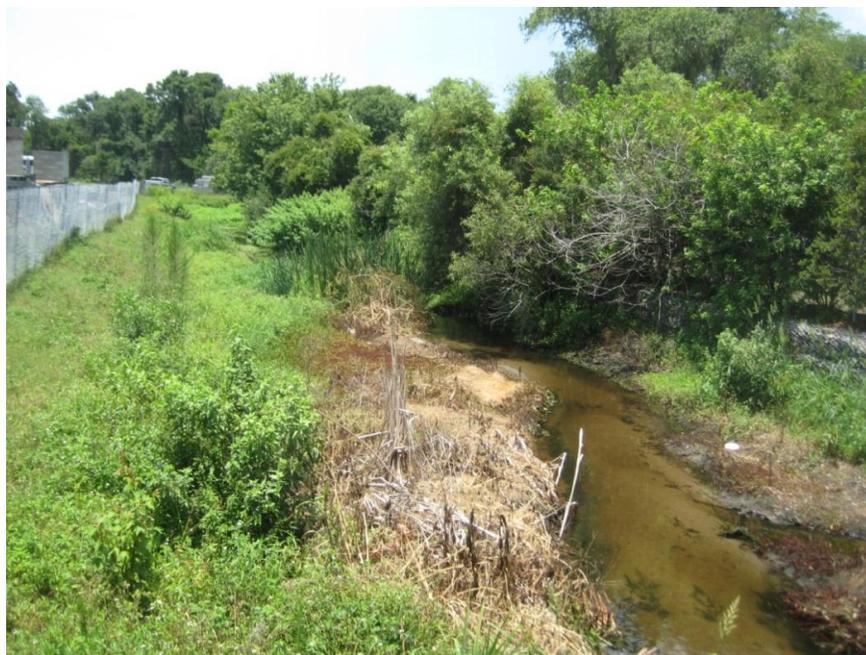
Figure 4-28. Site Curlew 12 looking downstream.

Site Curlew 12 is located at Greenbriar Blvd north of Virginia Ave. Gabions on the east bank are shown downstream in Figure 4-28. Upstream of the bridge both sides of the channel are lined with gabions (Figure 4-29). The upstream channel bottom was relatively clean but downstream a 2 – 4 inch layer of loose sand was observed.

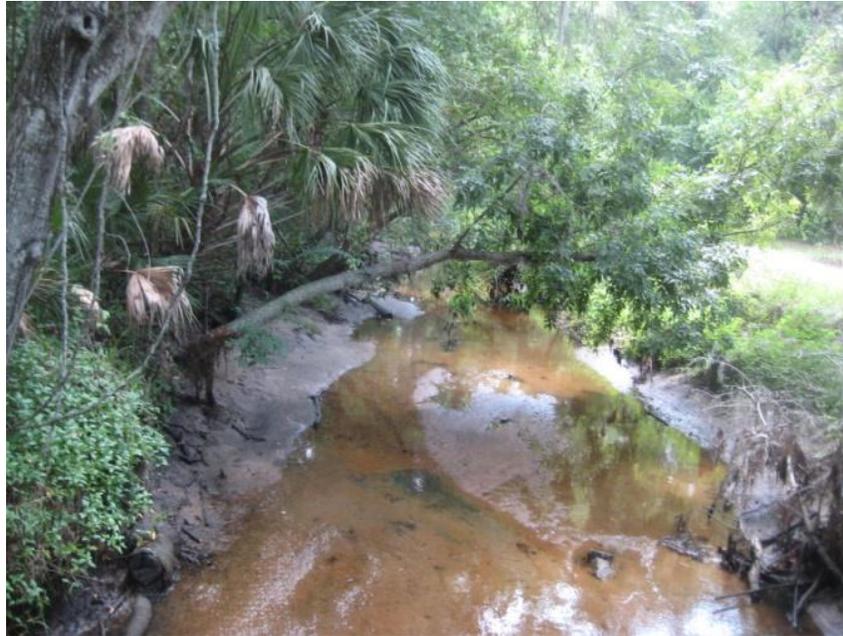
Figure 4-33. Site Cedar 1 looking upstream.

Site Cedar 1 is located in the park at the south end of Harvard Avenue, near Pinellas County water quality monitoring site 9-2. Figure 4-33 shows the channel to have shallow banks and to be relatively clear of fine-grained debris. A layer of loose sand approximately 2 – 4 inches deep was observed. The terrain is fairly flat and the channel has minimal slope.

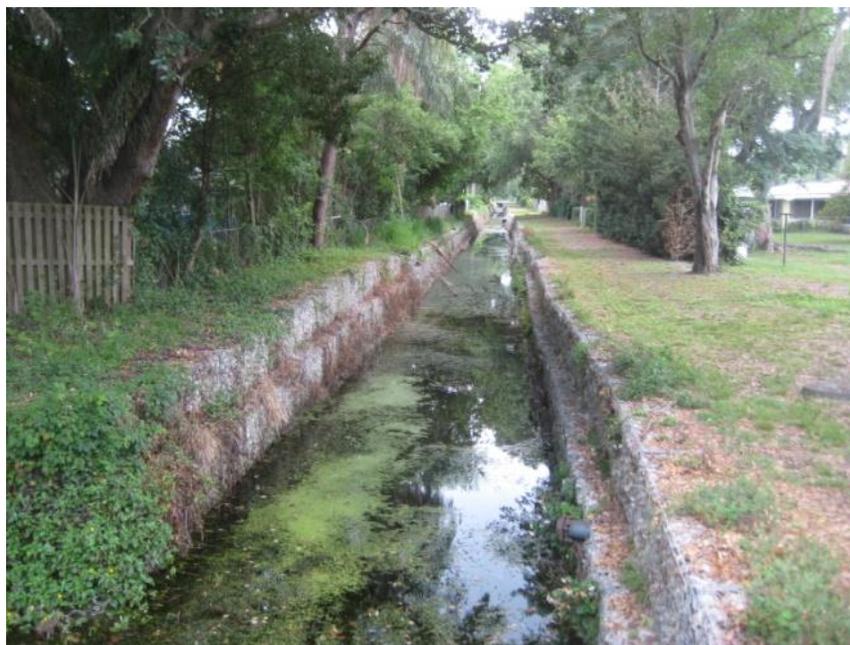
Figure 4-34. Site Cedar 2 looking upstream.

Site Cedar 2 is located west of Pinehurst at the end of Jackmar Road, near Pinellas County water quality monitoring site 9-3. Figure 4-34 shows that the channel is lined with gabions constructed to control channel erosion. Minimal loose sediment was observed at the site.

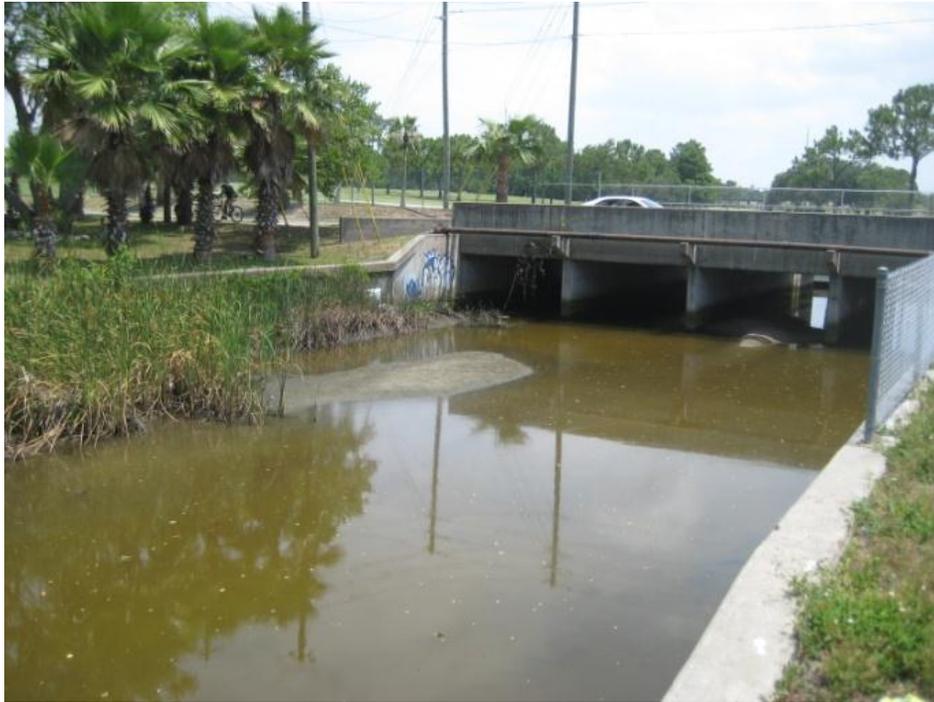
Figure 4-43. Site Stevenson 4 looking upstream.

Site Stevenson 4 is located north of the Palmetto Street crossing, east of Betty Lane. The channel has seawalls on both sides but sediment accumulation on the east side has promoted the establishment of cattails and other vegetation as shown in Figure 4-43. A soft sand bottom approximately 4 inches thick was measured off the west seawall.

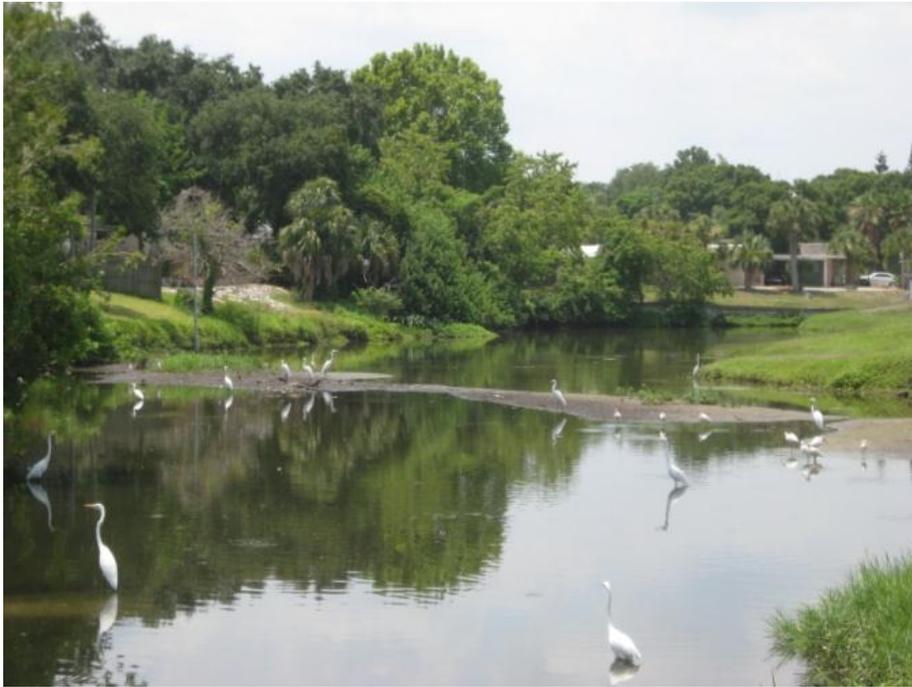
Figure 4-60. Site McKay 6 looking downstream at sediment sump.

- Reducing sediment transport was recommended for one site on McKay Creek. This could be accomplished by the enhancement of an existing sediment sump at SW 8th Ave.
