Historical Longshore Bar Mapping Tampa Bay, Florida

Roy R. Lewis III
Coastal Resources Group, Inc
P.O. Box 5430
Salt Springs, FL 32134

November 29, 2005

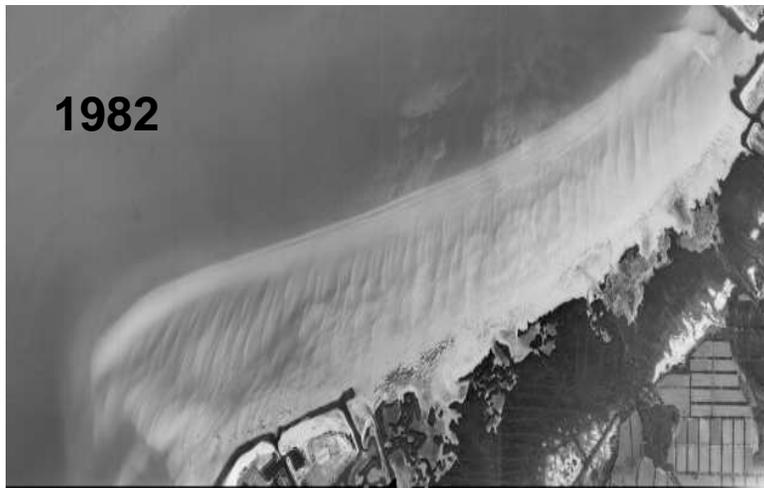
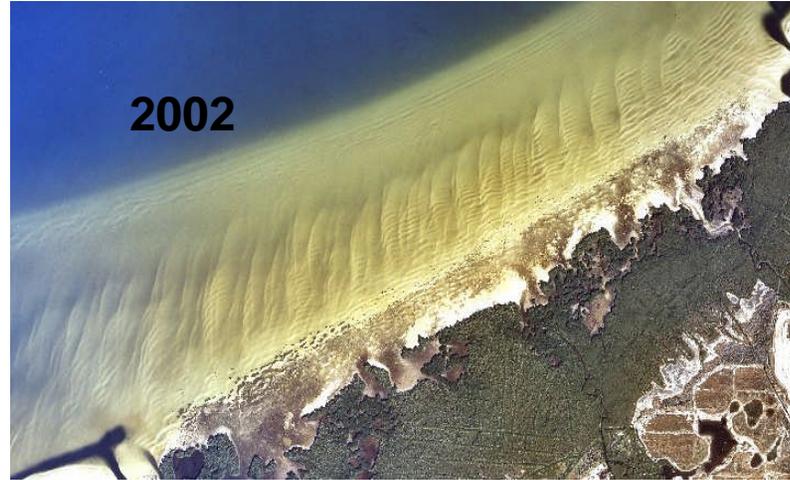
Figure 3. Wolf Branch seagrass bar aerials, 1938,1950,1982,2002.

Figure 1 shows the project study area. Figure 2 shows the seven subdivisions of the bay. Figure 3 contains four vertical aerial photographs at approximately the same scale for the four time periods for the South Interbay Peninsula in Middle Tampa Bay. Figure 4 contains four vertical aerial photographs for the same time periods for the Wolf Branch area also in Middle Tampa Bay. Figures 5-8 show the results of the mapping for the four time periods: Circa 1940, 1950, 1980 and 2004. Figure 9 shows the combined information for all time periods on a single background map.

The results of the photointerpretation and mapping are summarized in Tables 1 and 2, and Figures 10 and 11. For the bay as a whole, the total length of longshore bars has decreased by approximately 50% (- 56.8%), while the number of longshore bars and more than doubled, from 126 circa 1940 to 280 in 2004 (+222%), after a sharp decline from 126 visible features circa 1940, to only 93 circa 1980. The decline in total length we attribute to the overall decline in seagrass meadow coverage during the same period, and the resulting loss of stabilizing cover on both the seaward and landward sides of the longshore bars as hypothesized by Lewis et al. (1985) and Lewis (2002). The initial decline, followed by the recent increase in numbers of bars we attribute to the same loss of stabilizing cover and now a gradual recovery process, but with smaller linear features which may, over time, coalesce to form more singular features. The process of decline in overall seagrass coverage coincident with loss of the longshore bar is apparent in the aerial photographs in Figure 4 for the Wolf Branch area of Middle Tampa Bay. The decline and recovery process is illustrated by the series of aerial photographs in Figure 3 for the south Interbay Peninsula area.
