**RESTORATION OF SEAGRASS HABITAT IN TAMPA BAY USING
LARGE MANATEE GRASS (*SYRINGODIUM FILIFORME*) SOD
UNITS AND A DISCUSSION OF PLANTING SITE SEDIMENT
ELEVATION DYNAMICS**

the Hillsborough County Environmental Recovery Fund
Project 06-02

J.O.R. Johansson, W.M. Avery, K.B. Hennenfent and J.J. Pacowta
City of Tampa, Bay Study Group

February 2, 2009

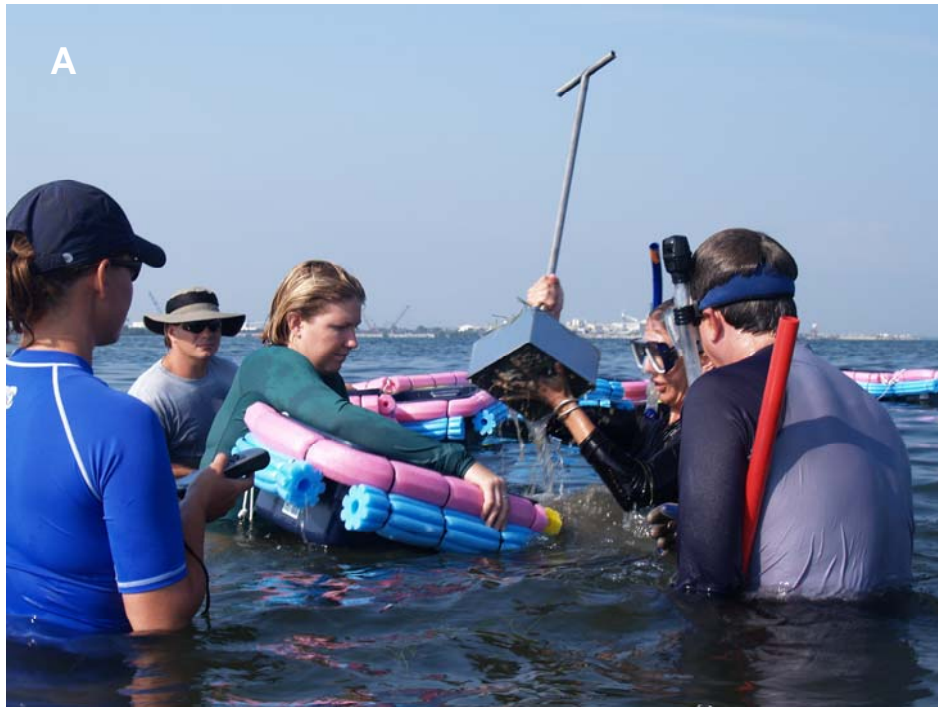
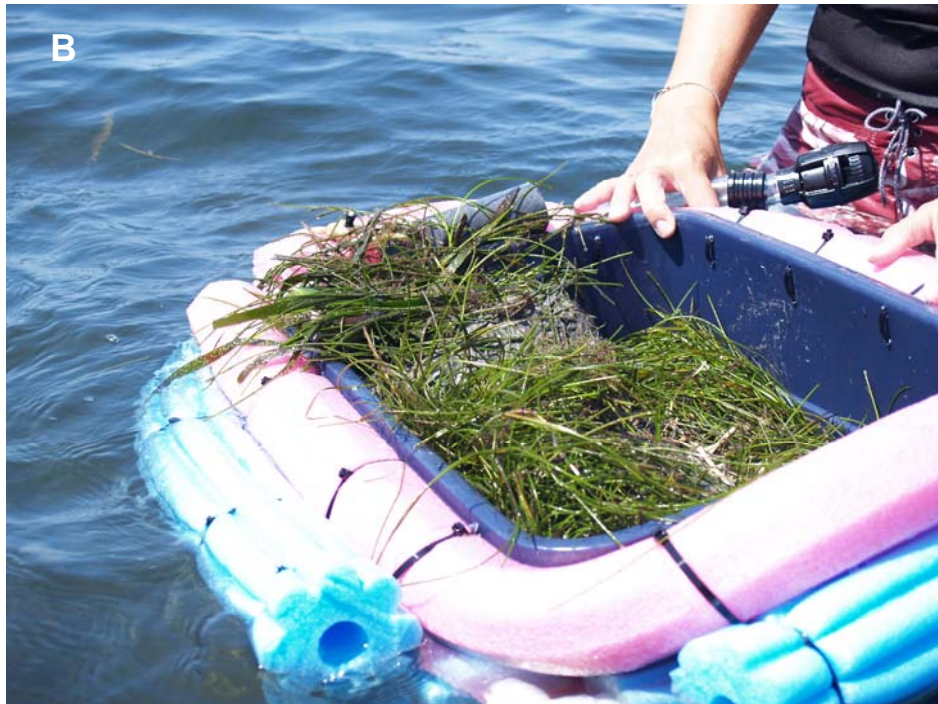
Figure 3. Harvesting of manatee grass sod units, showing (A) stainless steel collection device and WAAS corrected GPS recorder, and (B) sod transportation container.

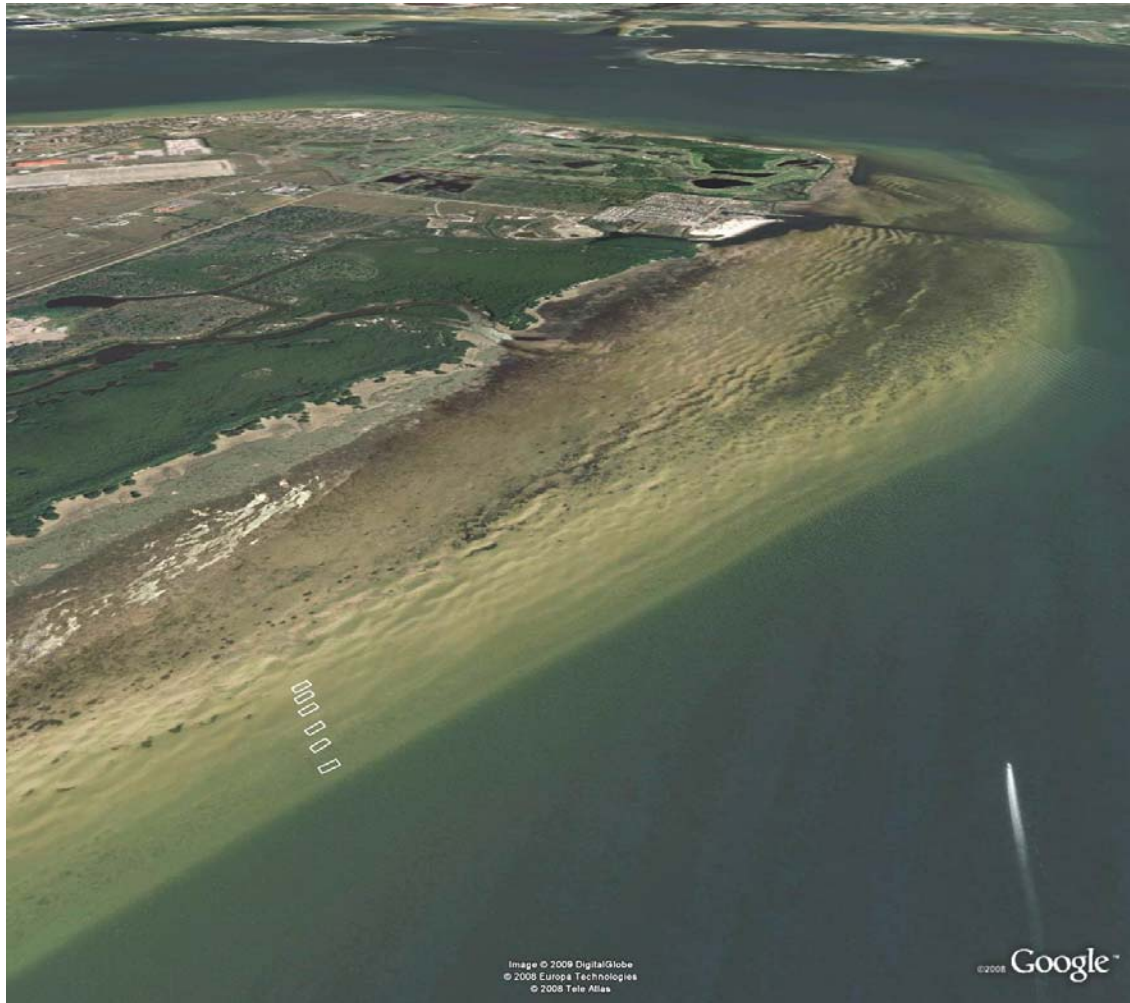
Figure 4. Location of the six manatee grass planting plots on the estuarine shelf south of MacDill AFB in Middle Tampa Bay. Planting Plot 1 is the most off-shore plot and Plot 6 is the most near-shore plot. Hillsborough Bay is seen in the background.

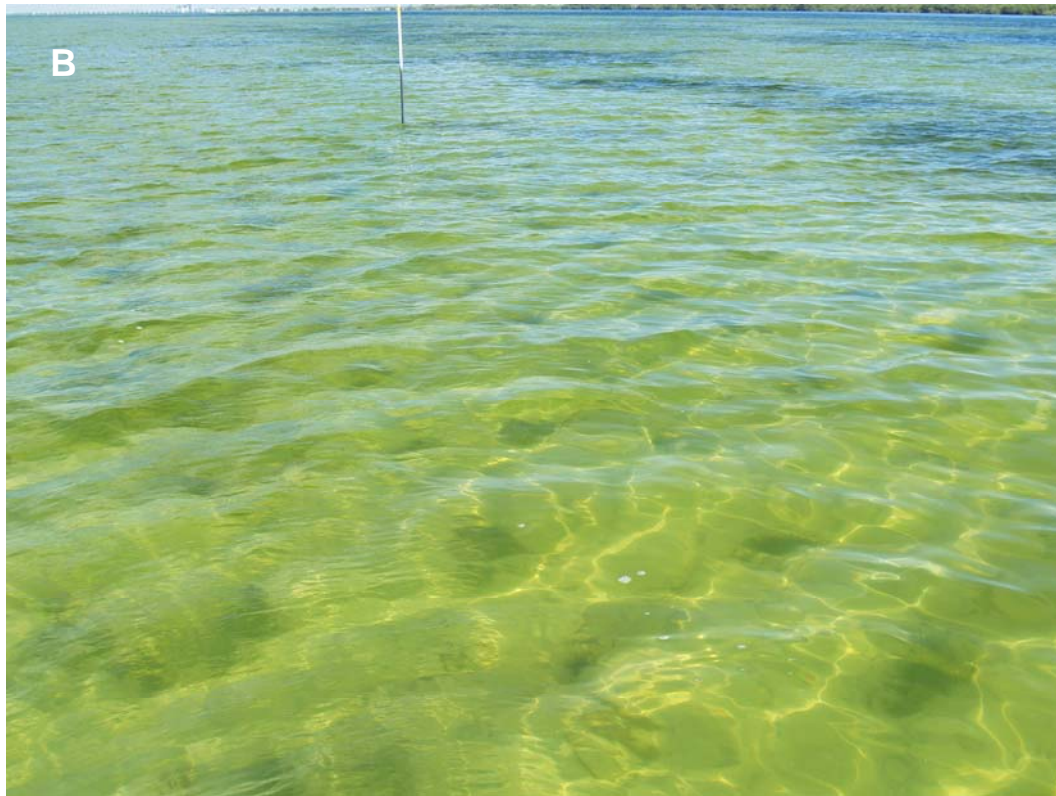
Figure 6. (A) Drawing showing the planting design of the manatee grass sod units used for each of the six planting plots. Planting units were placed on 1m centers in the 10m by 20m plot area. (B) Photo of the freshly planted sod units.

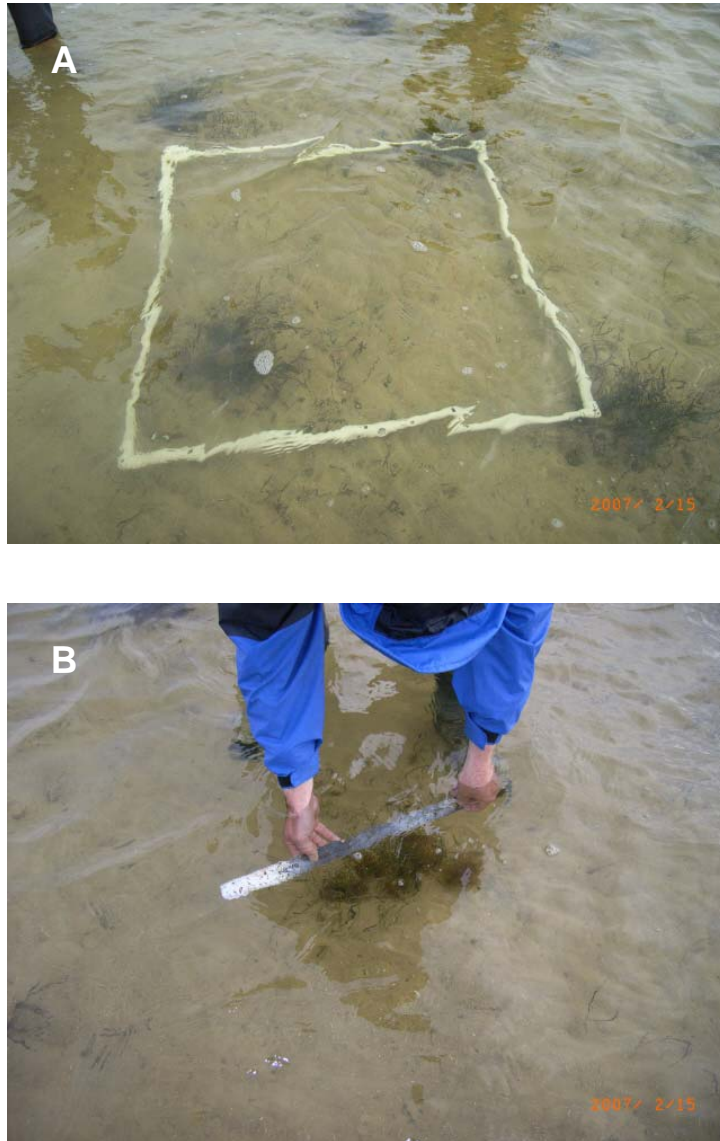
Figure 7. Monitoring of the planted manatee grass sod units. (A) Measurements of percent seagrass coverage and (B) area coverage.

Coalition of the planted manatee grass sod units was first noted during the monitoring survey in January 2007. Because of the ongoing coalition, a modified monitoring technique was used for that and subsequent surveys of the manatee grass growing within the perimeter of the planting plots. The new method used 20 randomly placed 1m^2 quadrates within each planting plot to determine the above listed seagrass characteristics. Further, area coverage of the planted manatee grass for each of the six planting plots was estimated by multiplying the average percent cover from the 20 1m^2 placements by the plot area (200m^2).

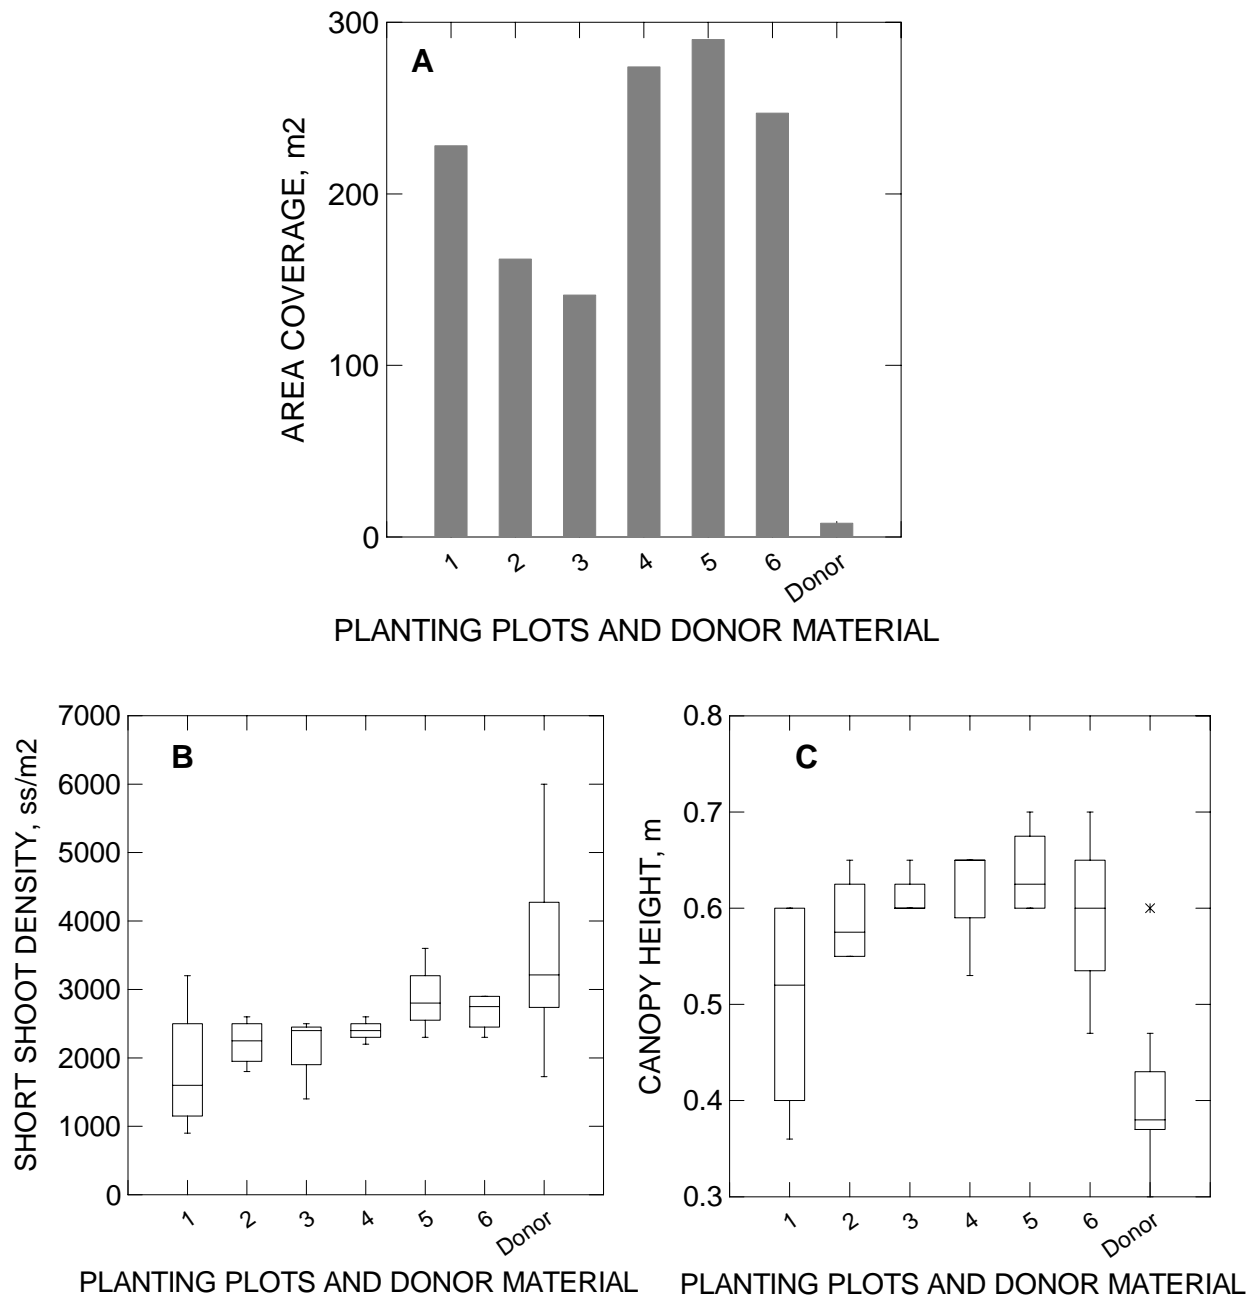
Figure 9. Comparison of results from the September 2008 monitoring of seagrass characteristics for the planted manatee grass at each planting plot and the initial characteristics of the donor material: (A) area coverage (please note that all plots initially had 8m² of total coverage), (B) short shoot density and (C) canopy height.

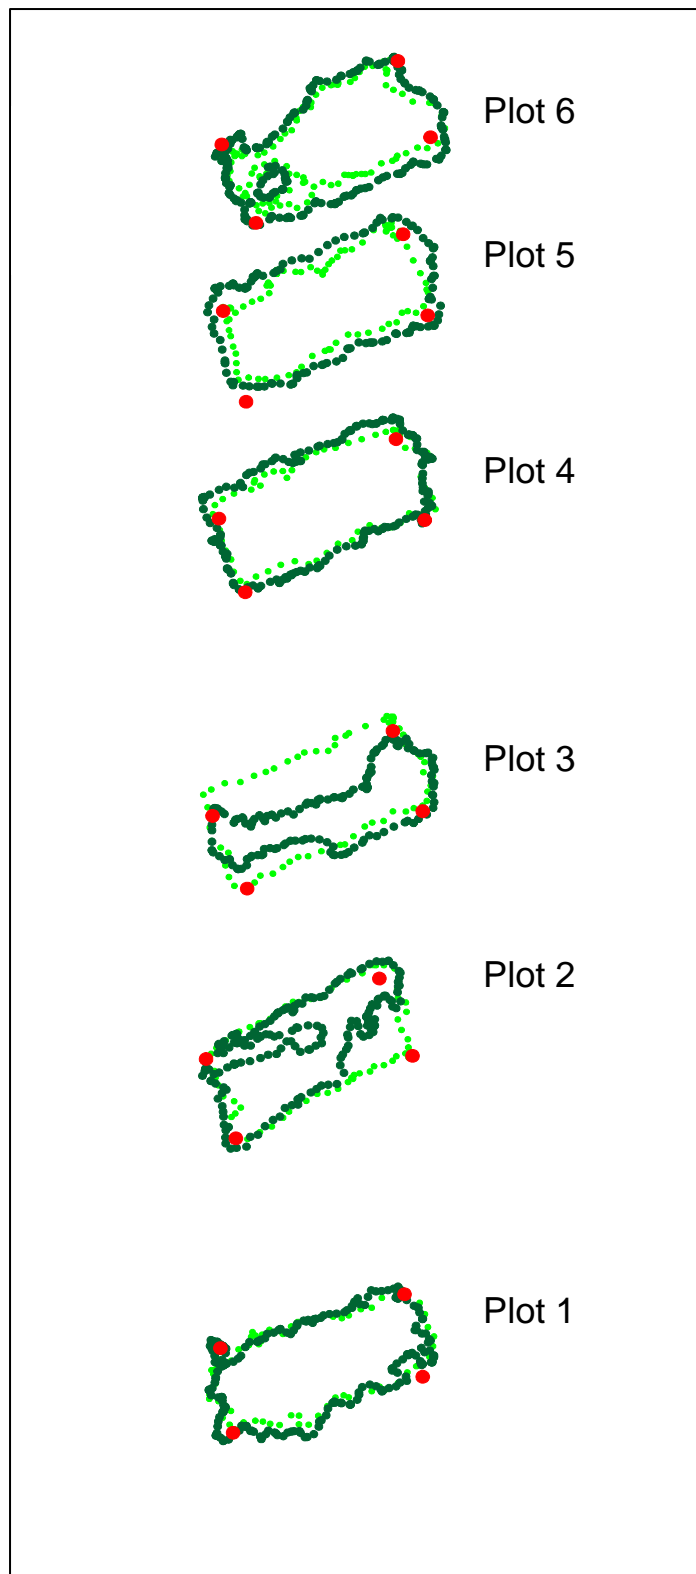
Figure 10. Perimeter surveys of manatee grass area coverage at the six planting plots conducted in January (light green symbols) and September 2008 (dark green symbols). The planting plot corner posts are also shown. The short sides of the plots are 10m.

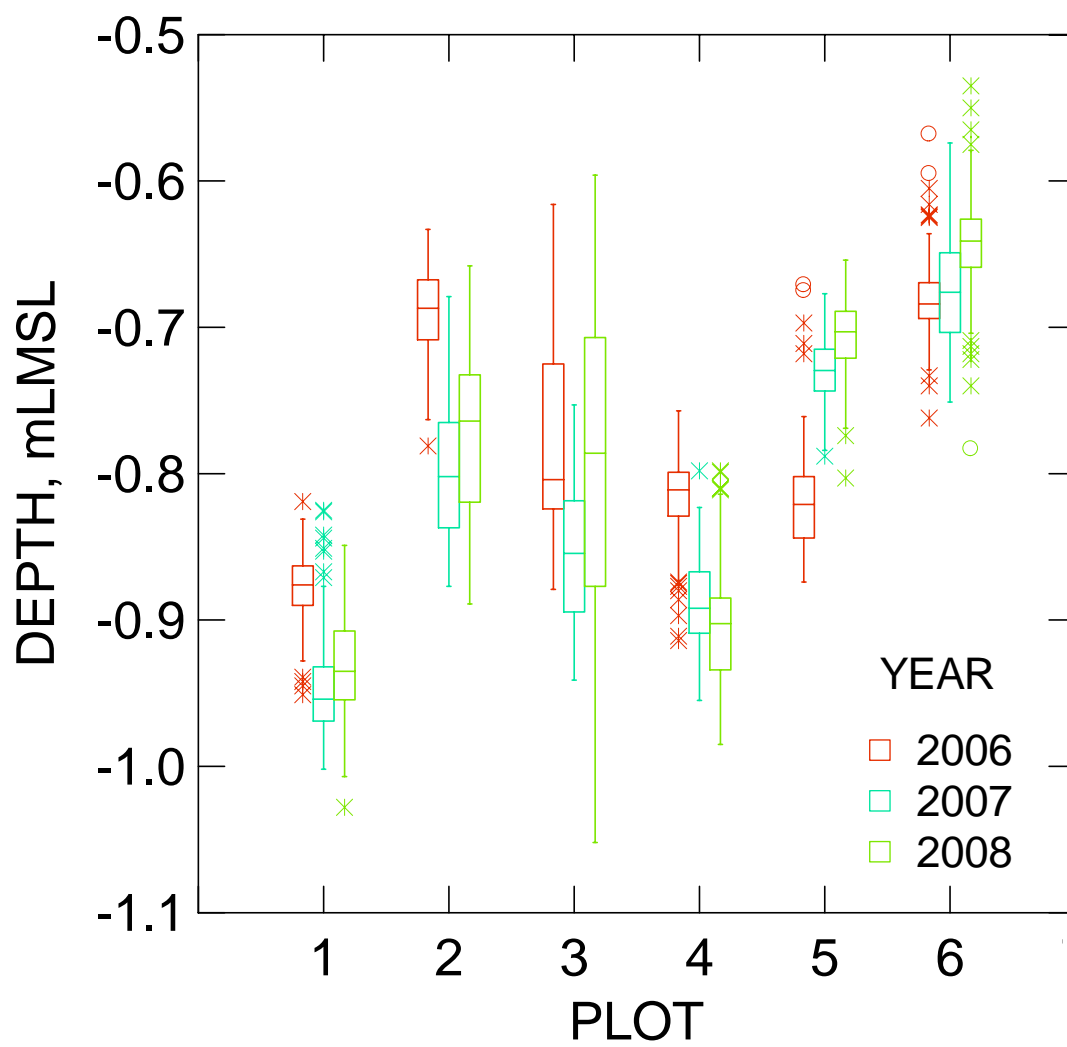
Figure 11. Box and whisker plots of measured sediment elevations (water depth at local mean sea level) within the perimeters of the six planting plots. Surveys were conducted in summer 2006, 2007 and 2008.

Plot 2. The depth of the planted plot increased substantially over the two year study period and the area just shoreward of the plot became substantially shallower (Figure 11 and 13A). The manatee grass coverage and density were, when compared to several other plots, relatively sparse and thin after two years of growth (Figure 9). It is not likely that the planted manatee grass caused the sediment accumulation noted in the shoreward area because areas both east and west of the shoreward area, which lacked manatee grass, had similar sediment accumulation.

Plot 3. The depth of the planted plot changed little over the two year study period; however, the south-east section became substantially deeper (Figure 11 and 13B). It will be shown later that all planted manatee grass was lost in this deepened area. The shoreward area within and just outside the plot became moderately shallower. The manatee grass coverage was relatively sparse after two years of growth when compared to several other plots and the density was relatively low (Figure 9). It is doubtful that the sediment accumulation noted in the shoreward area was caused by the relatively sparse manatee grass, because as with Plots 1 and 2, areas both east and west of the shoreward area had similar or greater sediment accumulation than the shoreward area.

Plot 4. The planted plot became substantially deeper over the two year study period, and the area just shoreward of the plot became slightly deeper (Figure 11 and 13B). The manatee grass coverage and density were both relatively high after two years of growth (Figure 9). However, no sediment accumulation was noted in the shoreward area and it appears that the well developed manatee grass in this planting plot had little or no impact on sediment accumulation.

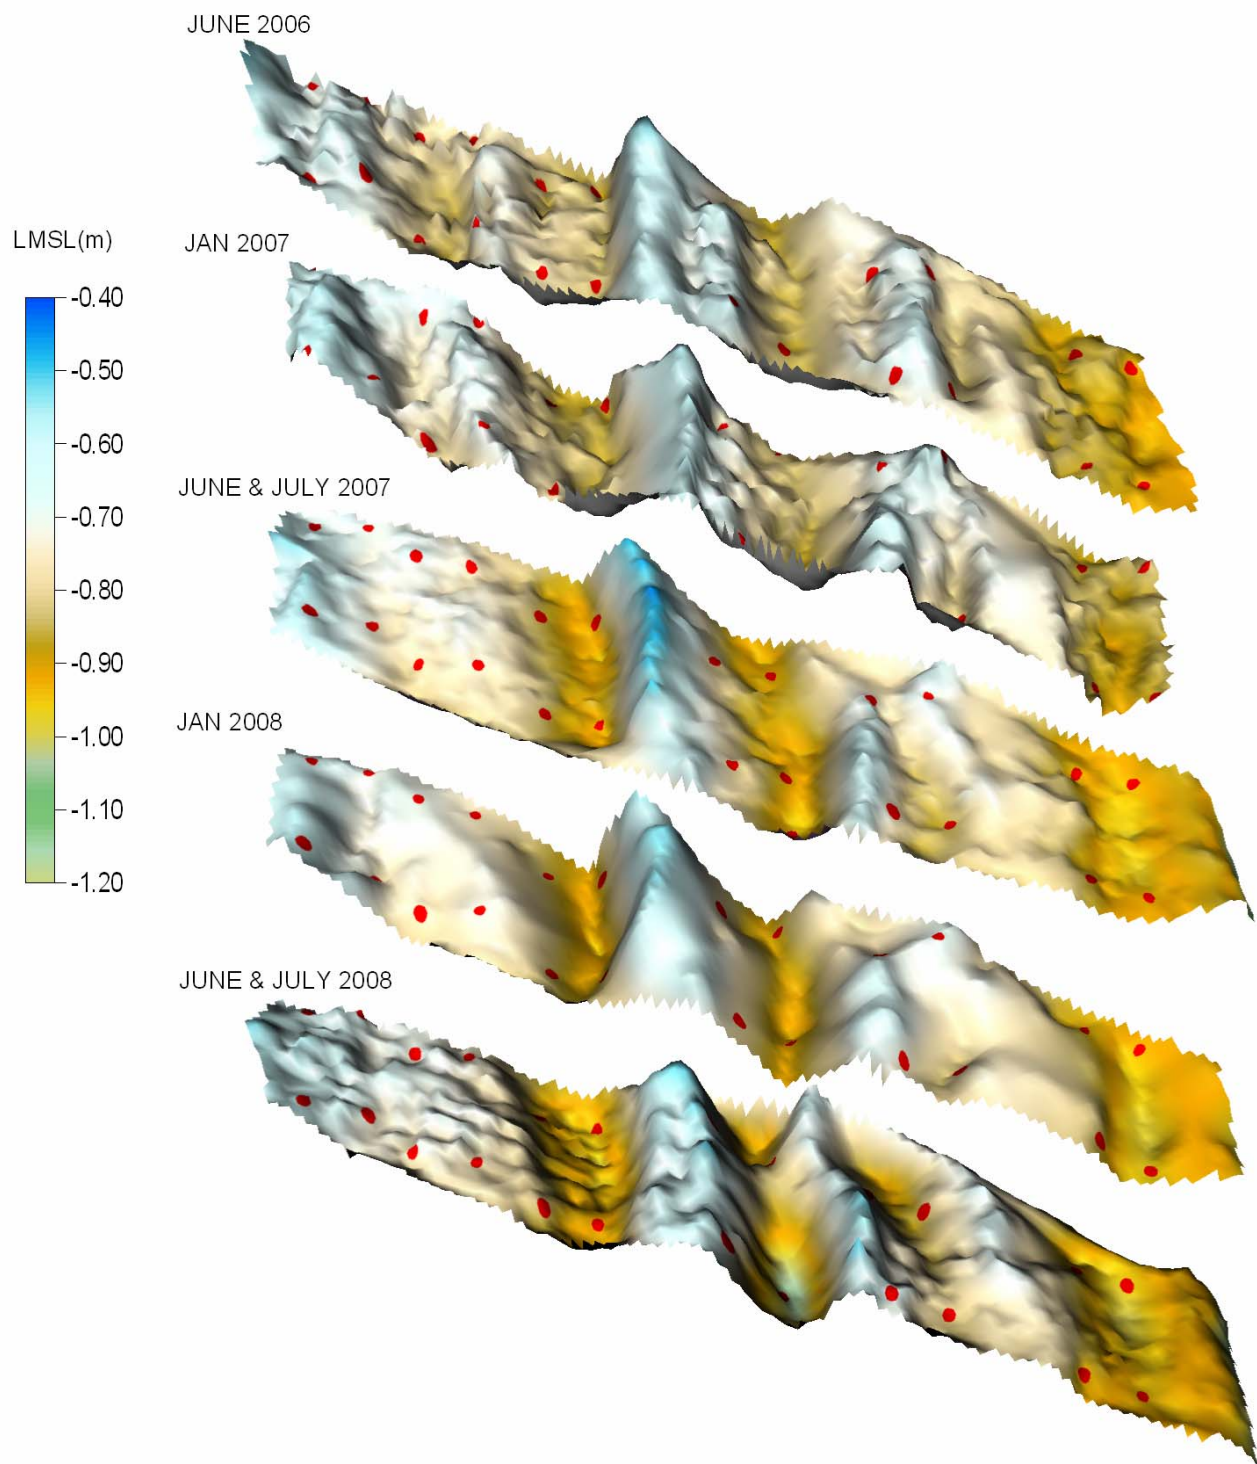
Figure 12. Sediment elevation surface plots showing bathymetry of the planting area at the start of the project and two years later at the end of the project. The red markers show the corners of the six planting plots (Plot 1, the most off-shore plot, is to the right and Plot 6, the most near-shore plot, is to the left).

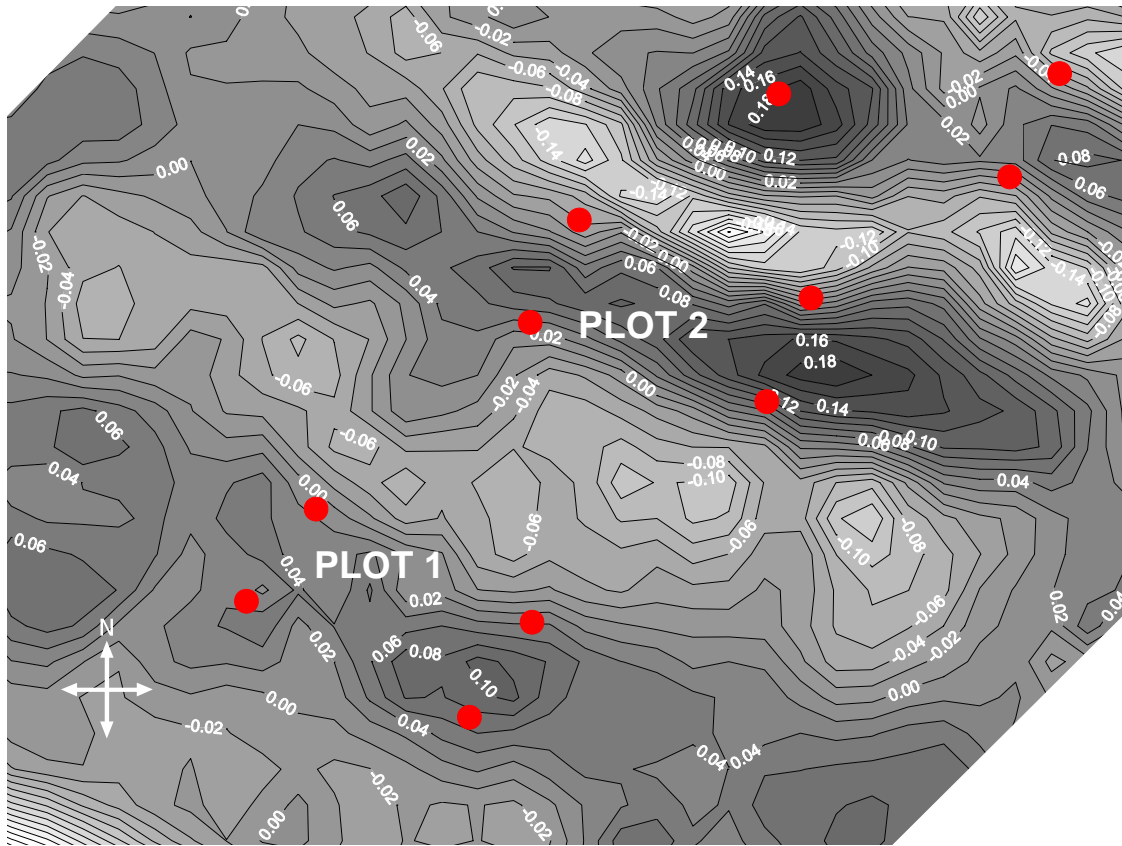
Figure 13A. Contours of sediment elevation change that occurred within and outside planting Plots 1 and 2 over the two year study project. Elevation surveys conducted in summer 2006 and summer 2008 were used for the change analysis. Positive values and dark shading show areas that became deeper, and negative values and light shading indicate areas that became shallower.

The substantial changes in sediment elevations which occurred in the outer-most, and generally deeper, half of the seagrass restoration area over the two year study period were most likely caused by off-shore generated waves impacting the outer edge of the estuarine shelf. The physical impact of waves in this area may have hindered the planted manatee grass to reach the high densities and area coverage attained by the more near-shore and protected plots (see Fonseca and Bell 1998; Koch 2001; Fonseca et al. 2002; Seddon 2004; Cruz-Palacios et al. 2005). Planting Plots 2 and 3 were located in this dynamic section of the planting area (Figure 12). These plots had the lowest manatee grass area coverage of all plots at the end of the study and also low above ground biomass (Figure 9). Further, both plots became overall deeper over the two year study period with sections of the plots losing up to 0.20m of sediments (Figures 13A and 13B).

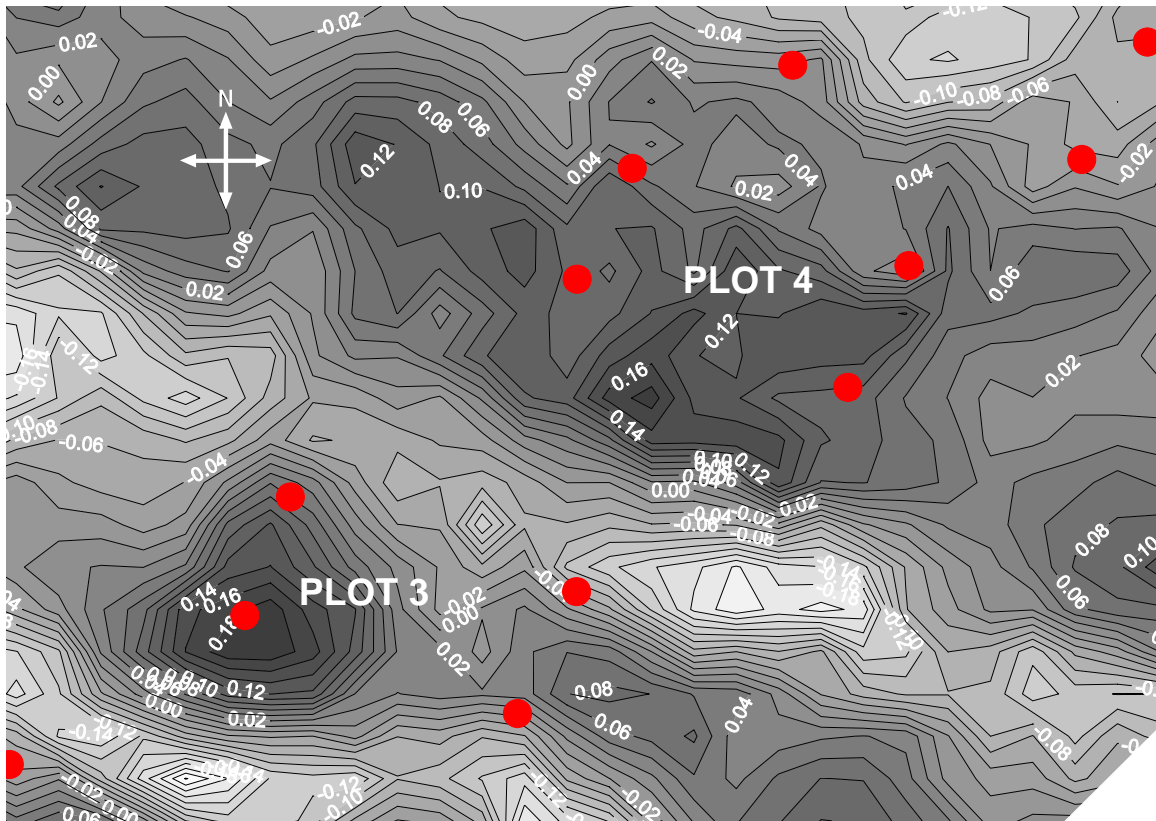
Figure 13B. Contours of sediment elevation change that occurred within and outside planting Plots 3 and 4 over the two year study project. Elevation surveys conducted in summer 2006 and summer 2008 were used for the change analysis. Positive values and dark shading show areas that became deeper, and negative values and light shading indicate areas that became shallower.

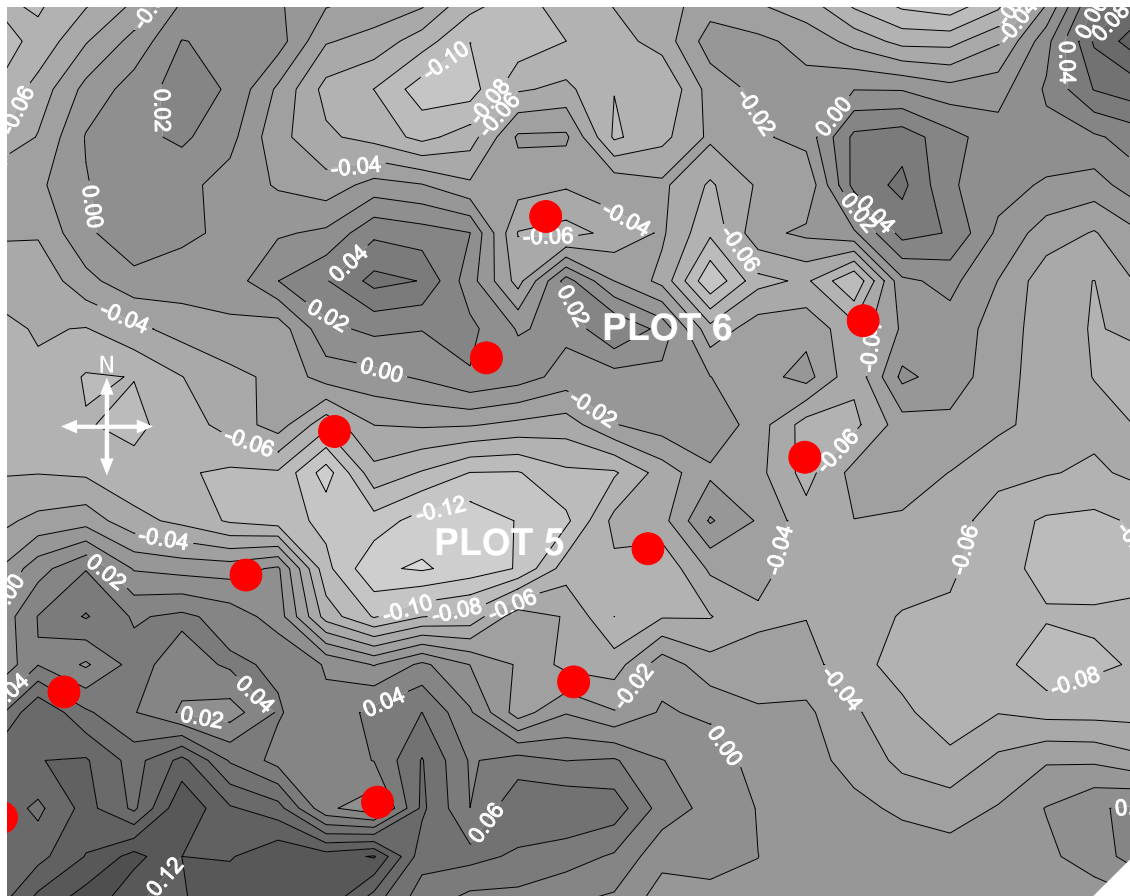
Figure 13C. Contours of sediment elevation change that occurred within and outside planting Plots 5 and 6 over the two year study project. Elevation surveys conducted in summer 2006 and summer 2008 were used for the change analysis. Positive values and dark shading show areas that became deeper, and negative values and light shading indicate areas that became shallower.

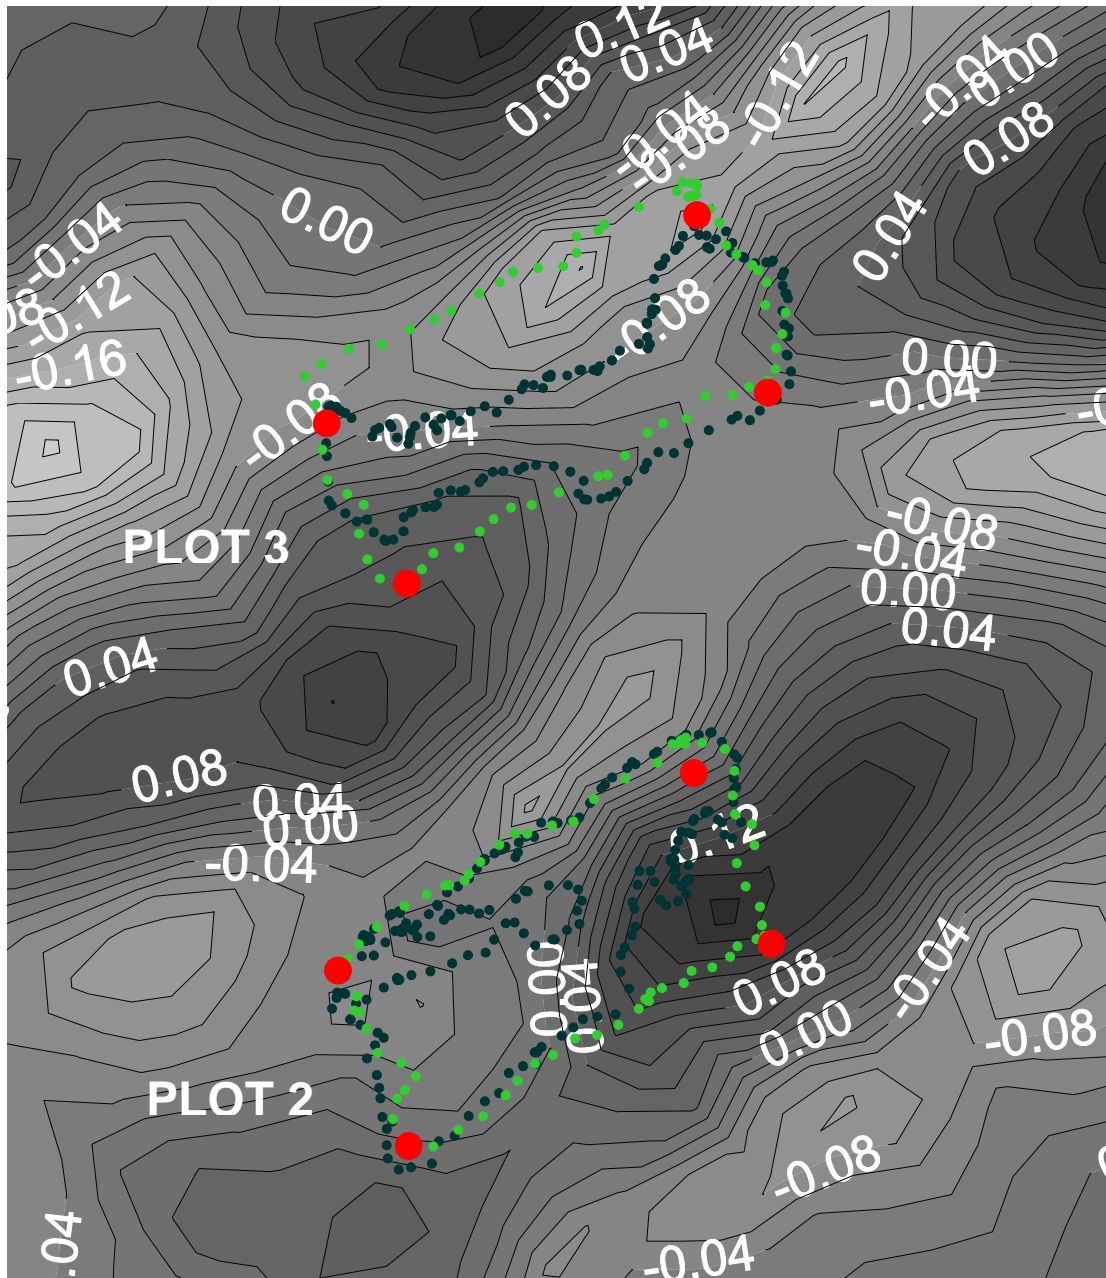
Figure 14. Contours of sediment elevation change that occurred within and near planting Plots 2 and 3 between January 2008 and summer 2008. Positive values and dark shading show areas that became deeper, and negative values and light shading indicate areas that became shallower. Also shown are perimeter surveys of manatee grass area coverage from January 2008 (light green symbols) and September 2008 (dark green symbols). The planting plot corner posts are also shown. The short sides of the plots are 10m.

coverage during the last six months of the project and the losses, specifically, in Plot 3 were considerable (Figure 14). The recent losses make the future outlook for these two plots uncertain. Later it will be shown that these plots apparently were established in the most physically dynamic section of the planting area. Forces such as wave turbulence and sediment scouring and accretion, could be expected to be more detrimental to seagrass growth in this dynamic area than in more quiescent areas. Persistent exposure to these forces may cause additional seagrass losses in Plots 2 and 3 and the eventual demise of the planted manatee grass.

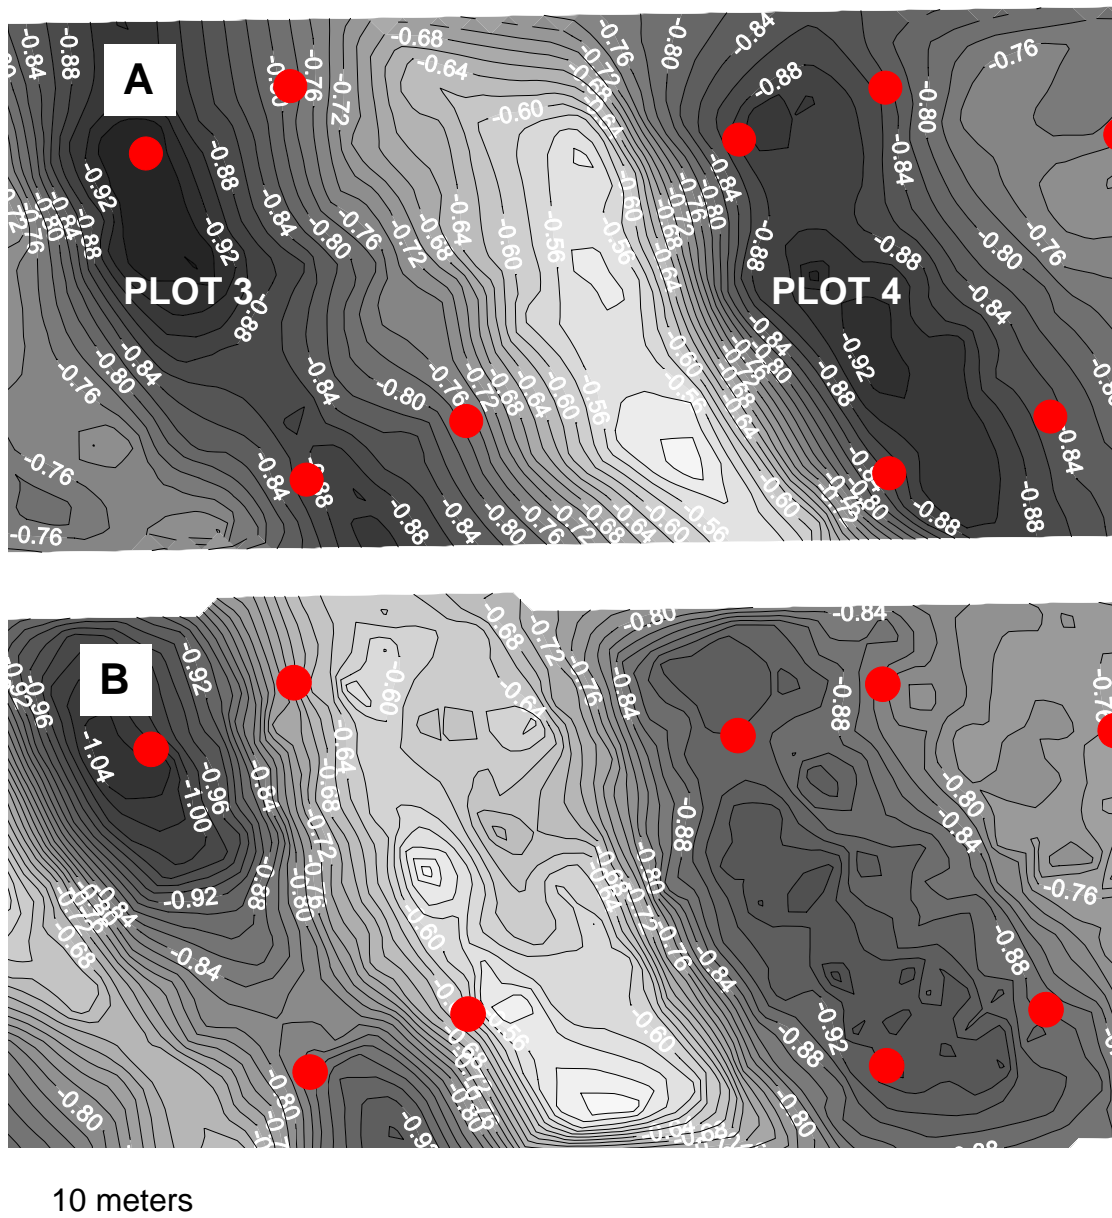
Figure 15. Contour plots showing bathymetry of planting Plots 3 and 4: (A) measurements from January 2008 and (B) measurements from June and July 2008. The red markers show the corners of the two planting plots. Plot 4 is to the right and Plot 3 is to the left. Note the apparent migration of the sandbar between Plots 3 and 4 toward the right, i.e. the off-shore direction. The short sides of the plots are 10m.

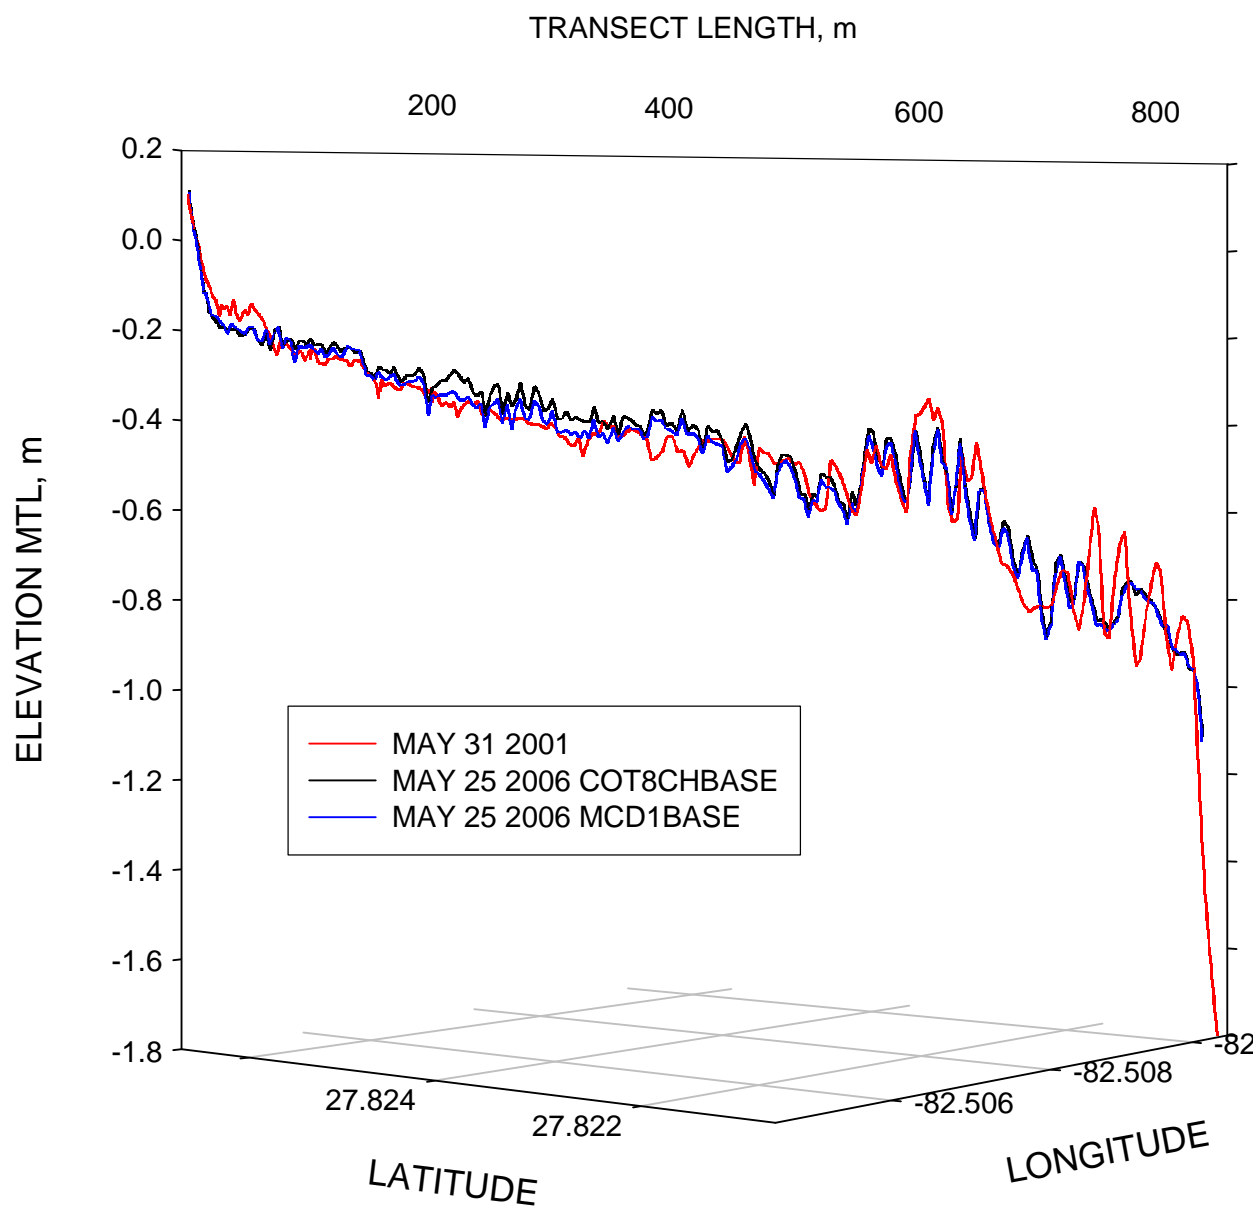
Figure 14. Site bathymetry provided by the City of Tampa Bay Study Group.

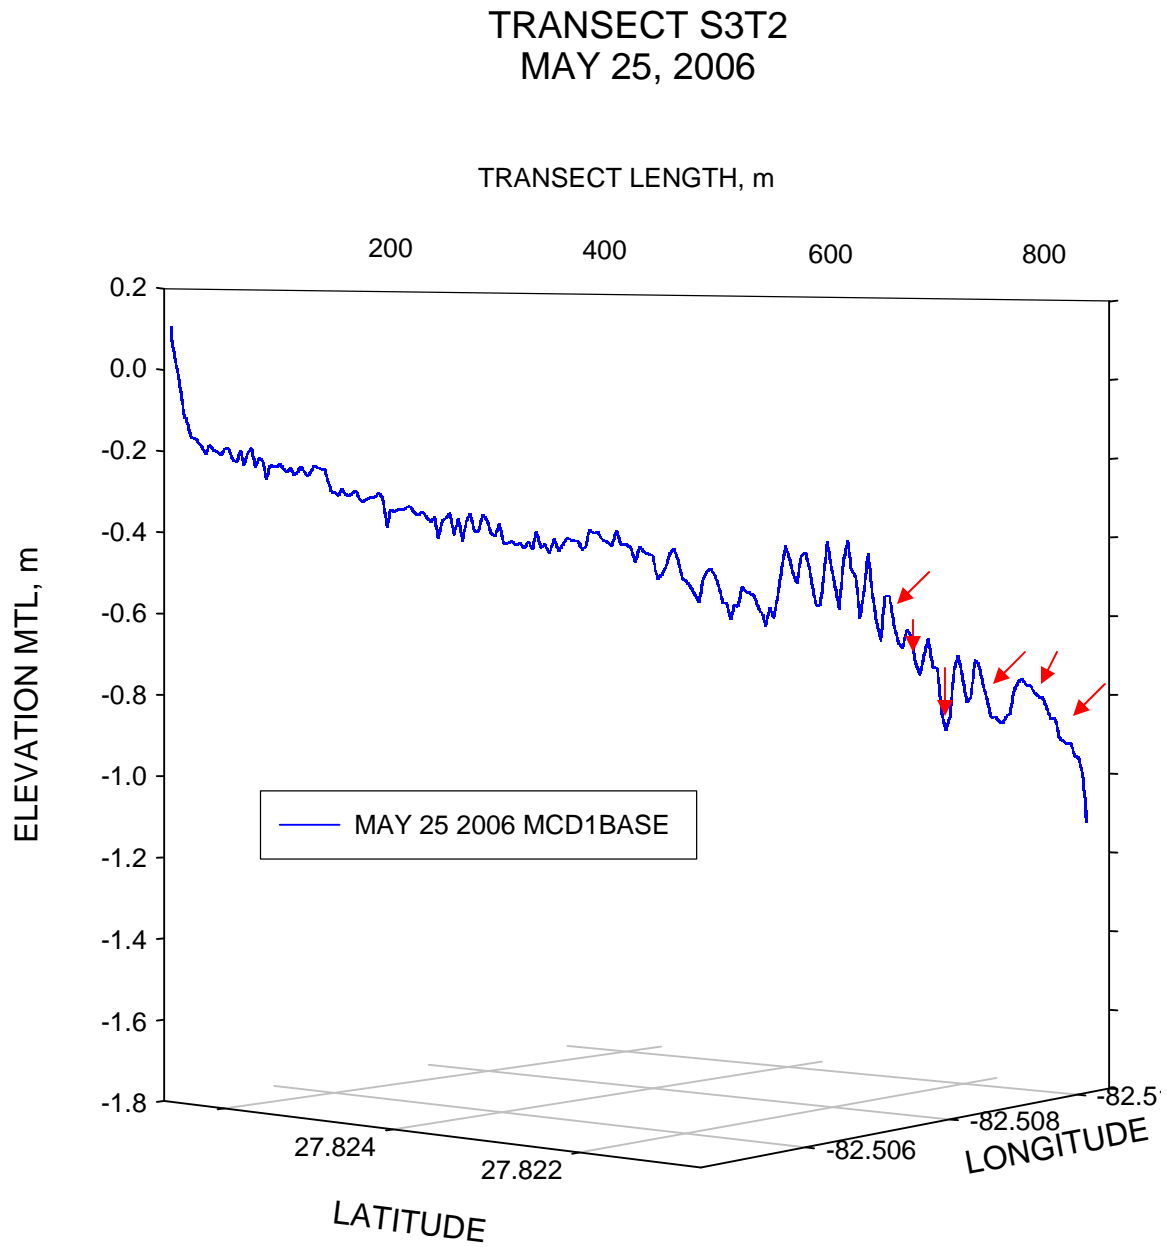
Figure 15. 2005 bathymetry provided by the City of Tampa Bay Study Group with locations of transplant plots approximated.

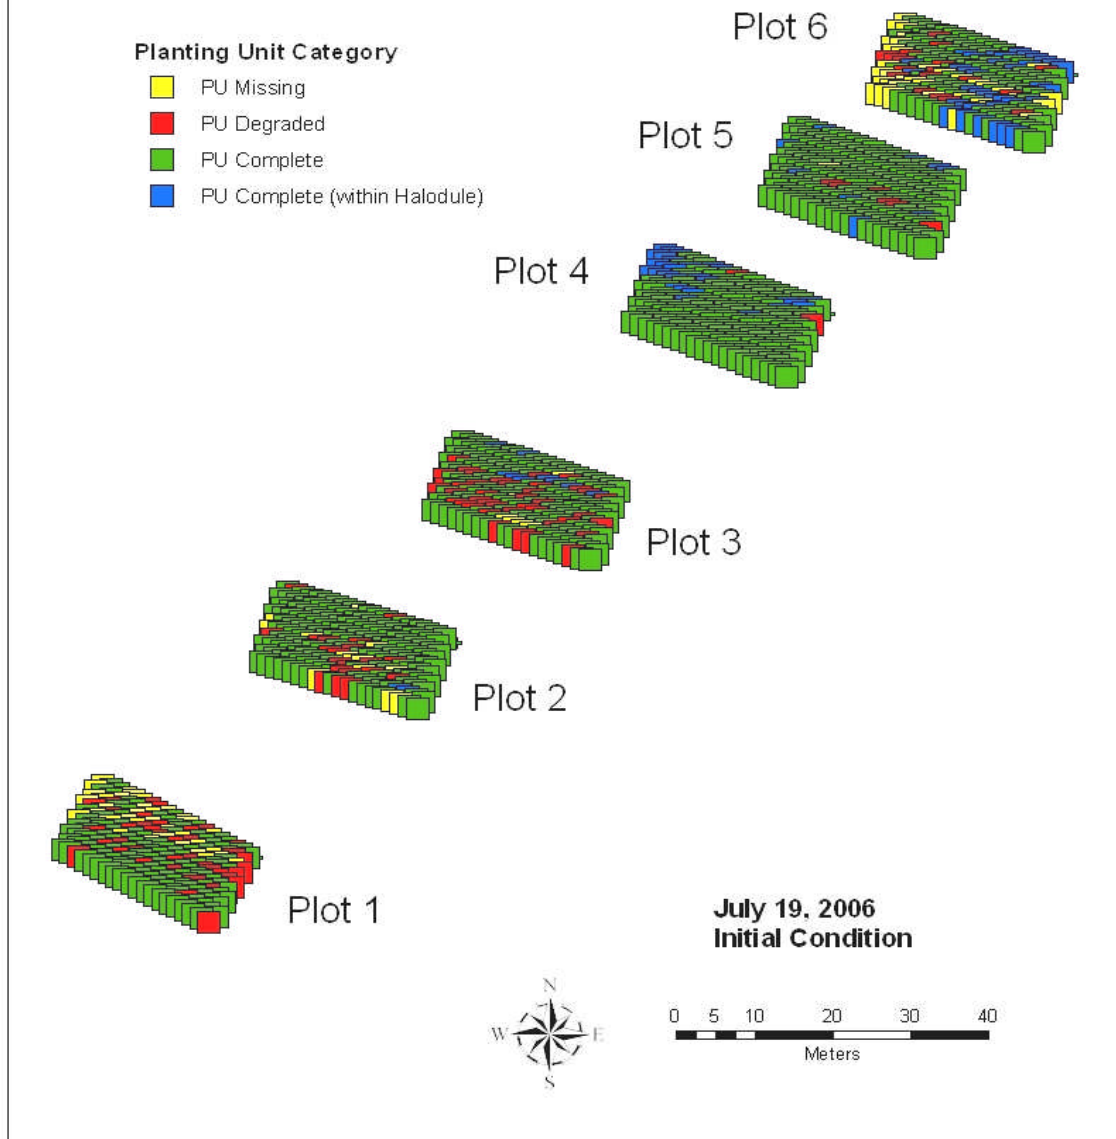
Figure 20. Relative location and initial condition of *Syringodium* transplant plots on shallow bank off MacDill AFB as of July 19, 2006 monitoring event. Graphic provided by Brad Robbins/Mote Marine Lab.

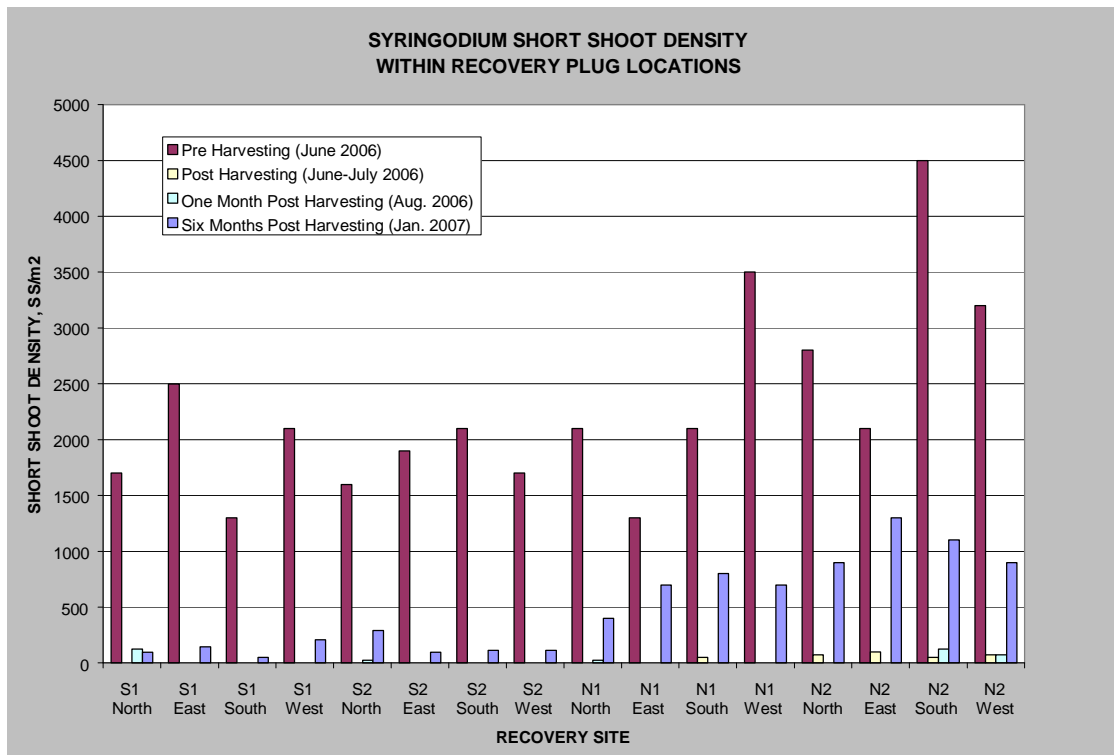
Figure 1. Summary of *Syringodium* recolonization of *Syringodium* donor site.
