Summary Report for Western Pinellas County Coastal Waters

Seagrass Integrated Mapping and Monitoring Program

Mapping and Monitoring Report No. 2

FWRI Technical Report TR-17, version 2.0

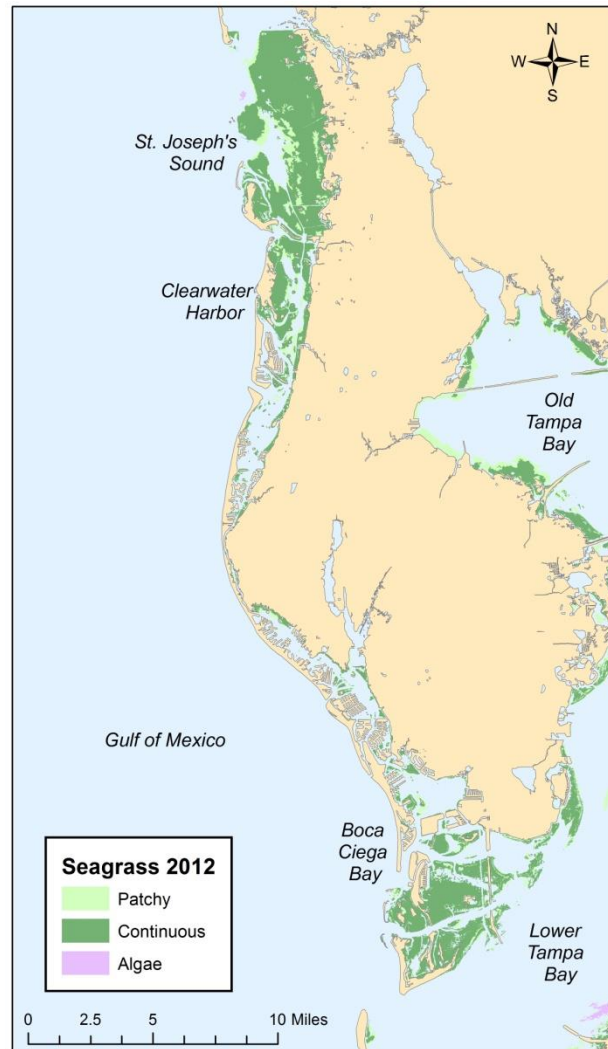
Figure 1 Seagrass beds in Boca Ciega Bay, Clearwater Harbor, and St. Joseph Sound, 2012.

Seagrass mapping assessment: Seagrass beds covered 26,214 acres in the coastal waters of western Pinellas County in 2014, and half of the beds were found in St. Joseph Sound in the northwestern part of this region (Figure 1). From 2006 to 2014,
