LAKE ASSESSMENT REPORT FOR MANGO LAKE IN HILLSBOROUGH COUNTY, FLORIDA

Date Assessed: June 23, 2009

Assessed by: David Eilers, Brian Rosegger and Cheran Williams

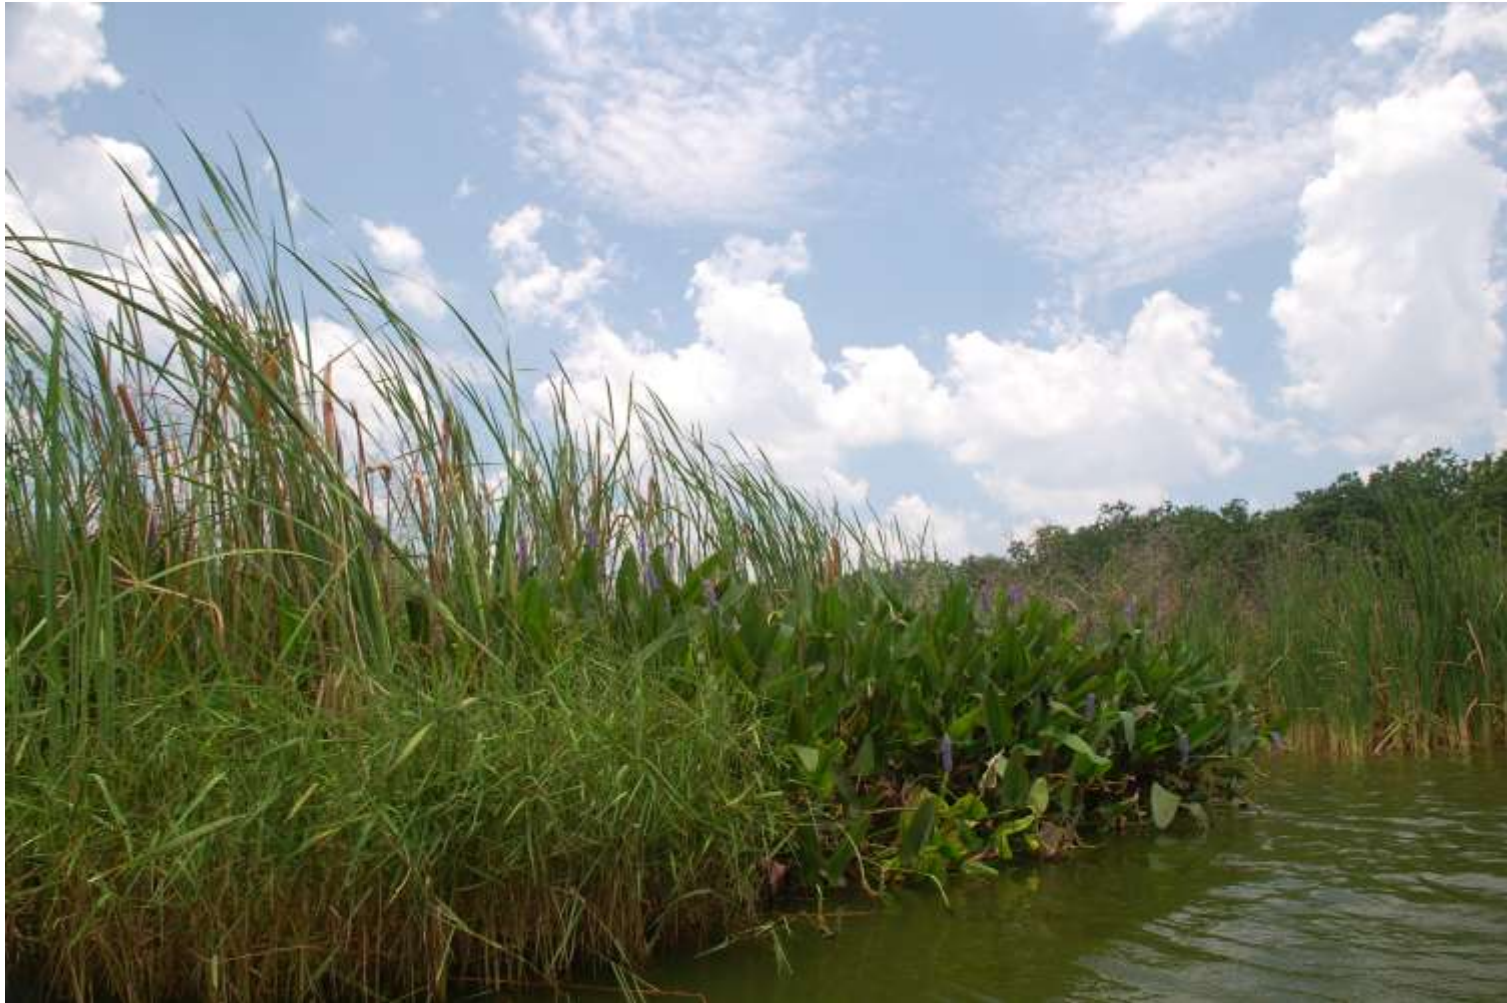
Figure 4. A photo of emergent vegetation on Mango Lake. The reedy vegetation on the left is Maidencane (*Panicum hemitomom*). The vegetation with arrow shaped leaves and purple flowers is Pickerel Weed (*Pontederia cordata*). Cattails (*Typha spp.*) are in the background behind the Maidencane and Pickerel Weed and to the right.

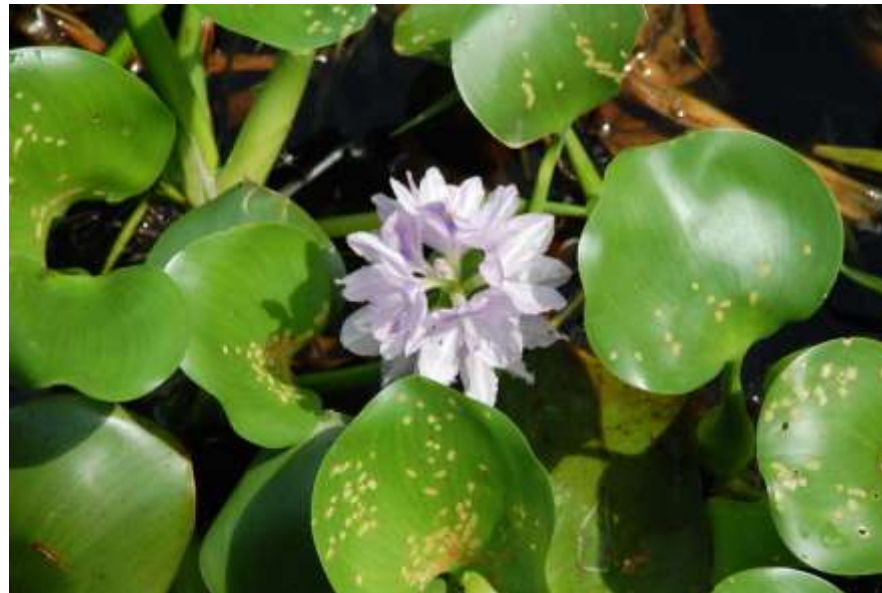
Figure 6. Photograph of *Eichornia crassipes*, on Mango Lake, is an non-native, invasive species which commonly displace other native species of floating leaved vegetation.

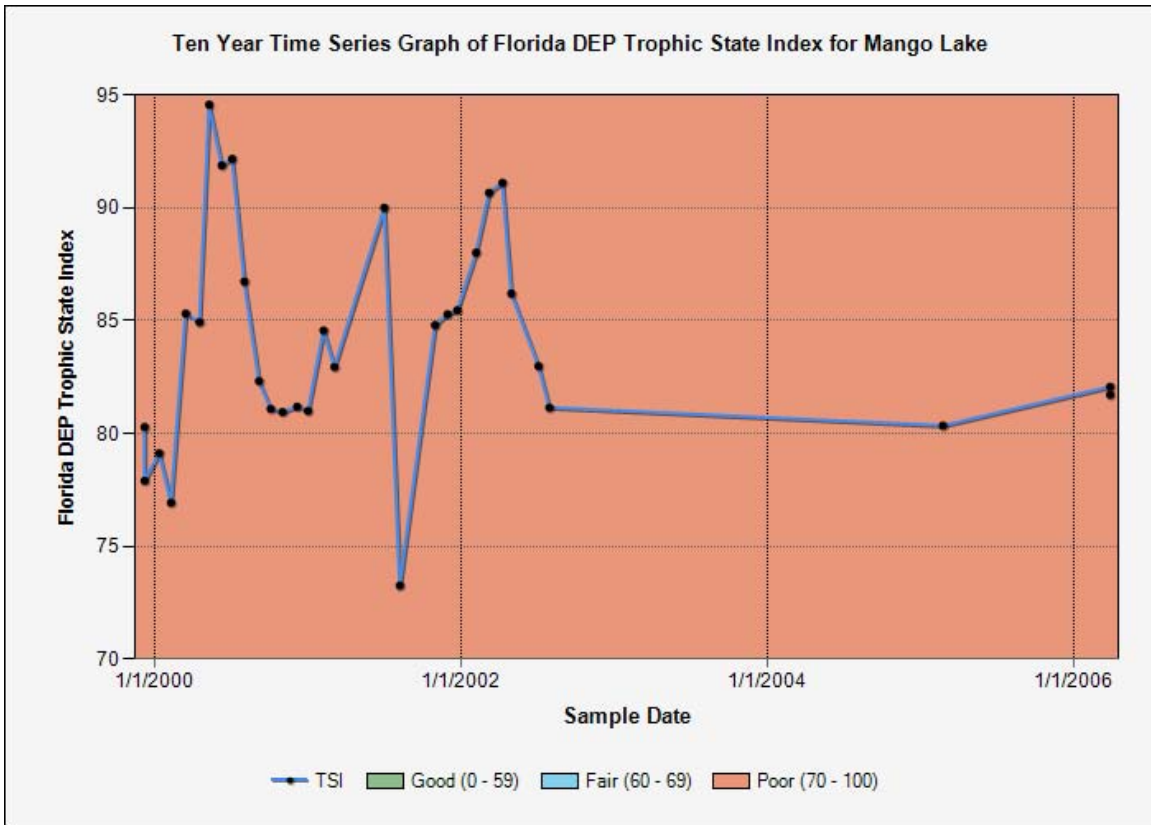
Figure 9. Recent Trophic State Index (TSI) graph from Hillsborough Watershed Atlas. For the latest data go to:

Note: The graph above includes benchmarks for using verbal descriptors of "good", "fair" and "poor". The verbal descriptors for these benchmarks are based on an early determination by stakeholders of the generally acceptable and understood terms for describing the state of lakes. The same benchmarks are used for nutrient graphs (Nitrogen and Phosphorus), chlorophyll graphs and trophic state index (TSI) graphs. The TSI is a calculated index of lake condition based on nutrient and chlorophyll (a) concentrations (please see "Learn more about Trophic State Index"). The benchmarks are established based on the TSI range that relates to a specific descriptor. The source for the TSI concentration relationships is the Florida Water Quality Assessment, 1996, 305(b) (Table 2-8).

As part of the lake assessment the physical water quality and chemical water chemistry of a lake are measured. These data only indicate a snap shot of the lakes water quality; however they are useful when compared to the trend data available from LAKEWATCH or other sources. Table 6 contains the summary water quality data and index values and adjusted values calculated from these data. The total phosphorus (TP), total nitrogen (TN) and chlorophyll (a) water chemistry sample data are the results of chemical analysis of samples taken during the assessment and analyzed by the Hillsborough County Environmental Protection Commission laboratory. These data compare reasonably well with the mean data from the LAKEWATCH data set for the lake. The trophic state index (TSI) calculated from the sample data is 69.90 which put the lake in the high eutrophic zone and indicates a highly productive lake with fair to poor water quality. These data indicate a possible improving trend in the lake's water quality which as indicated in Figure 6 was hypereutrophic (poor) between 2000 and 2006 when volunteer data was being submitted.
