## Seagrass Scar Imaging Project Report: Cockroach Bay Seagrass Scar Tracking Project

*Prepared For*  
*Hillsborough County Environmental Protection Commission*  
*By Florida Center for Community Design and Research*  
*University of South Florida*  
*Prepared March 17, 2011*  
*Study Period: October 2009 – January 2011*

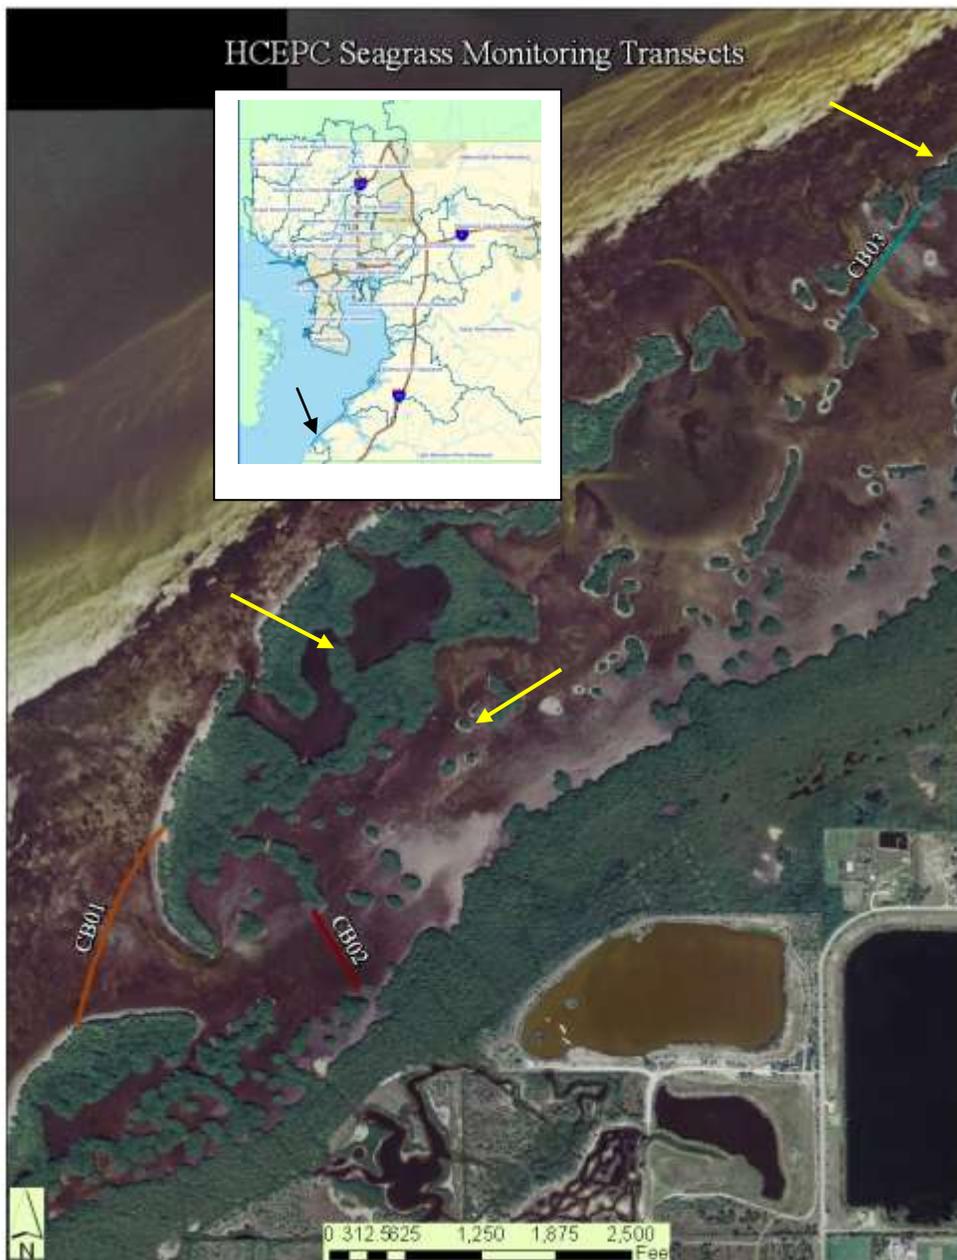
**Figure 1. Map of HCEPC transects in Cockroach Bay.**

Project began as an addition to the existing Hillsborough County Environmental Protection Commissions (HCEPC) Seagrass Monitoring Project in Cockroach Bay in October of 2009. The goals of the Florida Center for Community Design and Research was to support the efforts to identify and quantify motor boat propeller scars in seagrass bed (sea grass scars) within the manatee protection zones of Cockroach Bay (see map insert Figure 1). A second goal was to evaluate the use of a commercially available side-scanning sonar unit (Humminbird 797c<sup>2</sup>) to identify and map these scars. The initial focus of the study were 3 transects across passes leading into Cockroach Bay (CB01, CB02, CB03 in Figure 1); however, later in the project four City of Tampa transects were added expanding this scope.

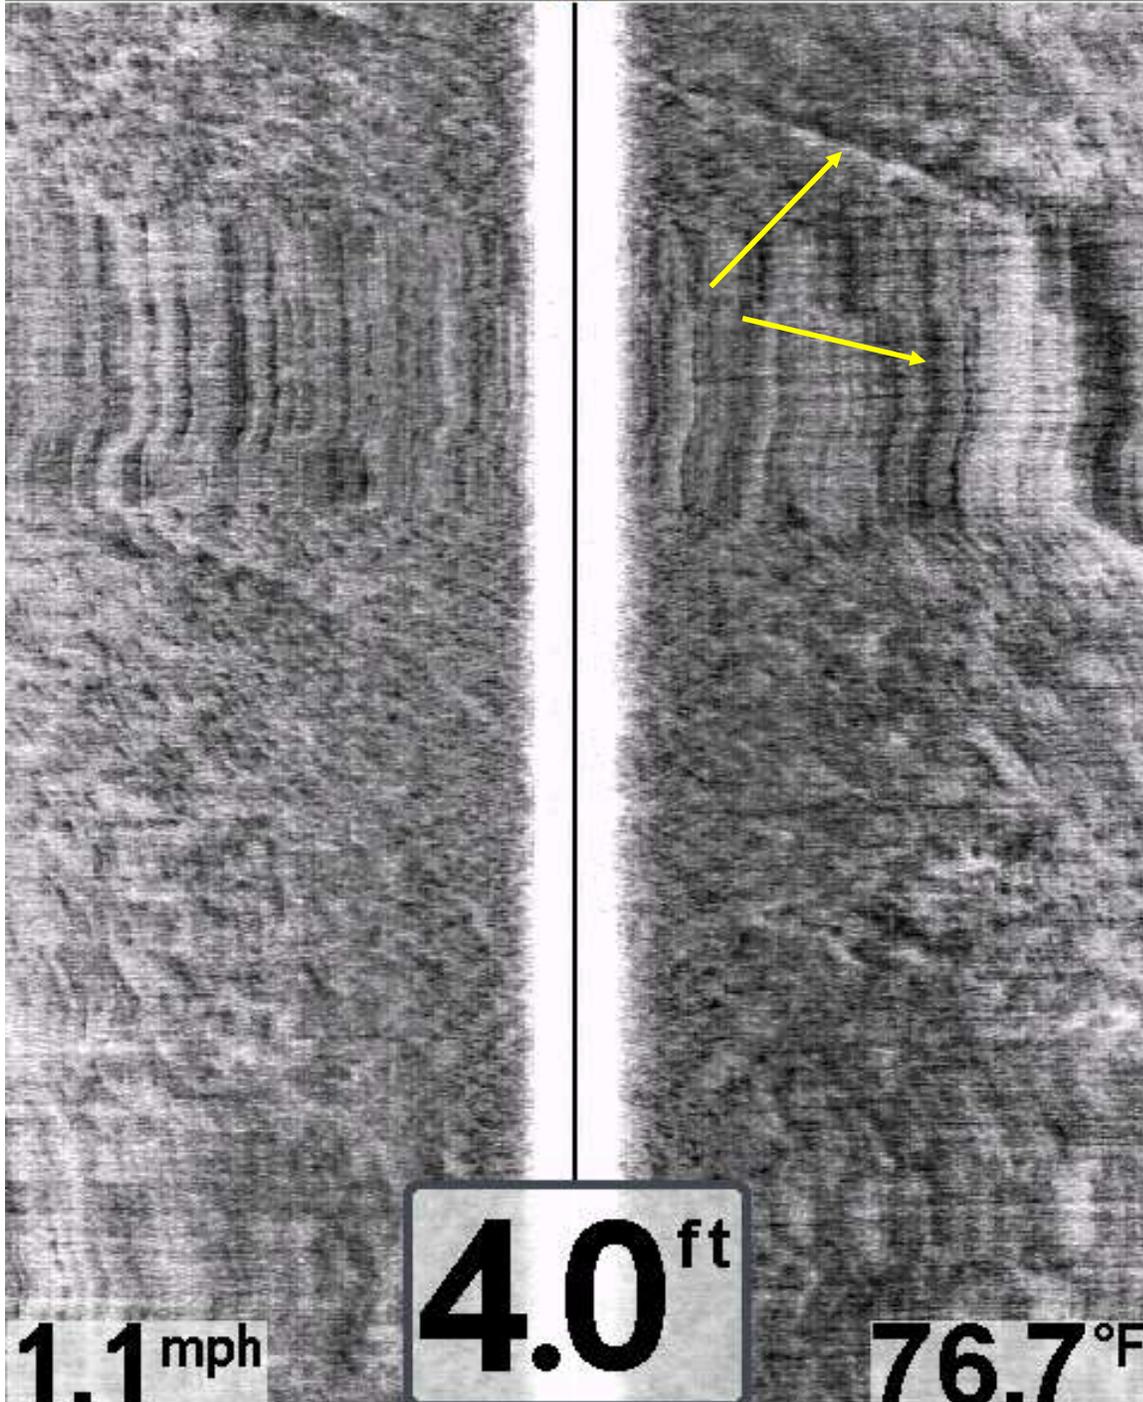
Figure 2 Image from transects run in October of 2009.

The initial trials of the side-scanning sonar were conducted using a method that required the field biologist to slowly move the instrumented kayak across the transect until a linear scar feature crossed the transect. At that time the kayak was stopped and a digital image was taken and saved. This technique captured images of the scars, but also resulted in images that had blurred portions because the unit continues to image the same location repeatedly when stationary. This technique also resulted in only capturing the GPS position for the top most return of the image, creating errors in location. Further complications occurred when several scars crossed the transect in close proximity. However, even with these limitations, the method was successful in identifying scar features. Figure 2 is a Humminbird image from transects run in October of 2009. A seagrass scar is visible along the top most portion of the image. Immediately below that is a blurred portion caused by pausing the forward movement of the kayak to image the weak scar feature in the middle to lower portion of the figure. Table 1 provides the results of the assessments for the three transects and Figures 3-5 provide the relative positions of the scars crossing transect CB01, 02, 03.

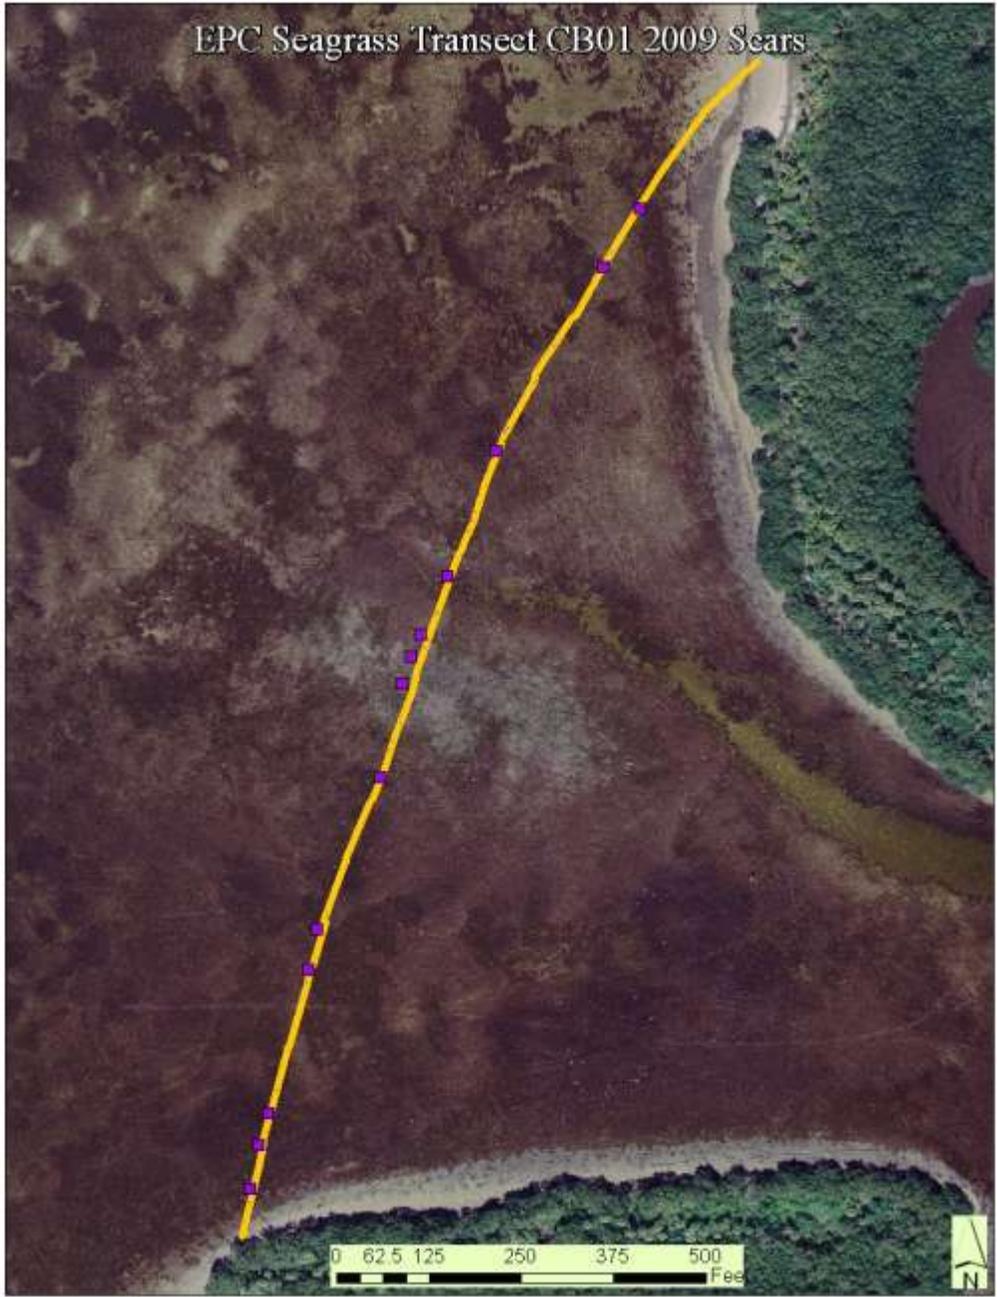
**Figure 3 Map showing the locations of the 13 seagrass scars found on transect CB01 during the October 2009 monitoring effort.**

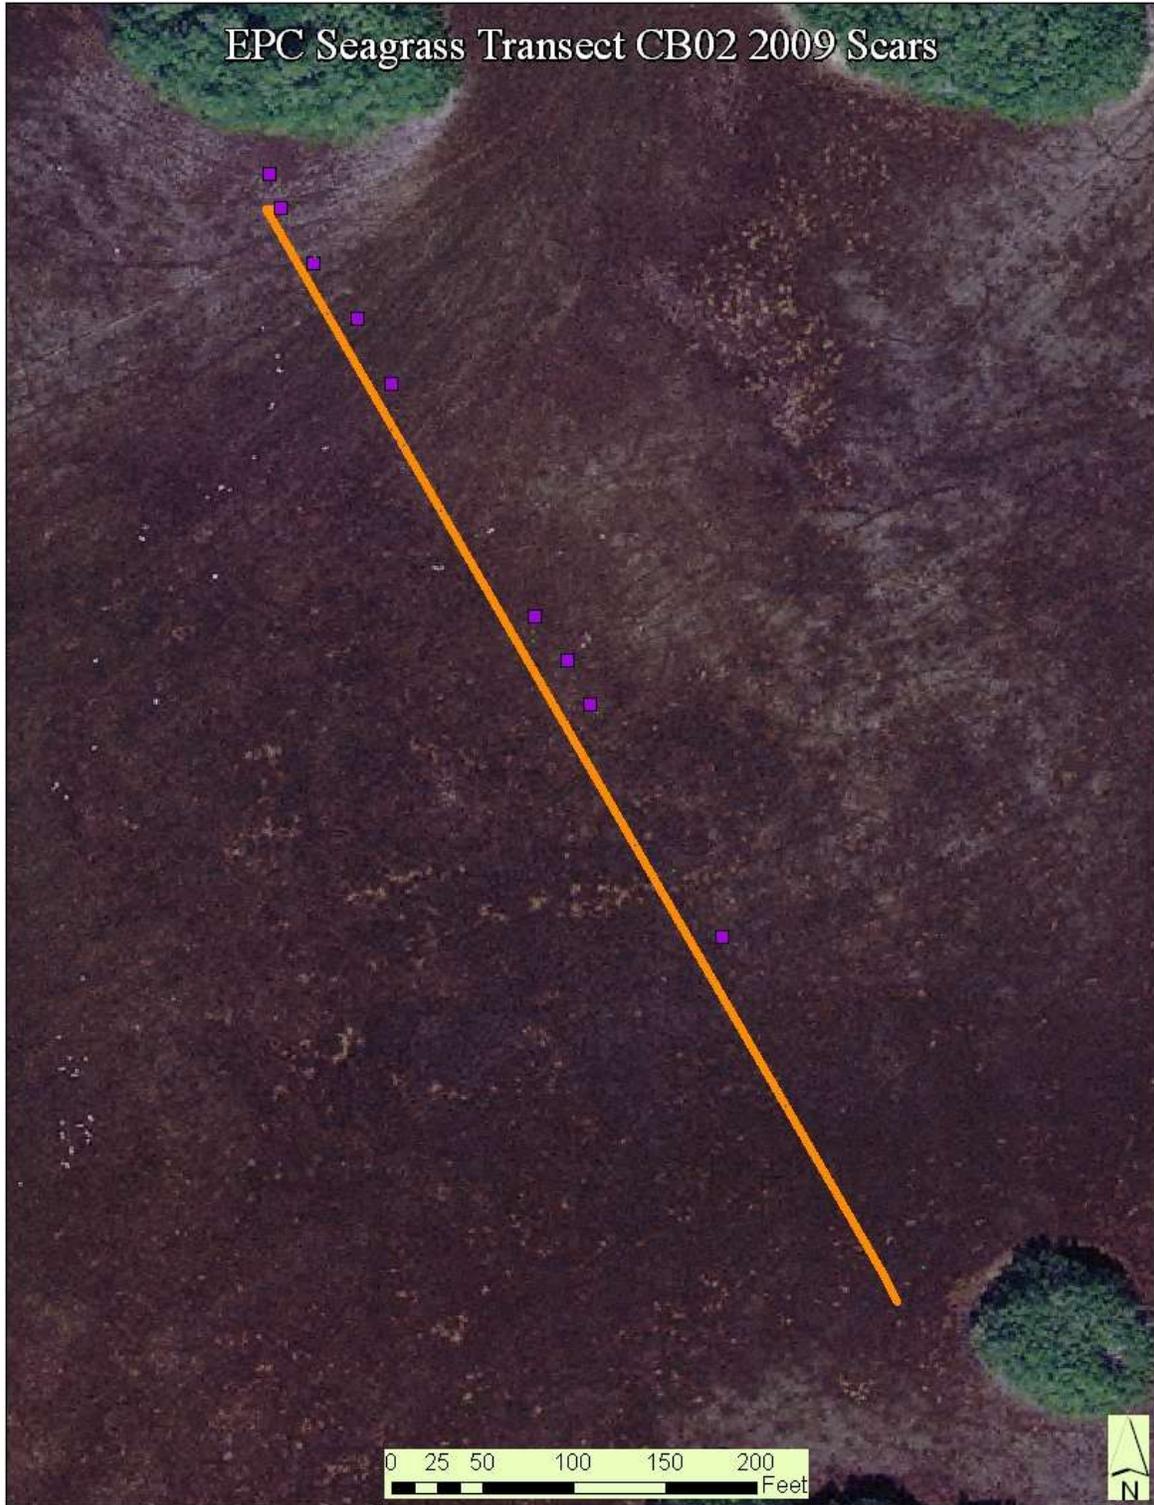
**Figure 4. Map showing the locations of the 9 seagrass scars found on transect CB02 during the October 2009 monitoring effort.**

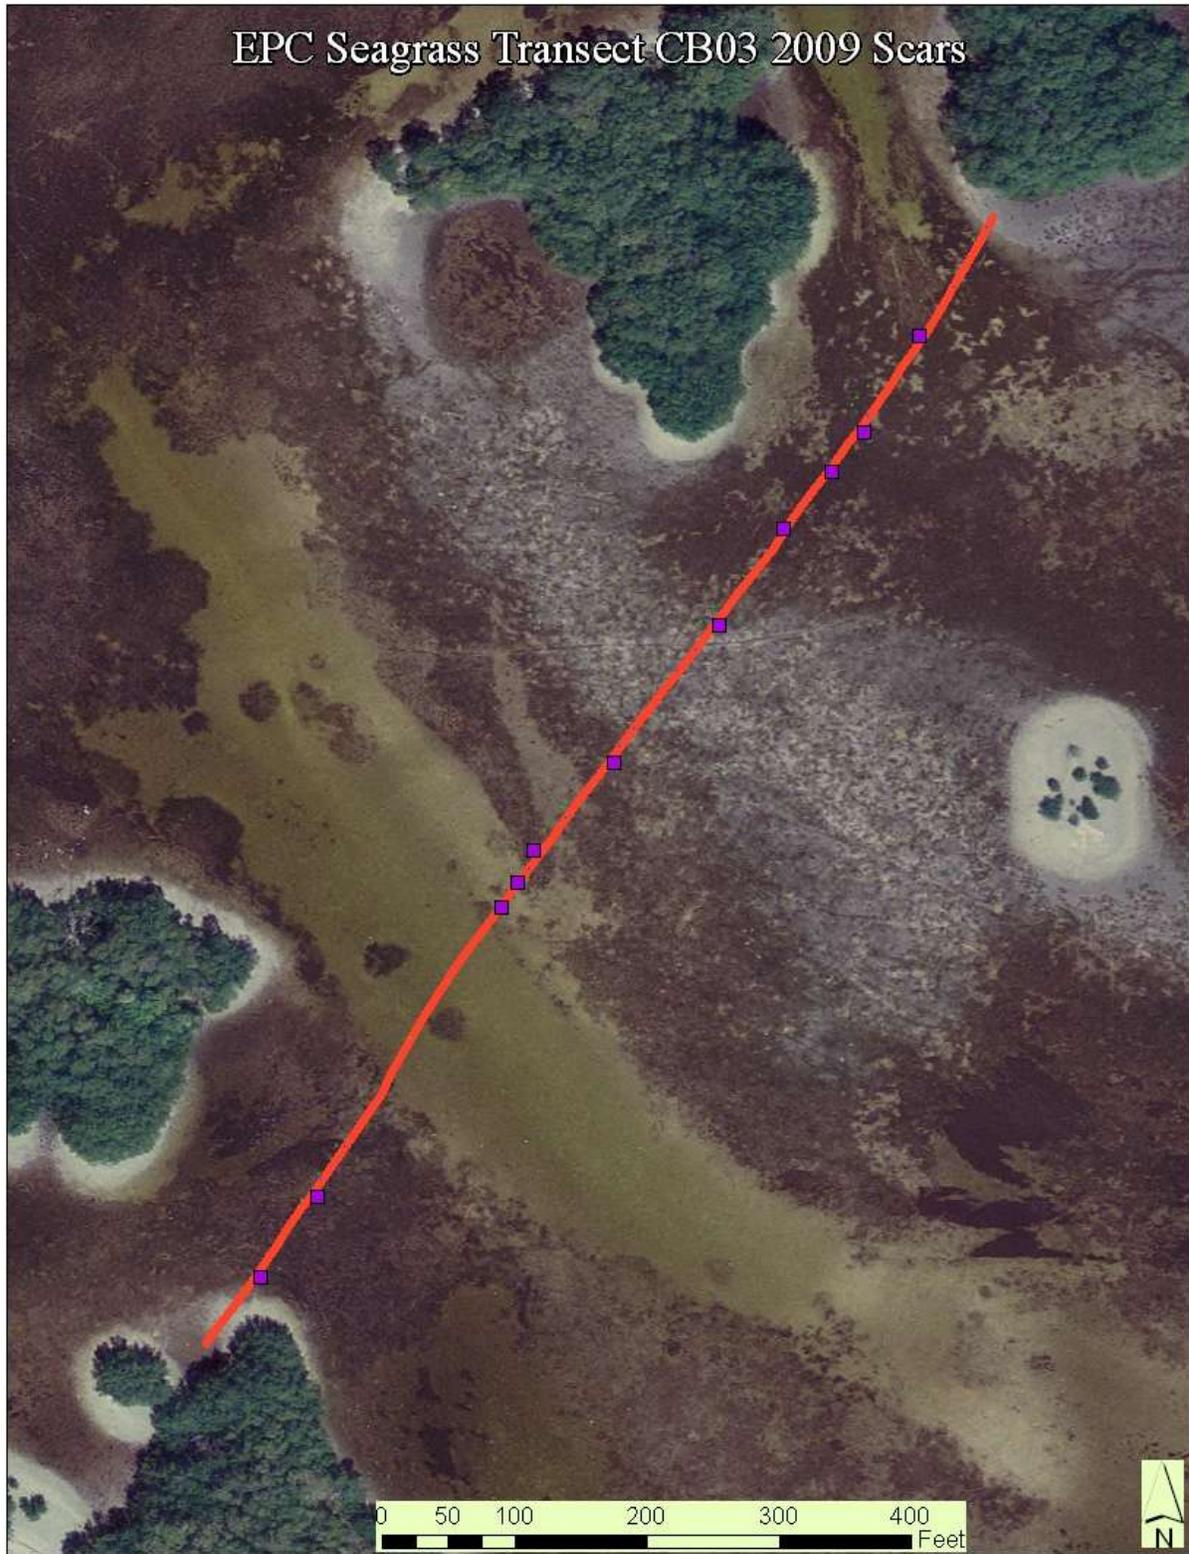
**Figure 5 Map showing the locations of the 11 seagrass scars found on transect CB03 during the October 2009 monitoring effort.**

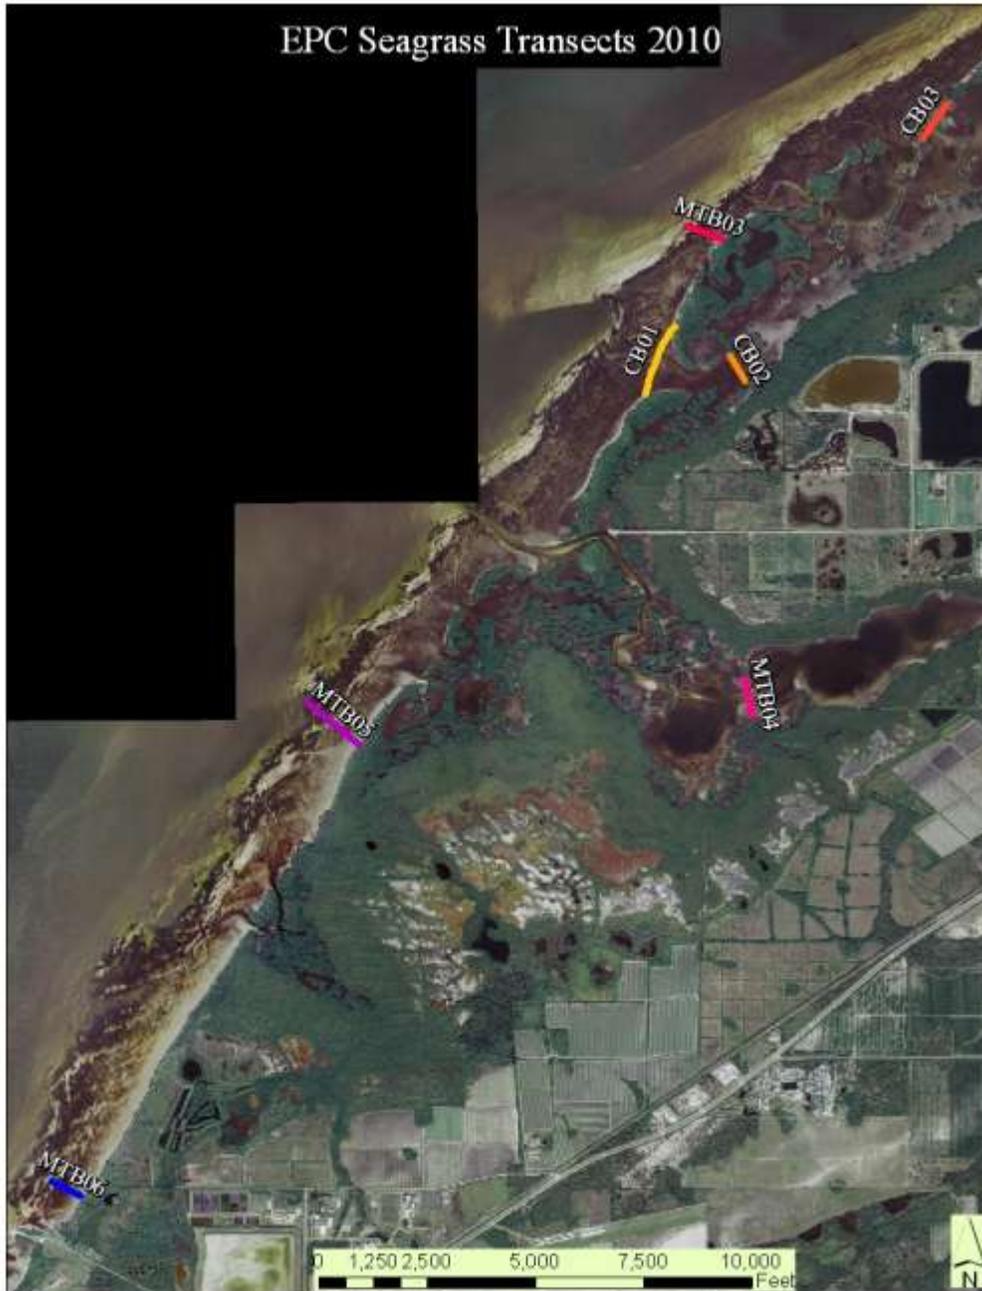
**Figure 6. Map showing the locations of EPC seagrass transects used for the April and October 2010 monitoring efforts.**

In April of 2010 the monitoring effort was expanded to include four City of Tampa Transects (MTB03, B04, B05, B06). Three of these transects are on the outside of Cockroach Bay and are setup perpendicular to the shoreline, while the fourth resides across a pass in inner Cockroach Bay. The methods used for the April 2010 monitoring effort were the same as those used for the October 2009 effort. Figure 6 shows the position of the April Transects in Cockroach Bay. Table 2 provides the results of this field assessment and Figures 7-13 show the position of located scars.

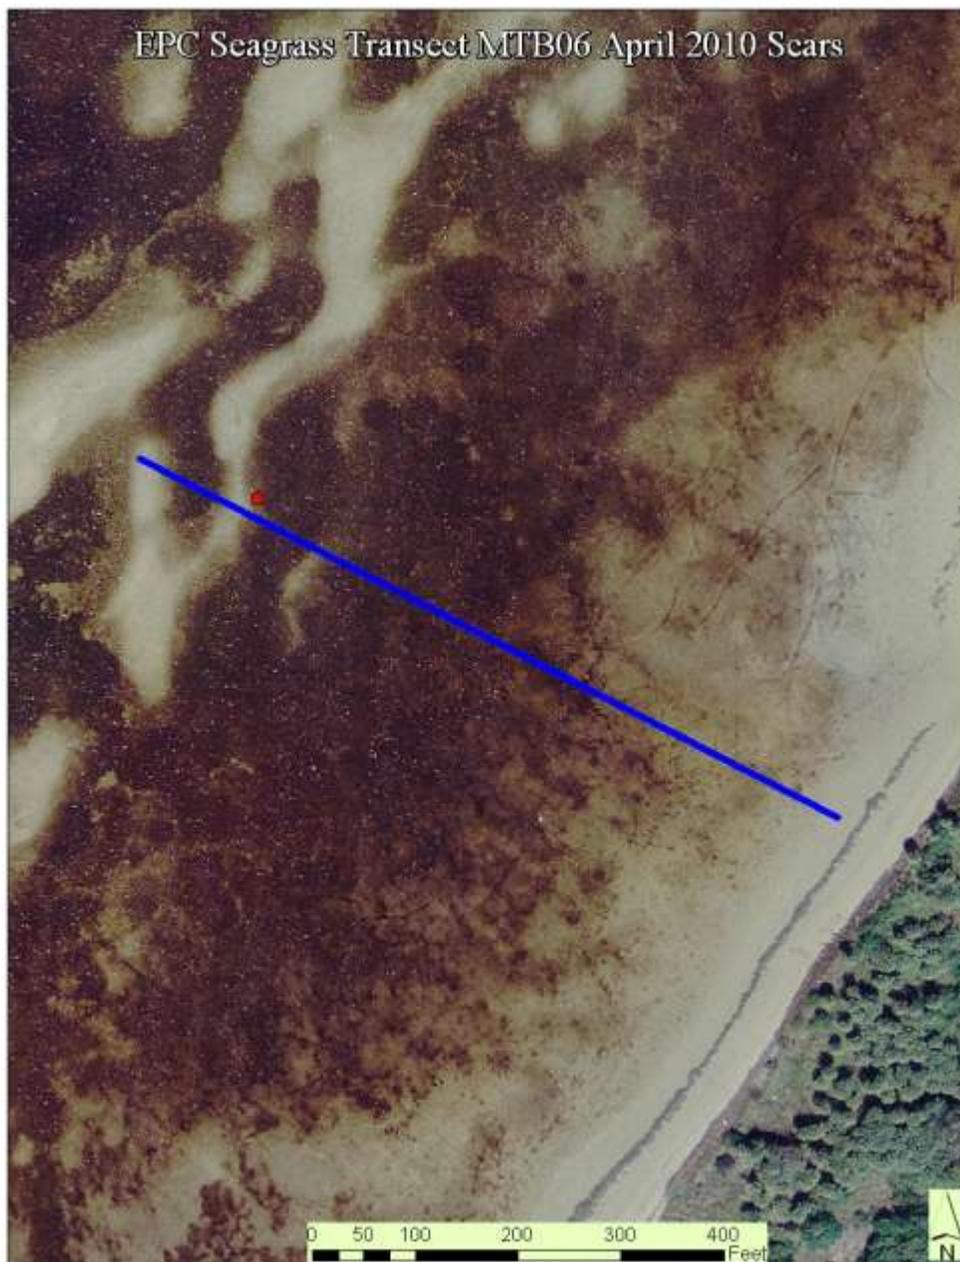
**Figure 7. Map showing the locations of the 1 seagrass scar found on transect MTB06 during the April 2010 monitoring effort.**

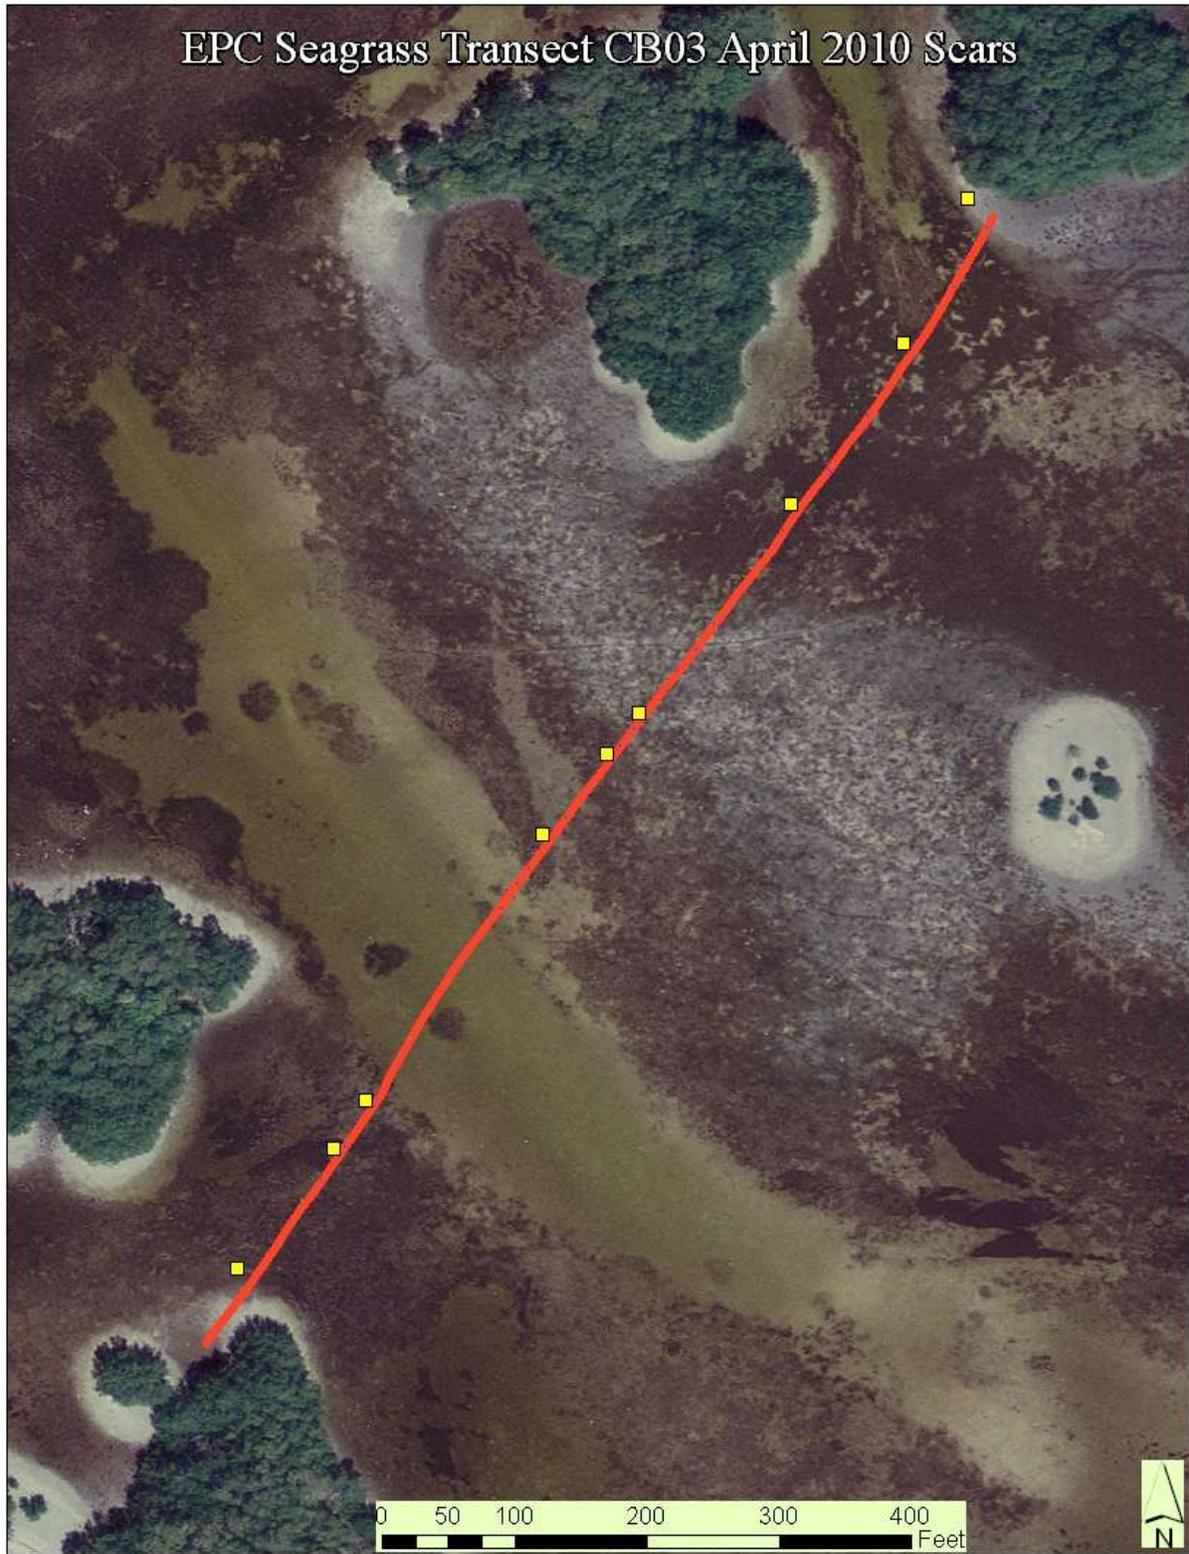
**Figure 11. Map showing the locations of the 9 seagrass scars found on transect CB03 during the April 2010 monitoring effort.**

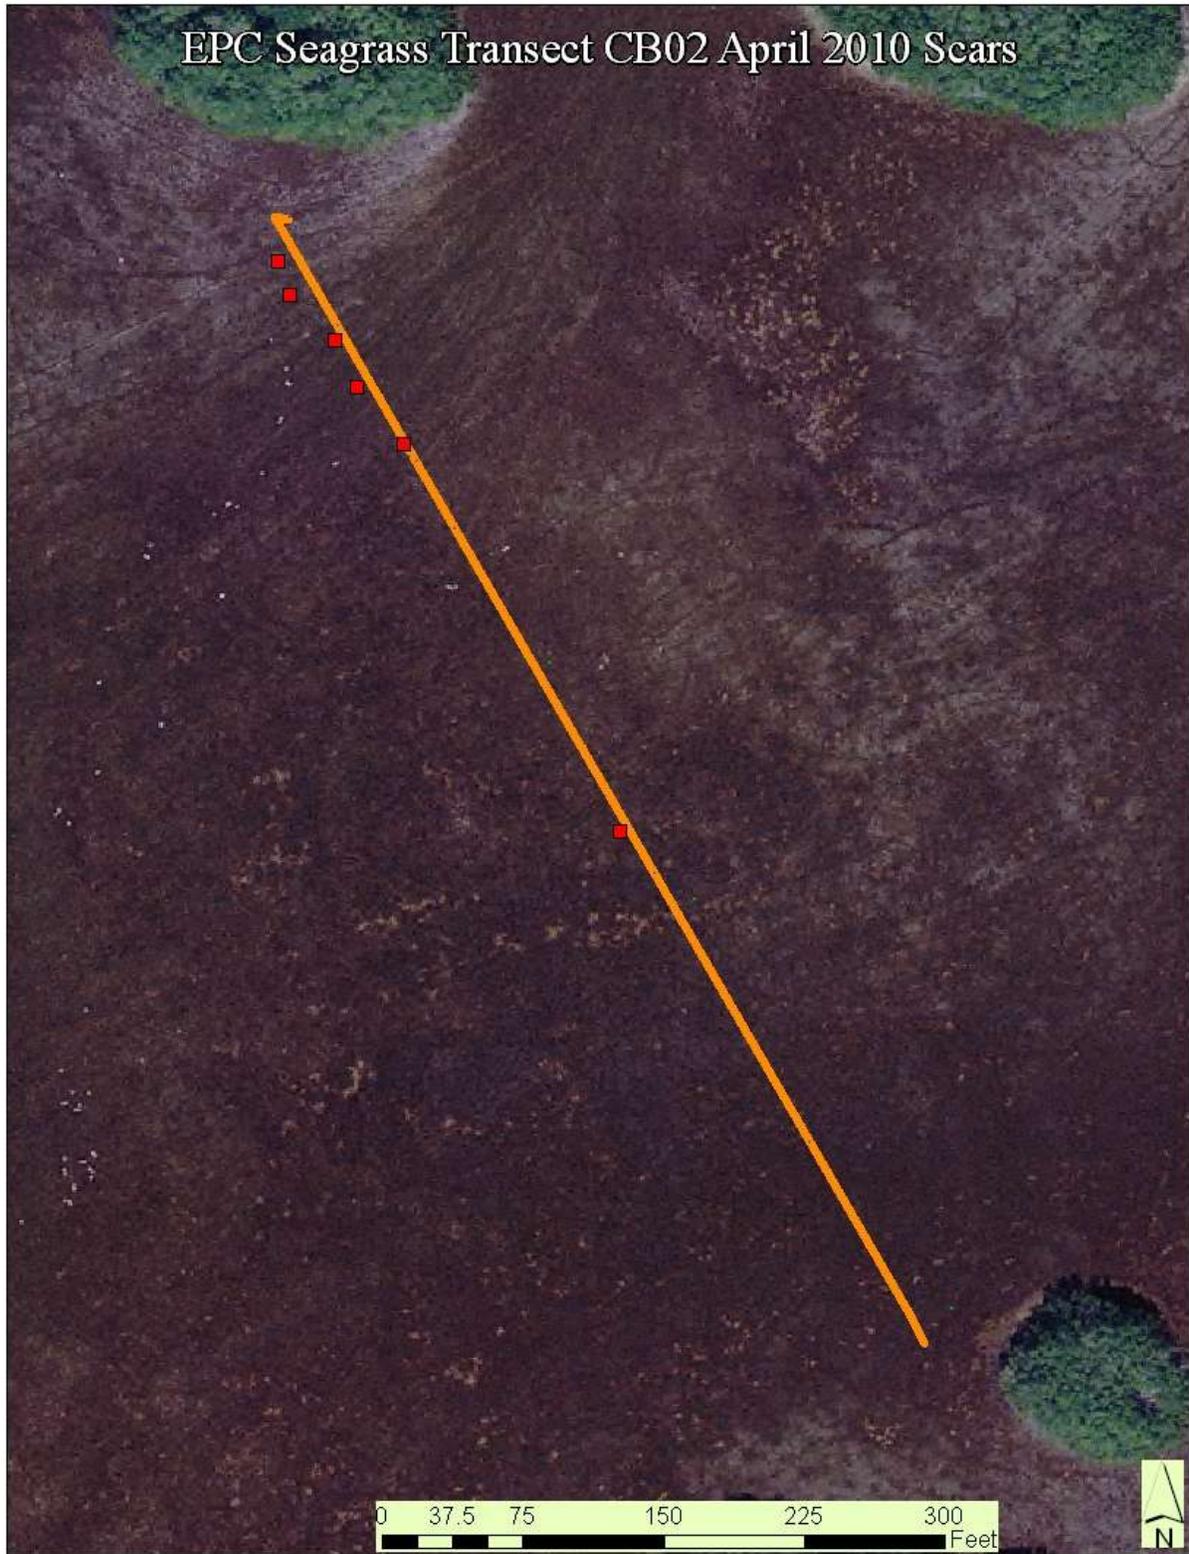
**Figure 12. Map showing the locations of the 7 seagrass scars found on transect CB02 during the April 2010 monitoring effort.**

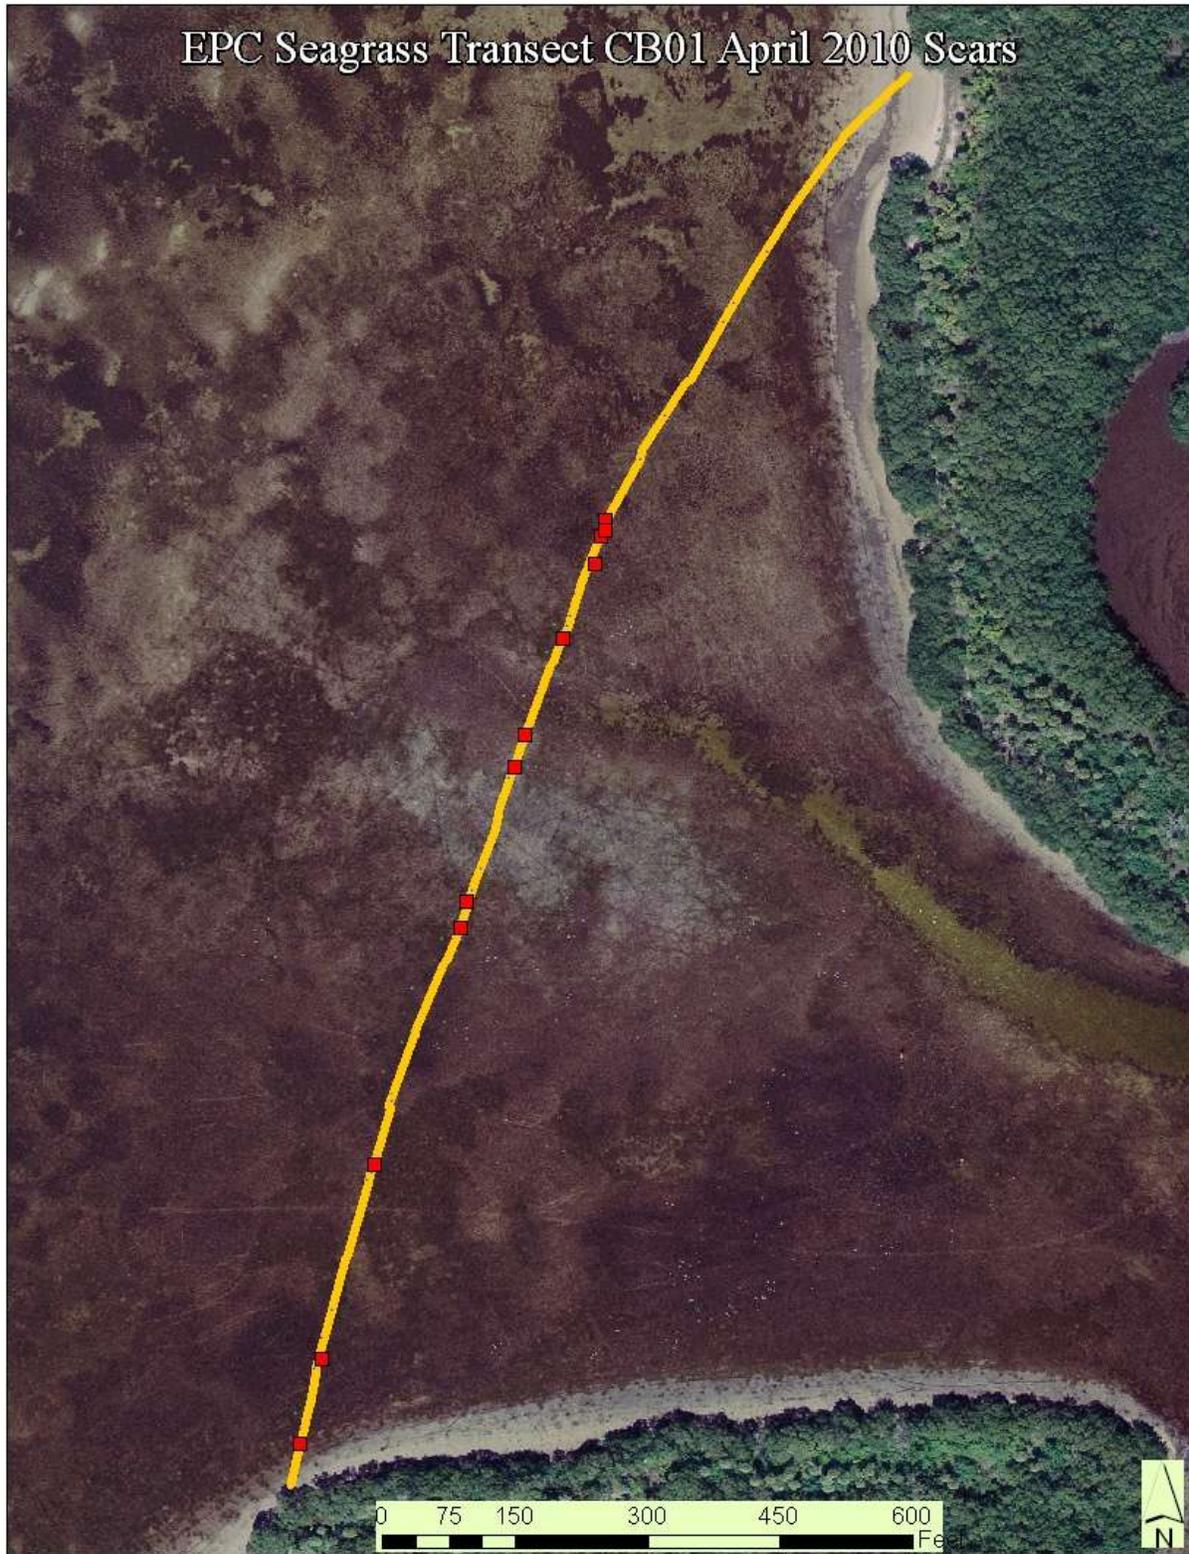
**Figure 13. Map showing the locations of the 12 seagrass scars found on transect CB01 during the April 2010 monitoring effort.**

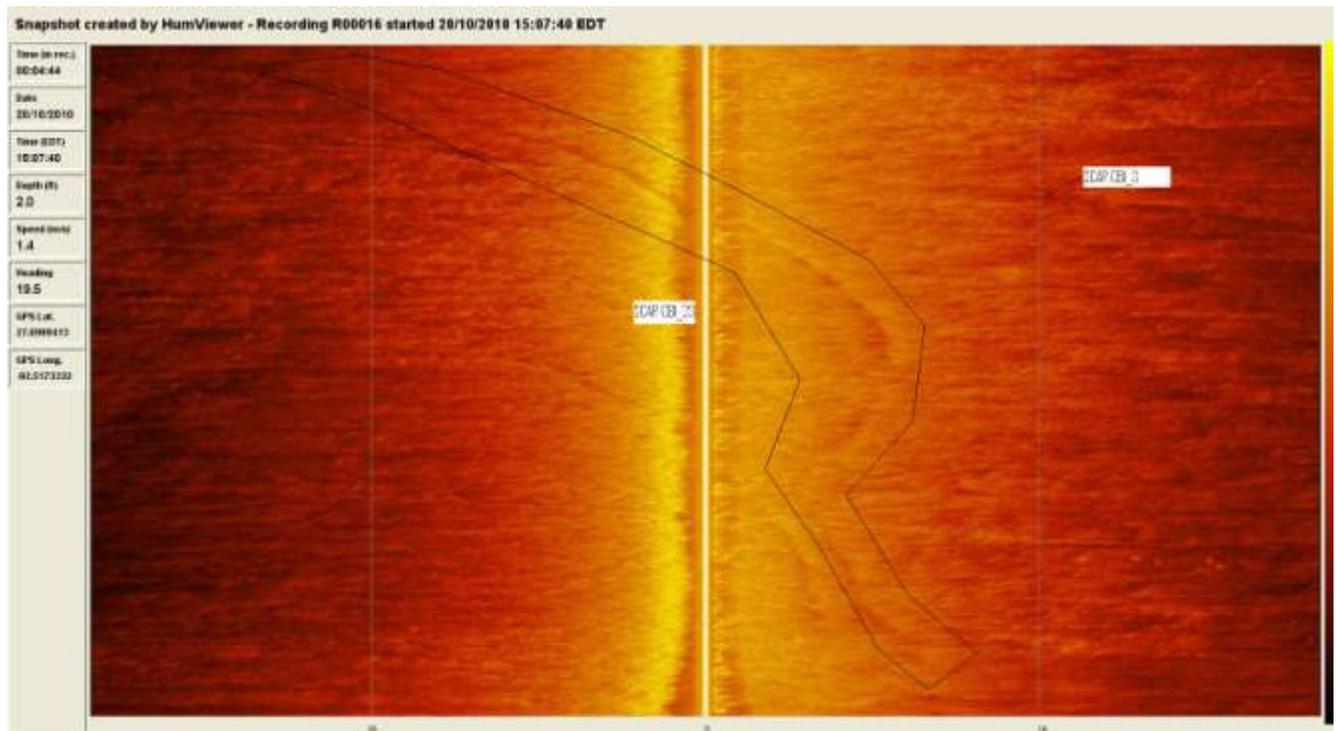
**Figure 14. Snapshot image output from HumViewer software from October 2010 monitoring effort on transect CB01.**

HumViewer allows the user to replay recorded transects on a PC and output data as sub-recording images, snapshot images, .csv data files, or .kml files. In addition, this software includes a tool that displays the GPS coordinates for any point in the side scan recording and allows for adjustment of the brightness and contrast of the image to reveal features.

Appendix A contains the field procedures for use of the Humminbird 797c<sup>2</sup> to record data for later processing using HumViewer. Appendix B contains the analyst procedures for processing recorded data using HumViewer software. Figure 14 shows a typical HumViewer output chart. Table 3 provides the results from the October Assessments and Figures 16-21 show the position of seagrass scars that were discovered during the assessment along the various transects.

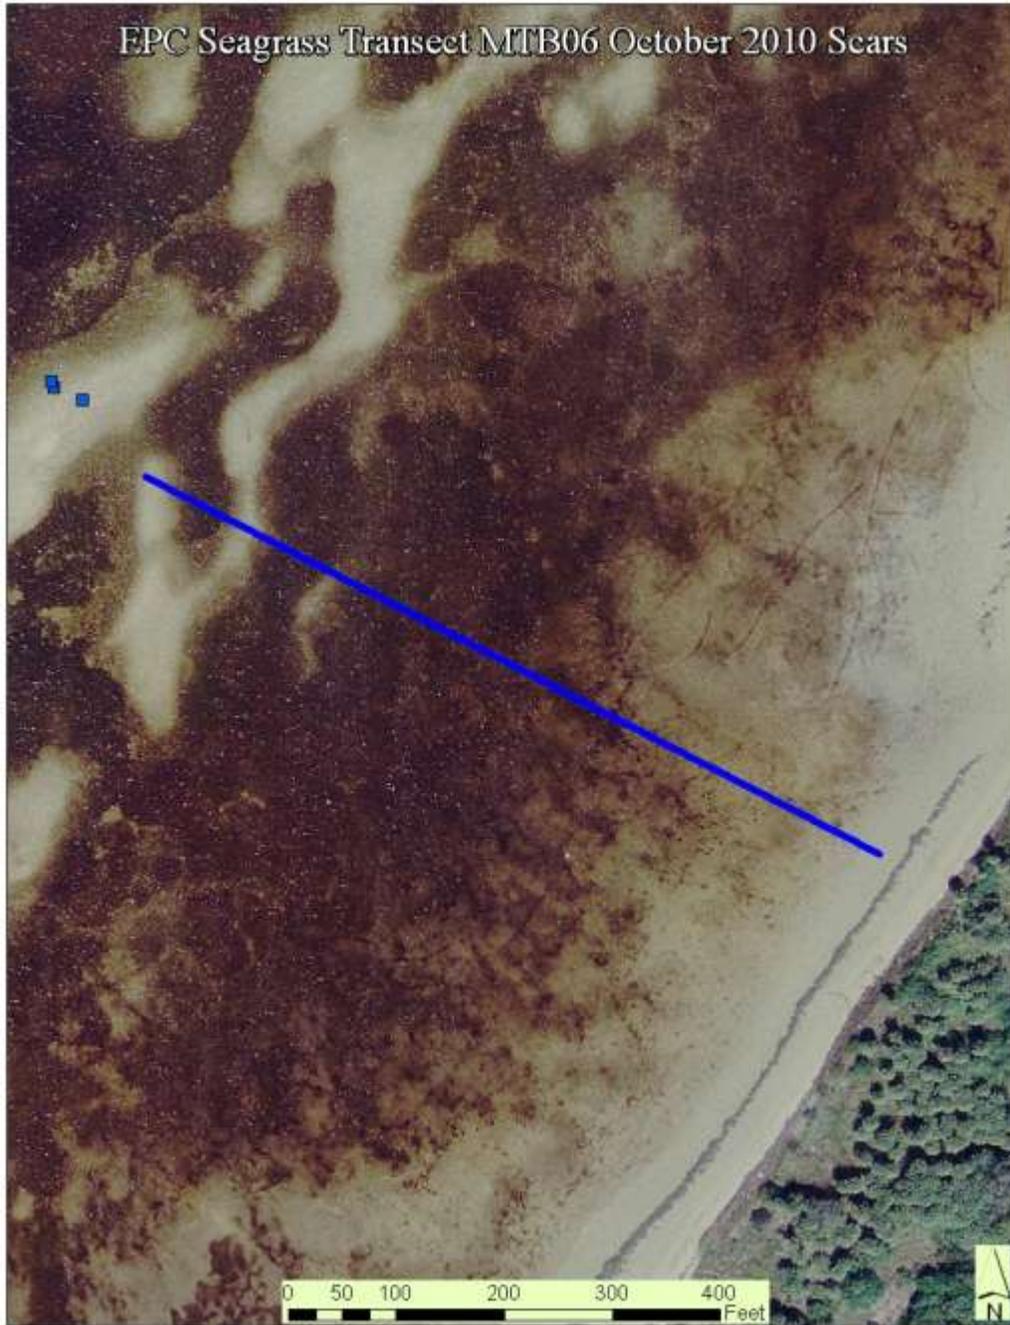
**Figure 15. Map showing the locations of the 3 seagrass scars found on transect MTB06 during the October 2010 monitoring effort.**

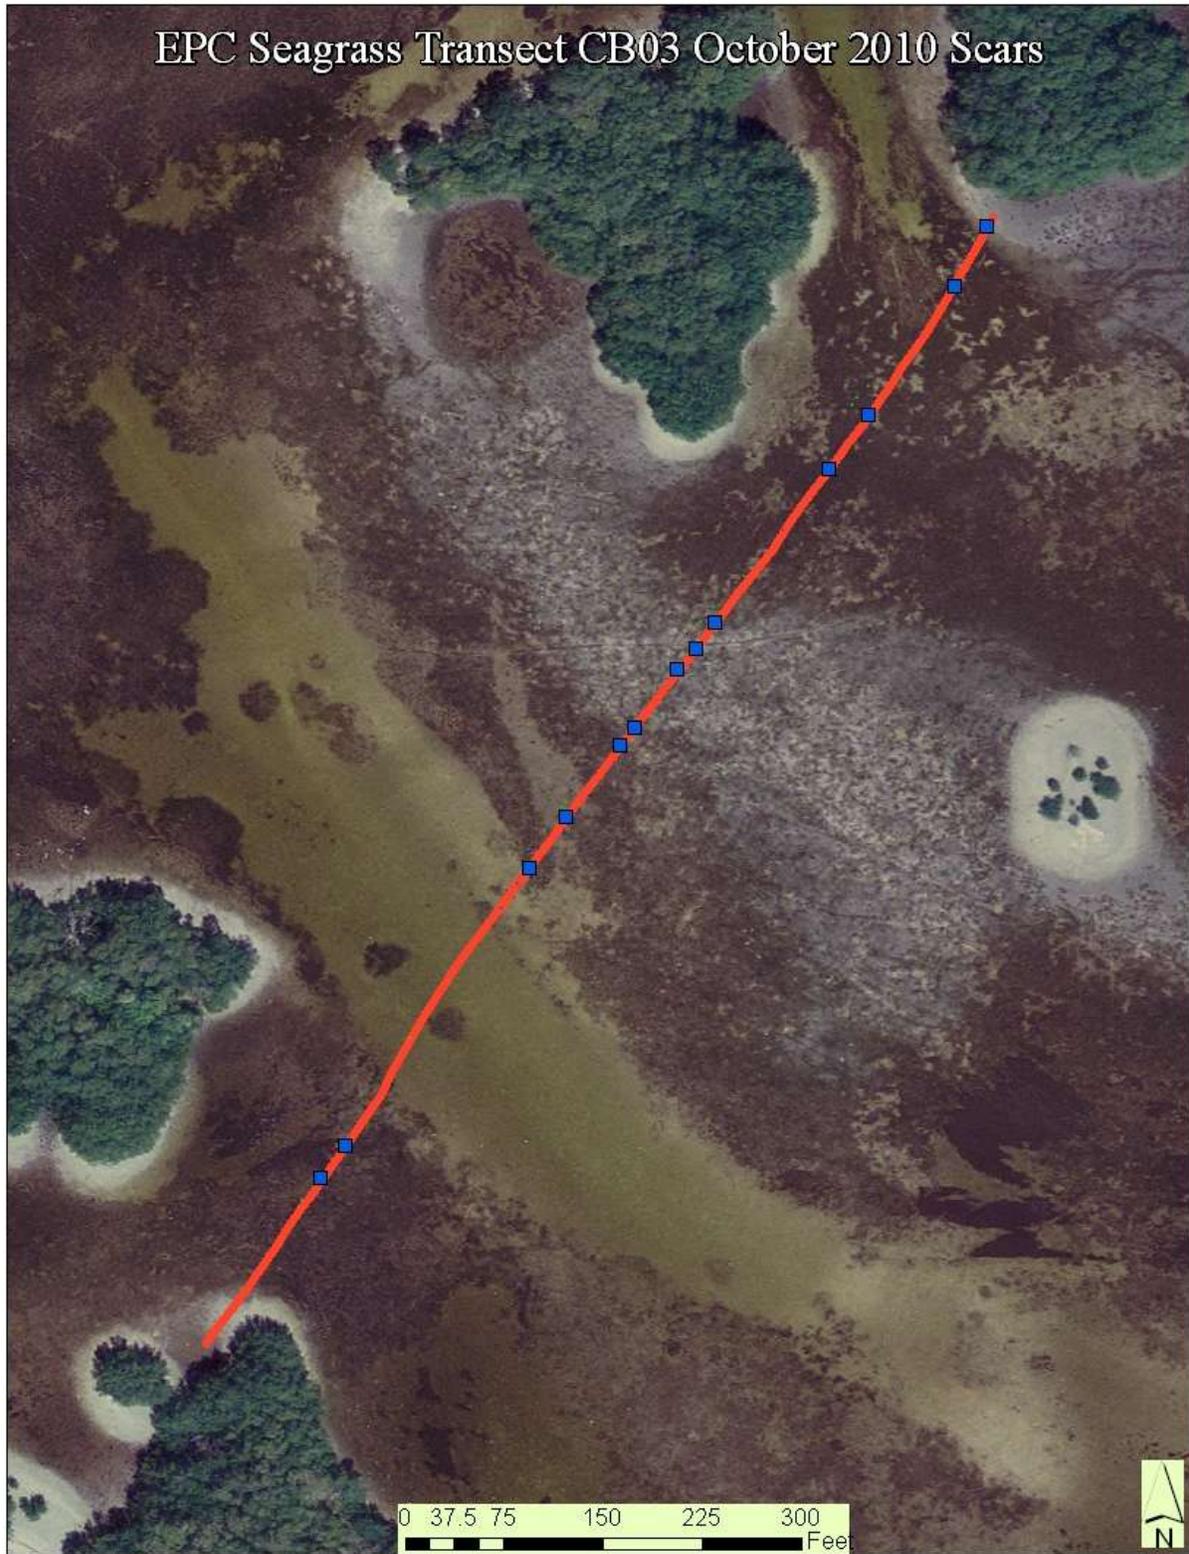
**Figure 19. Map showing the locations of the 13 seagrass scars found on transect CB03 during the October 2010 monitoring effort.**

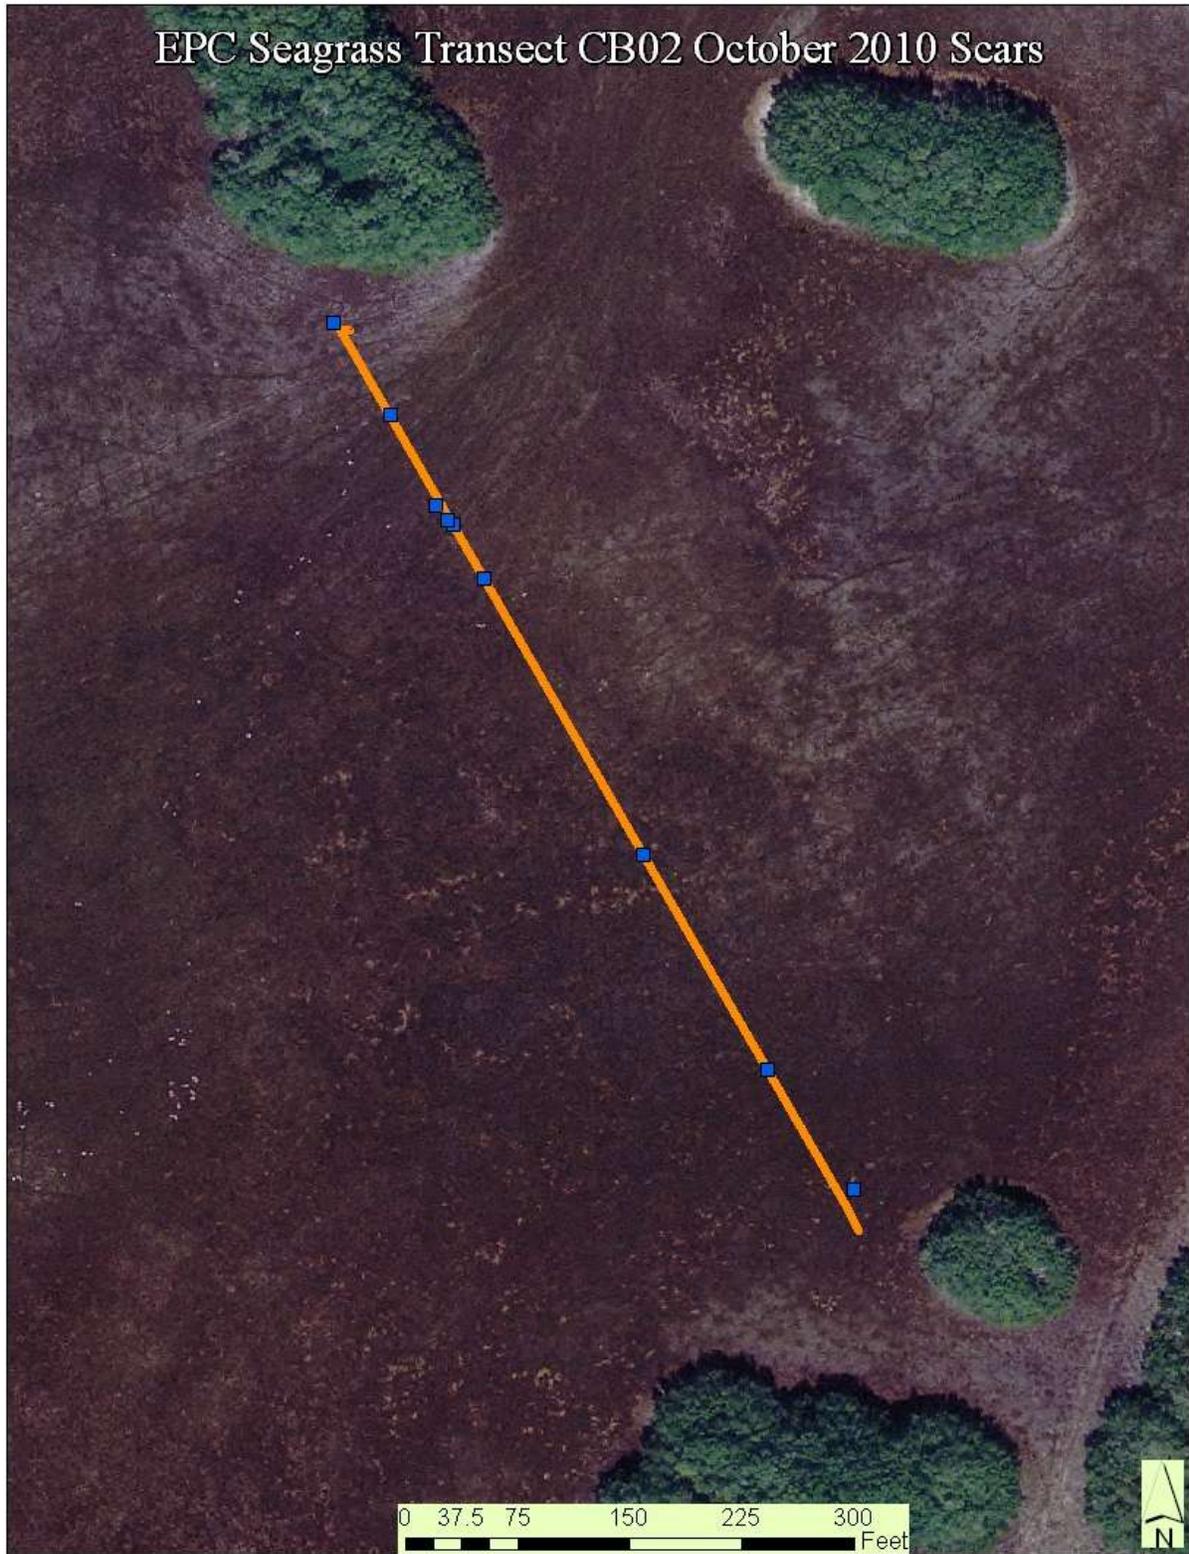
**Figure 20. Map showing the locations of the 9 seagrass scars found on transect CB02 during the October 2010 monitoring effort.**
