## Seagrass Scar Imaging Project Report: Cockroach Bay Seagrass Scar Tracking Project

*Prepared For*  
*Hillsborough County Environmental Protection Commission*  
*By Florida Center for Community Design and Research*  
*University of South Florida*  
*Prepared March 17, 2011*  
*Study Period: October 2009 – January 2011*

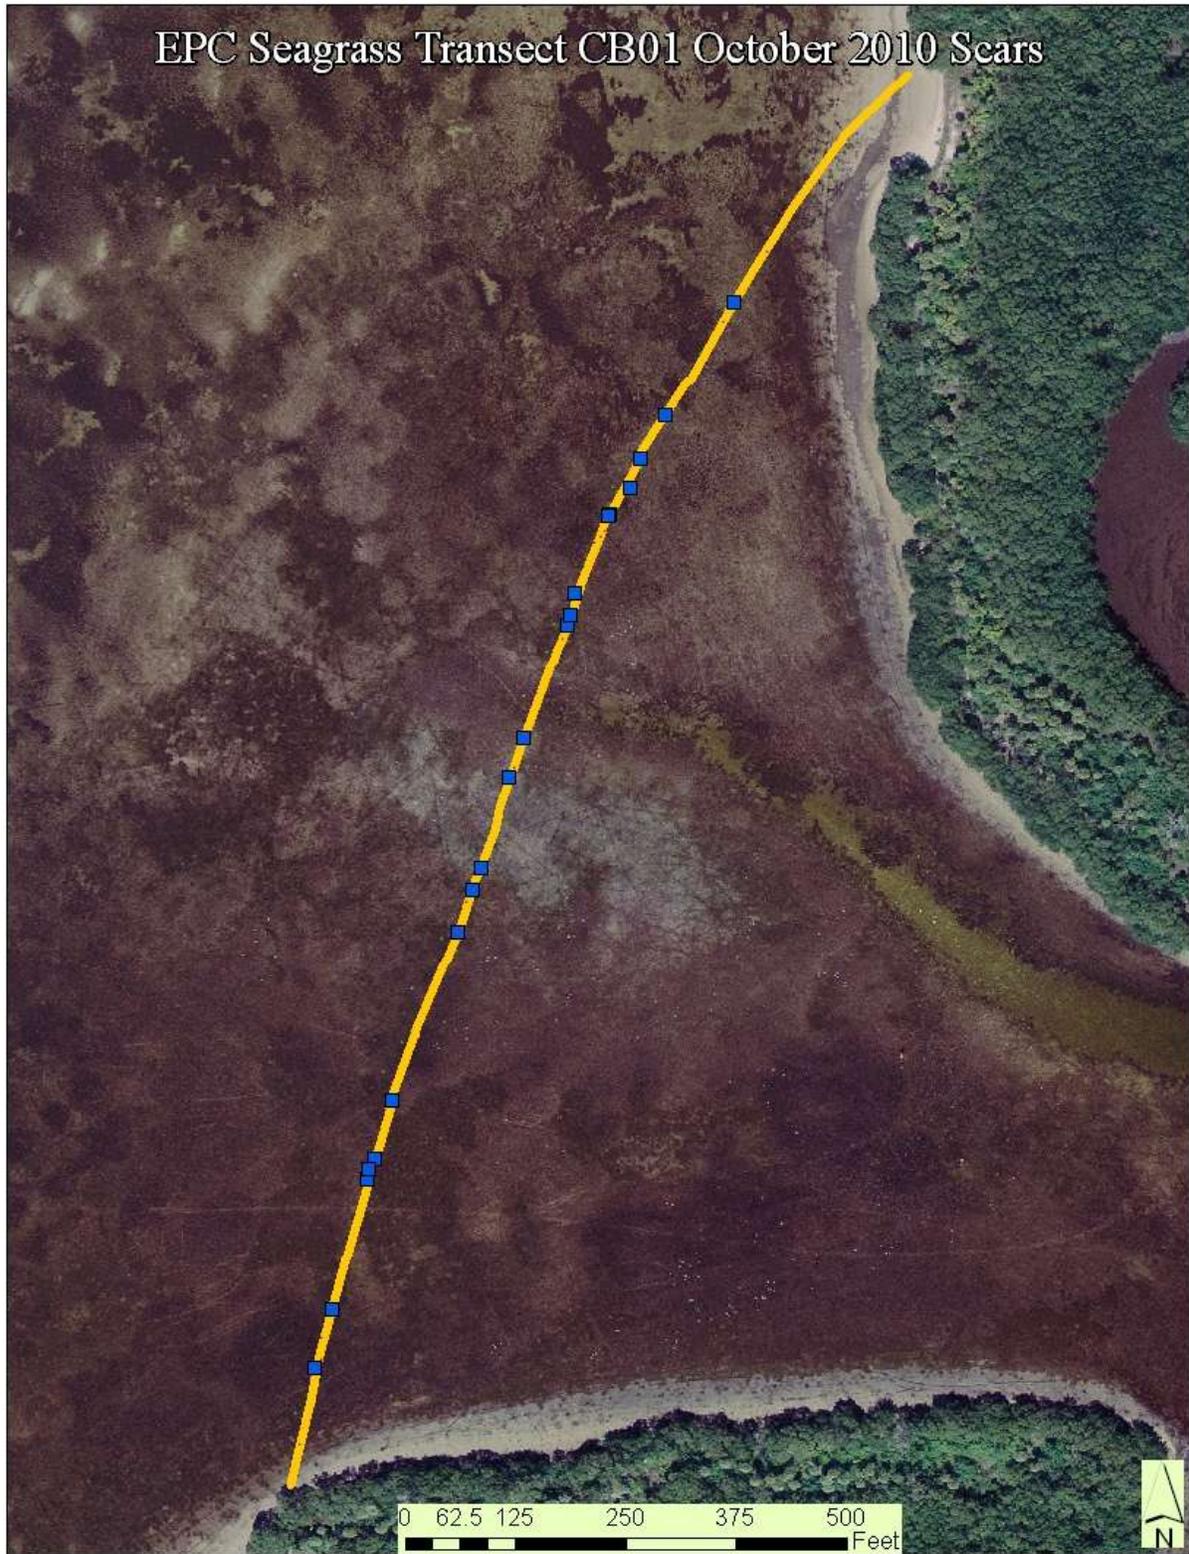
**Figure 21. Map showing the locations of the 20 seagrass scars found on transect CB01 during the October 2010 monitoring effort.**

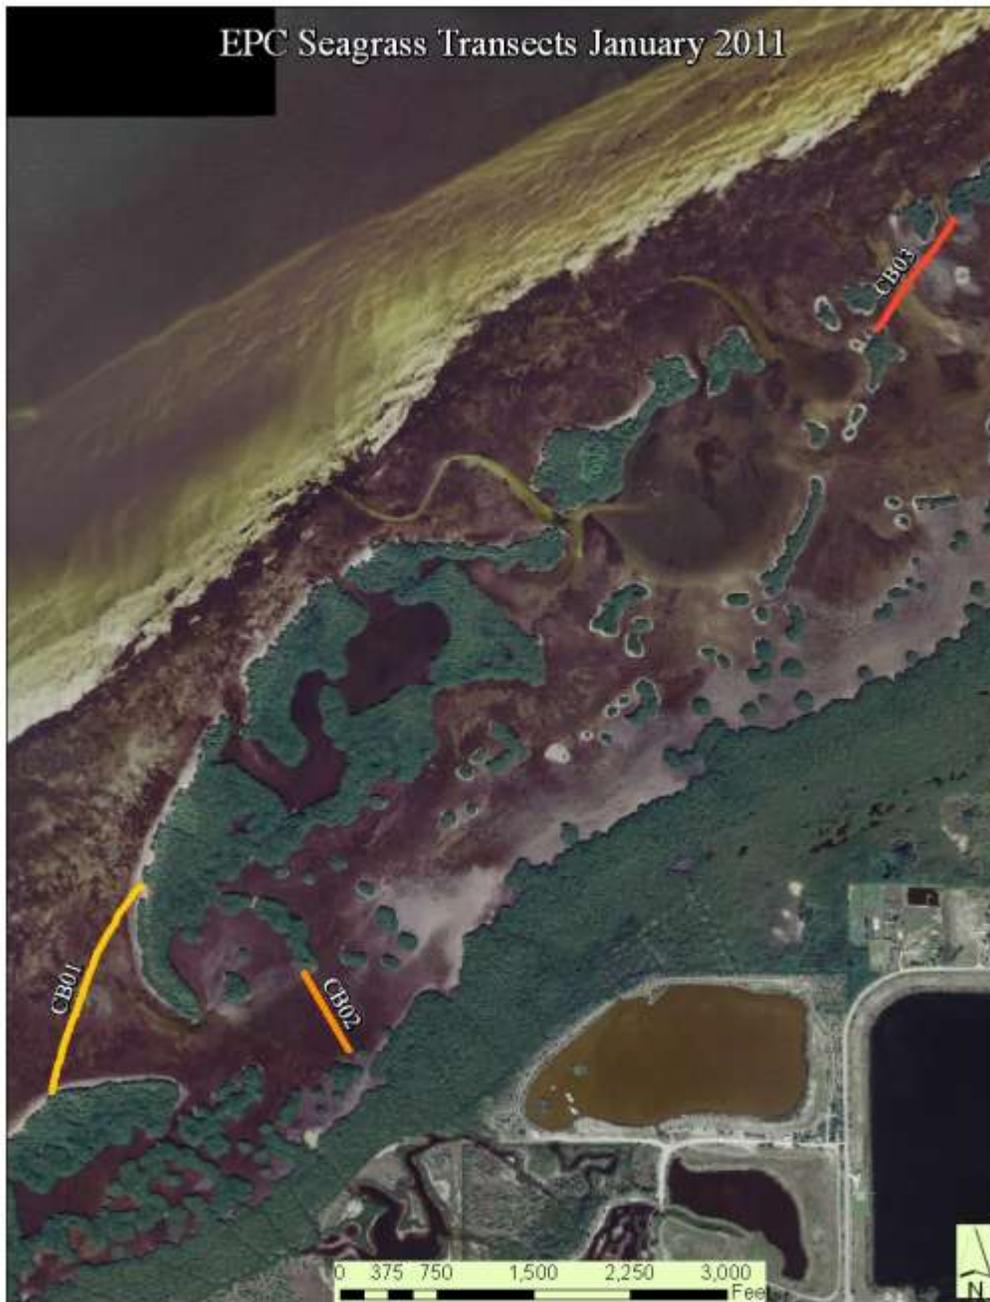
**Figure 22. Map of seagrass transects used for the January 2011 monitoring effort.**

The January 2011 monitoring effort included only the original EPC transects for Cockroach Bay; CB01, CB02 and CB03. The City of Tampa transects were not repeated as the central goal of the project was to monitor boats entering Cockroach Bay through the various island passes. Since the City of Tampa transects, with the exception of MTB03, are aligned perpendicular to the shoreline and not directly related spatially to any of these entry points to Cockroach Bay, it was deemed reasonable to focus the effort on the EPC transects.

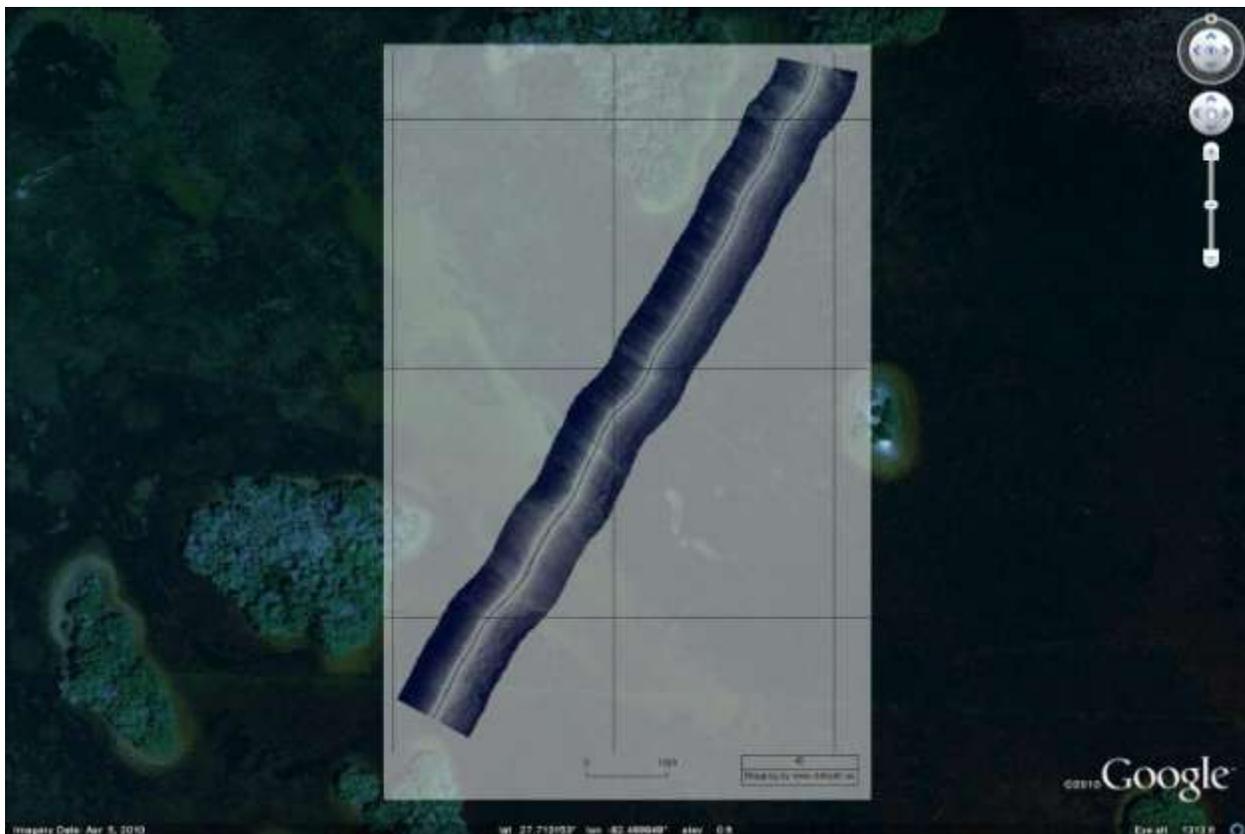
**Figure 23. The output of a sidescan assessment of CB03 transect. The chart analyzed with the Dr. Depth software and displayed as a KML feature in Google Earth.**

Dr. Depth is a sonar-data analysis application, developed in Sweden which allows among other things the creation of a mosaic of sidescan charts and to overlay these data in a spatially accurate manner in Google Earth. Development and Implementation of this software for seagrass scar monitoring is still under way by the Florida Center for Community Design and Research at this time. The long term goal for this effort would be to map the entire area surrounding the transect to get a highly accurate count of seagrass scars and to allow the measurement of scar length and direction. This software also shows promise for creating visually appealing displays for the data collected during the monitoring events.

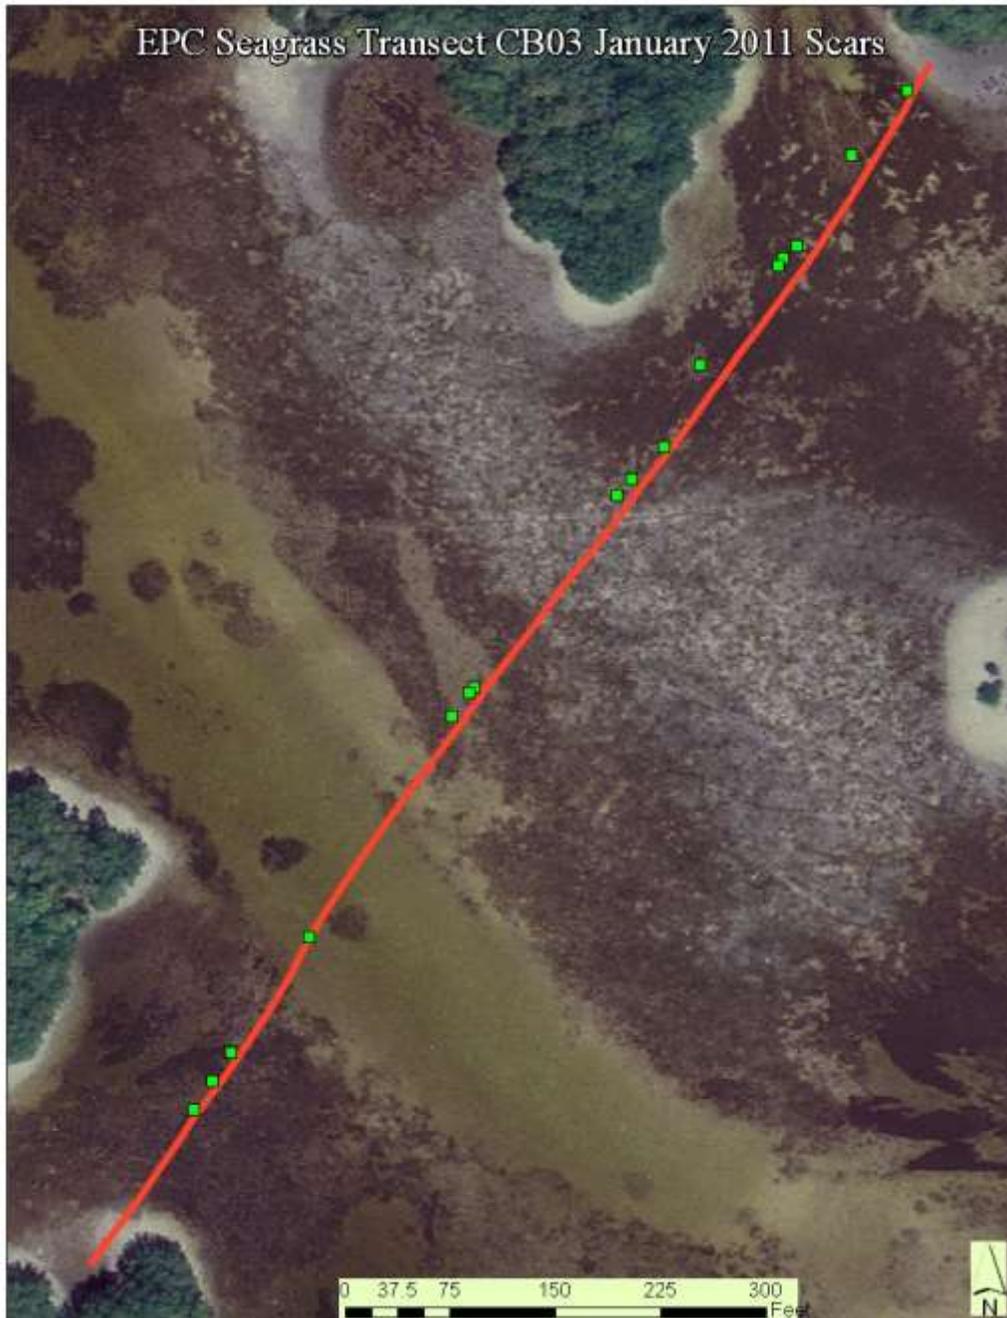
Figure 24. Map showing the locations of the 16 seagrass scars found on transect CB03 during the January 2011 monitoring effort.

A second goal of the January 2011 monitoring effort was to quality check the results of the Humminbird recordings when the HumViewer software is used. This effort was focused on transect CB03 and showed some varying results. Of the 16 scar features identified through chart analysis on HumViewer, 9 were confirmed as scars, 3 were fully recovered scars with no trough but the canopy height of the seagrasses had not recovered to full extent of the surrounding area, and the remaining 4 scars were results of the seagrass bed changing in density or species. These results show some advantages of the combined Humminbird/HumViewer application and some possible issues which need to be addressed. We are now evaluating a new software package with the potential of exploiting these new categories of scar images.

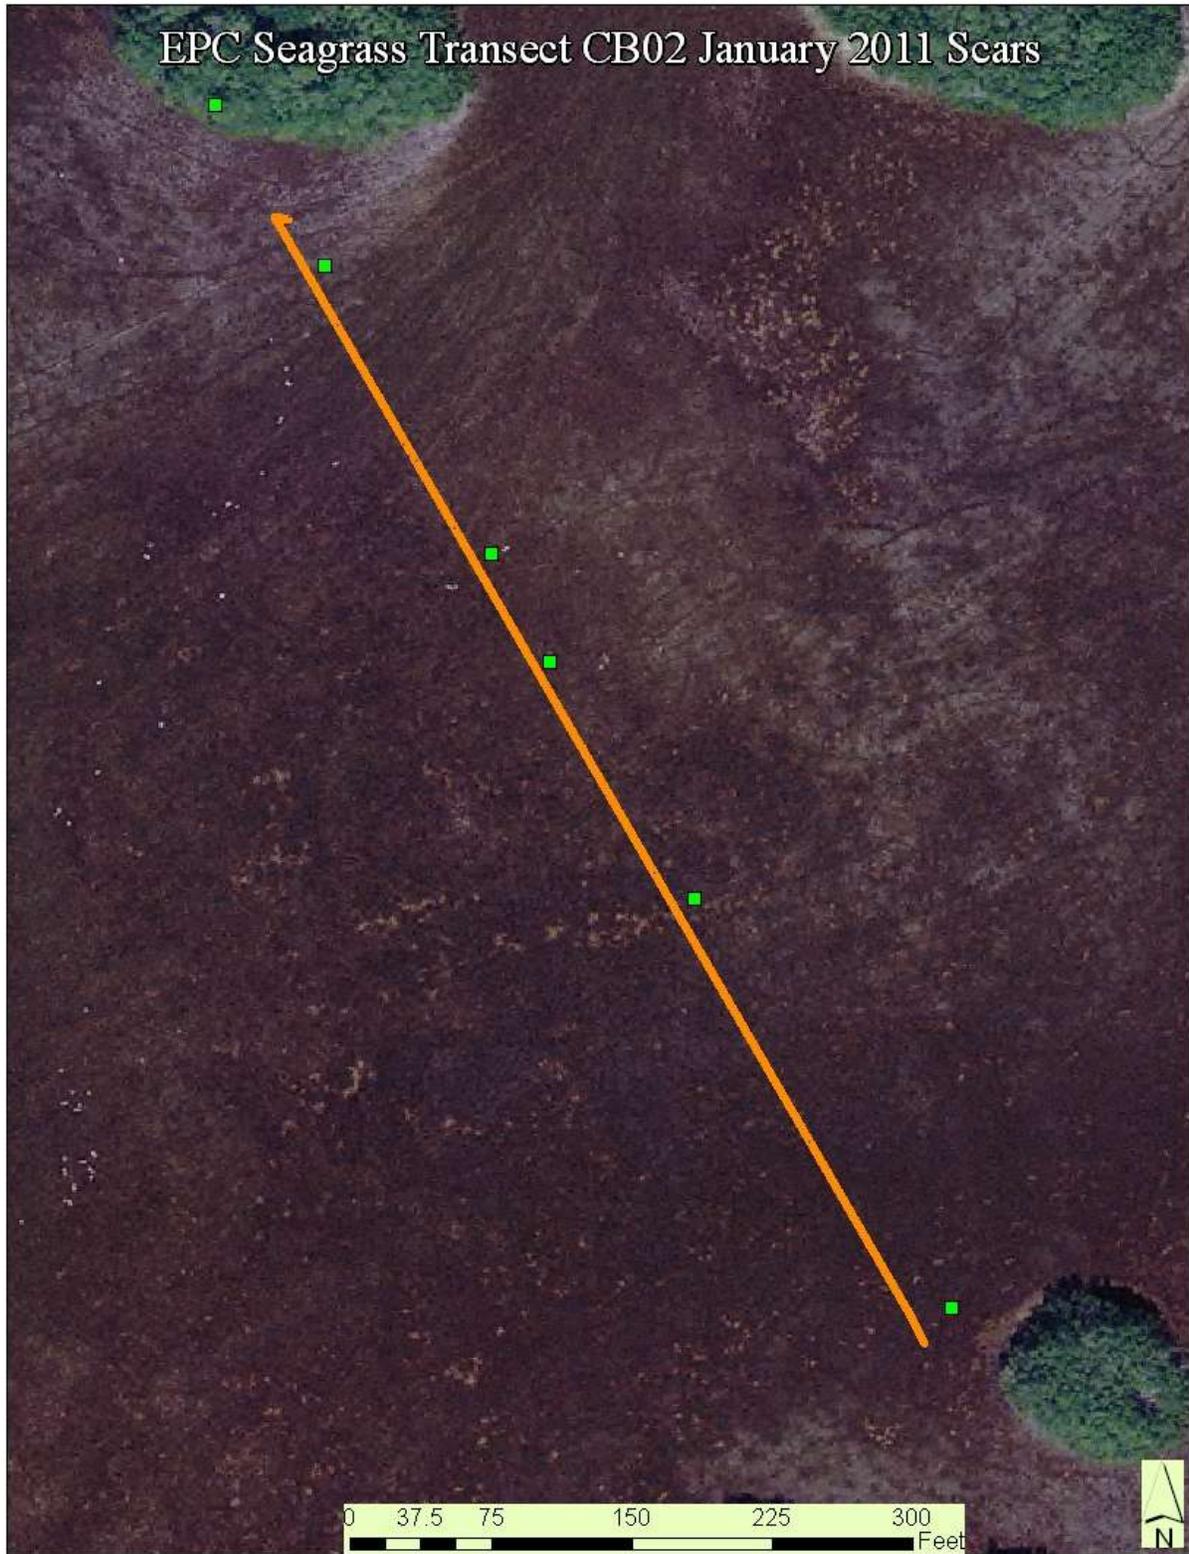
Figure 25. Map showing the locations of the 6 seagrass scars found on transect CB02 during the January 2011 monitoring effort.

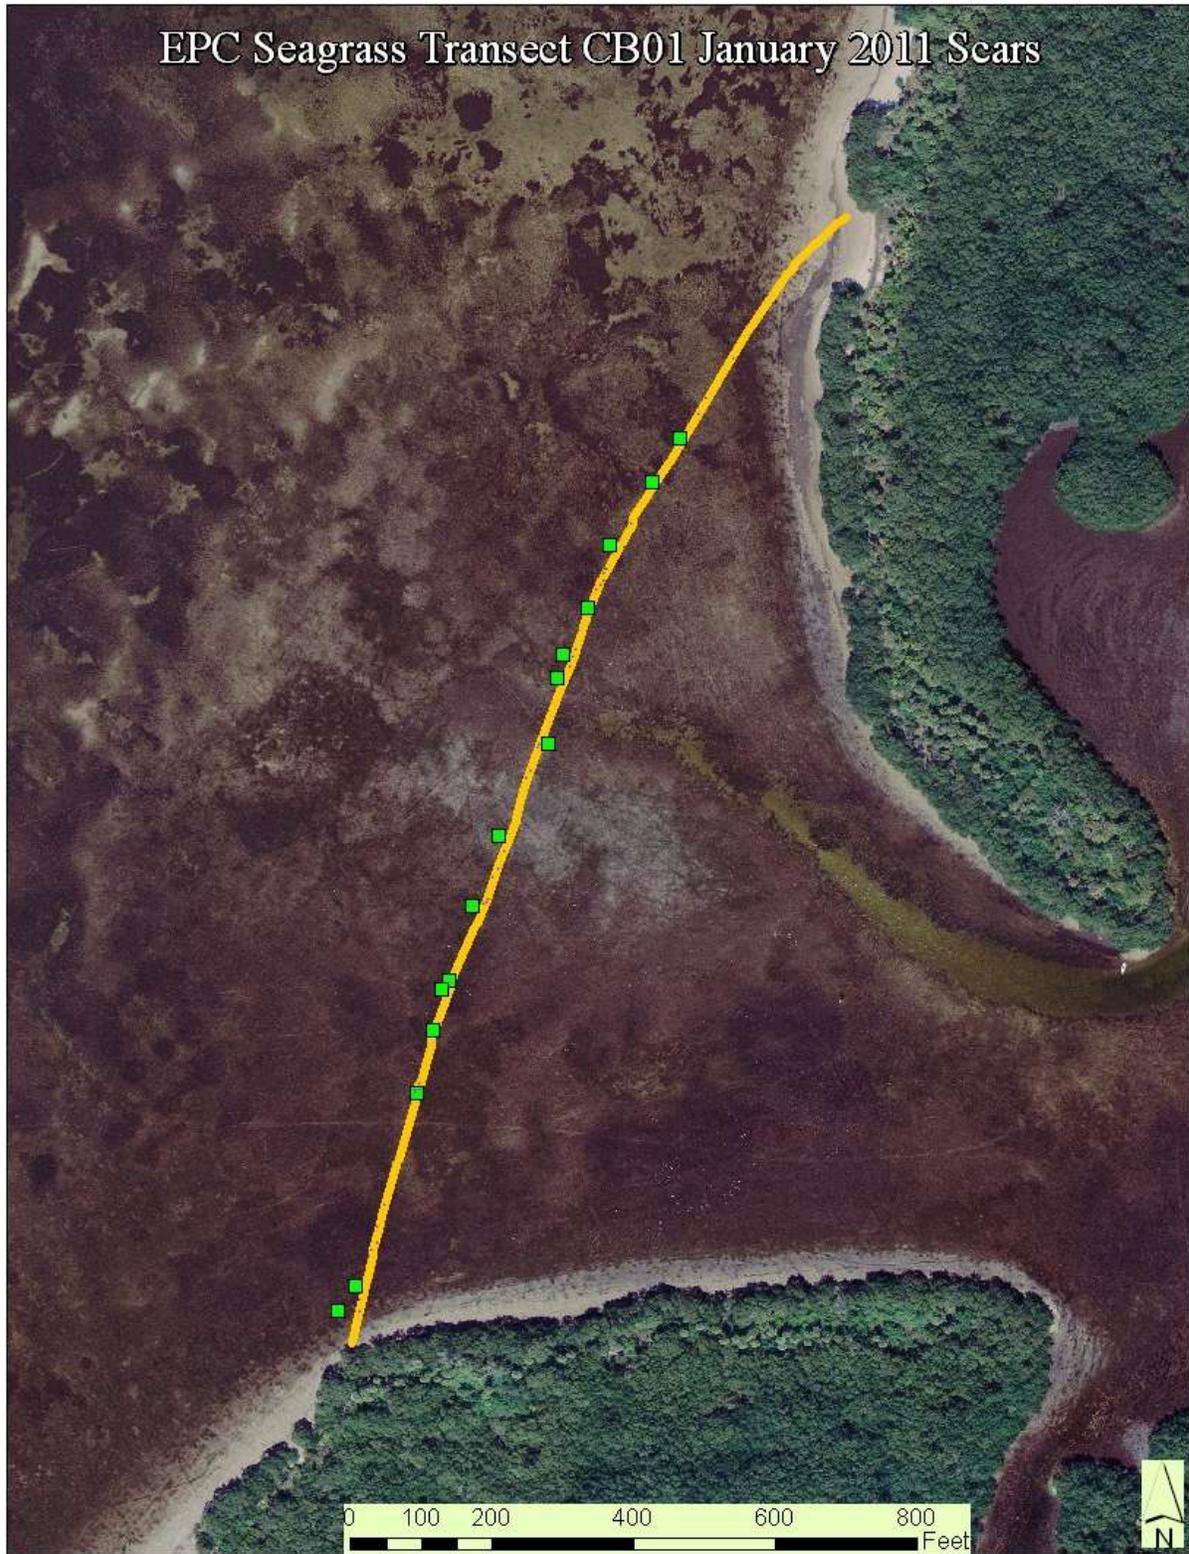
Figure 26. Map showing the locations of the 15 seagrass scars found on transect CB01 during the January 2011 monitoring effort.

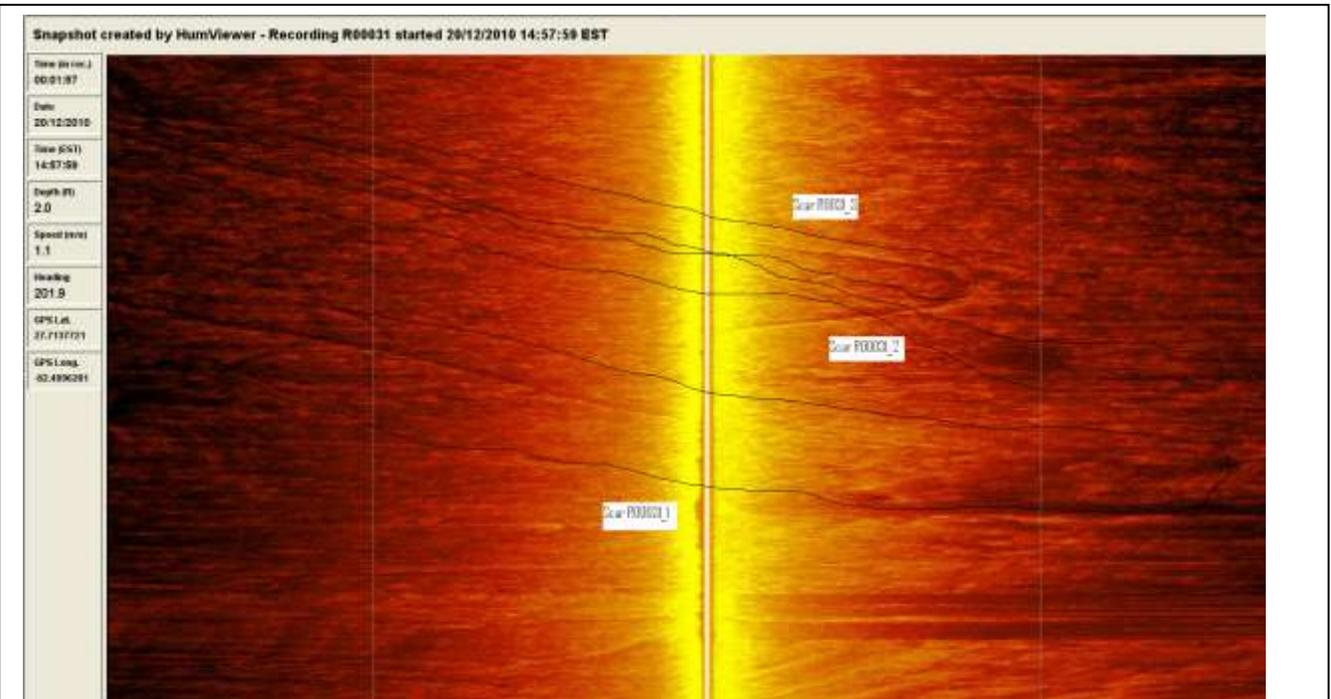
Figure 2. Example of an edited HumViewer Image with multiple scars crossing transects.

- From the File menu, select save snapshot and save it in the folder for the recording being analyzed using the same naming convention as the scar documentation in excel. **Note:** In heavily scared areas (multiple scars in a snapshot) it will be advantageous to bring the saved snapshots into paint program so that the scars can be highlighted and labeled. To accomplish this, right click on saved file, and open with Paint). Figure 2 is an example of the modified image.
