The lake assessments are created in partnership with Hillsborough County and the Florida Center for Community Design and Research
LAKE ASSESSMENT DOCUMENT

Church Lake 6/29/99 Watershed: Brooker Creek

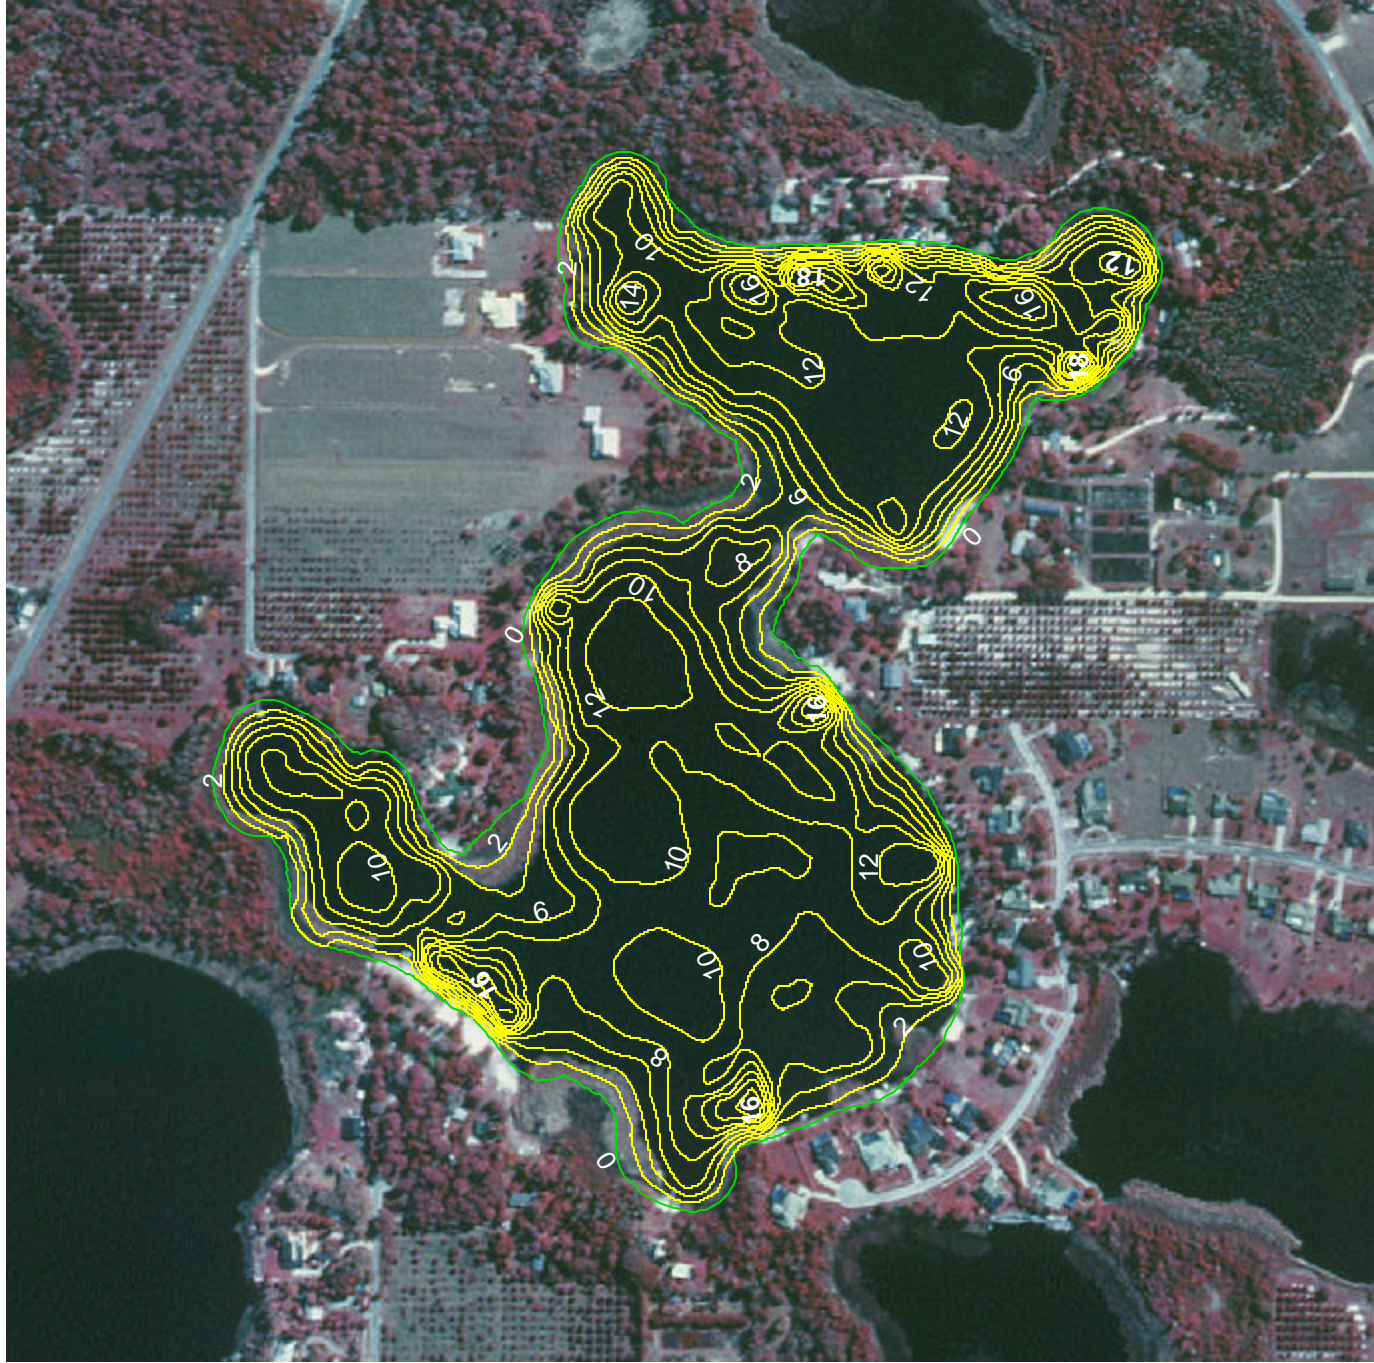
Church Lake

- Contour Lines Expressed in 2-Foot Intervals
- Lake Perimeter
- Ground Level

Survey Date: June 29, 1999

Lake water level was 32.78 ft above sea level when the lake was surveyed. Contours are expressed in absolute depth below this level.

Digital orthophotos by United States Geological Survey. All contours generated by Florida Center for Community Design and Research based on survey data provided by the Hillsborough County Lake Management Program.

The bottom of the lake was mapped using a sophisticated Global Positioning System (GPS) to determine the boat’s position, and a depth-finder to provide depth associated with that measured position. The result is an estimate of your lake’s area, mean and maximum depths, and volume (Table 1) and the creation of a bottom contour map.

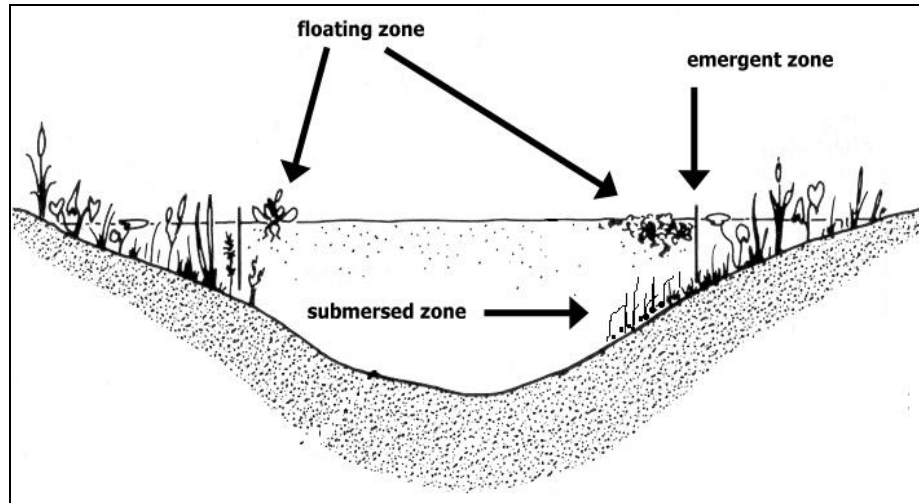
In addition to an overall survey of the types of plants on a lake, an estimate of the standing crop (biomass) of the lake has been obtained for many lakes. This was done by calculating the average weight of the vegetation within a quarter-meter square quadrat tossed haphazardly into three zones (see Figure) at each sampling site around the lake: (1) the emergent zone, (2) the floating zone and (3) the submersed zone. The average weight of the plants (Table 4) from all sampling sites and the dominant type of vegetation (Table 5) are provided. If data tables are not shown, no standing crop estimates were obtained for this lake.
