The lake assessments are created in partnership with Hillsborough County and the Florida Center for Community Design and Research
LAKE ASSESSMENT DOCUMENT

Cooper Lake 7/21/98 Watershed: Rocky/ Brushy Creek

I. Physical Data – Area, Depth, Volume, & Bottom Contours

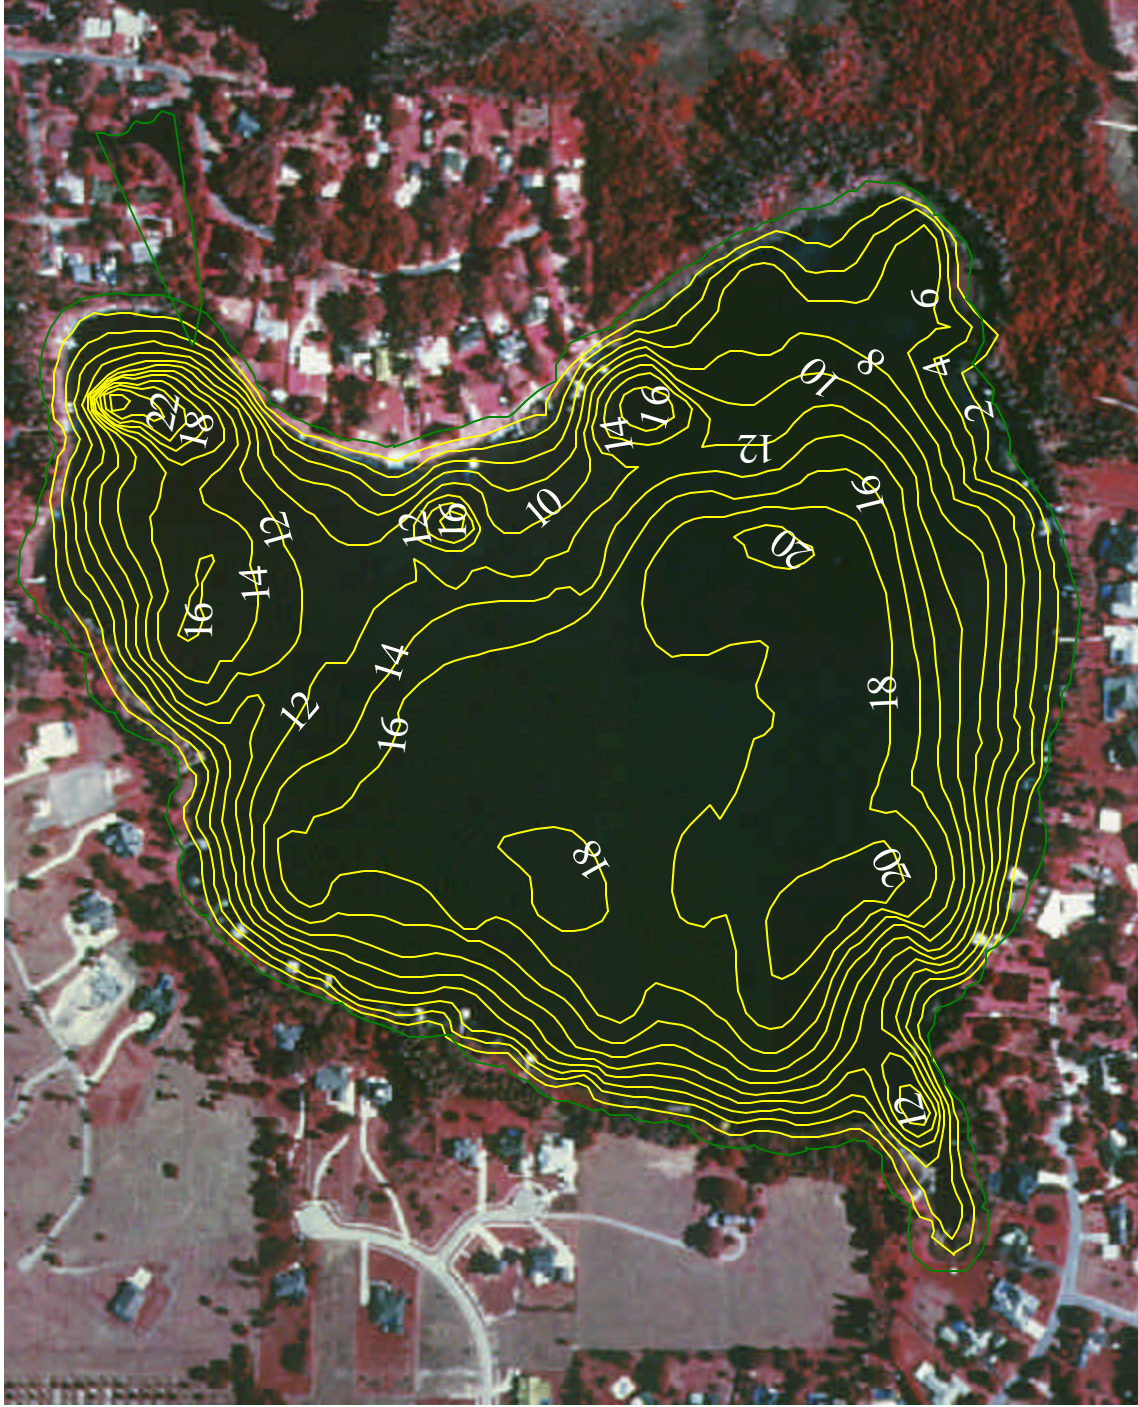
Cooper Lake

Contour Lines Expressed in 2- Foot Intervals
-

EXPLANATION:
Survey date July 21, 1998.

Explanation:
Lake water level was 60.31 ft above Mean Sea Level when the lake was surveyed. Contours are expressed in absolute depth below this level.

DATA SOURCES:
Digital orthophotos by United States Geological Survey. All contours generated by Florida Center for Community Design and Research based on survey data provided by the Hillsborough County Lake Management Program.
