The lake assessments are created in partnership with Hillsborough County and the Florida Center for Community Design and Research
LAKE ASSESSMENT DOCUMENT

Cove Lake 12/14/98 Watershed: Rocky/ Brushy Creek

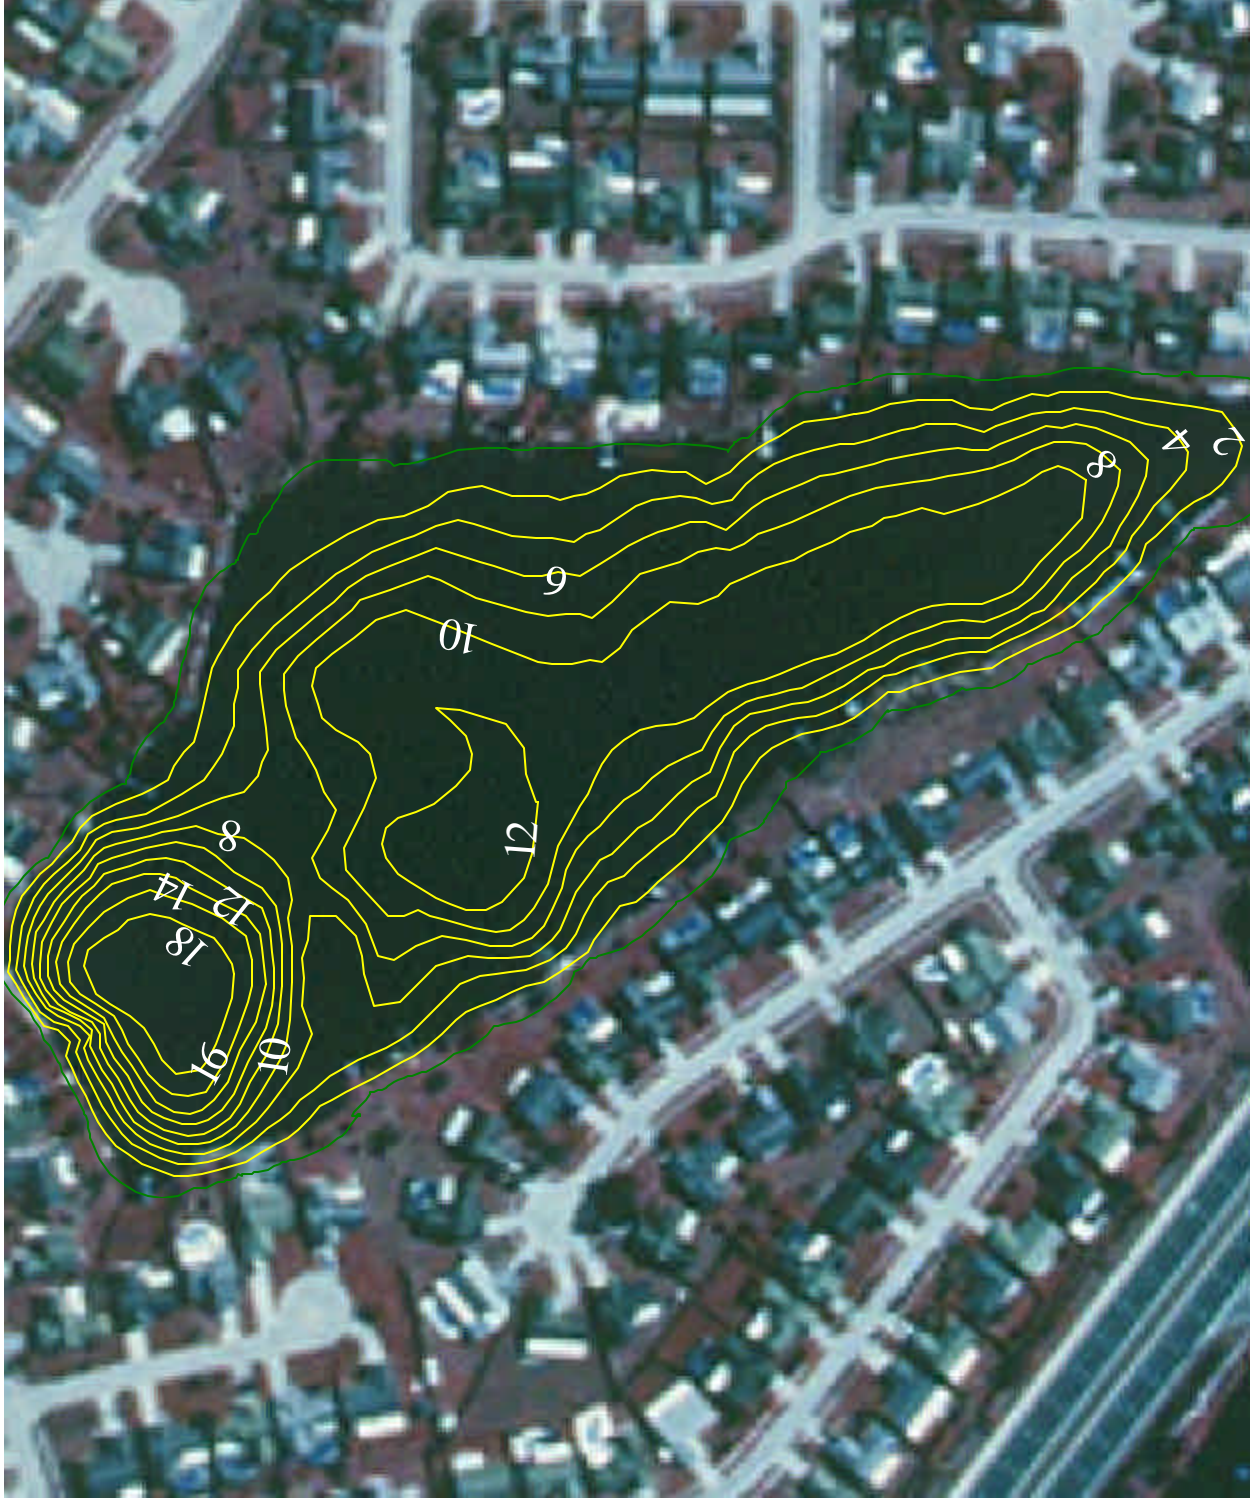
Cove Lake

The bottom of the lake was mapped using a sophisticated Global Positioning System (GPS) to determine the boat’s position, and a depth-finder to provide depth associated with that measured position. The result is an estimate of your lake’s area, mean and maximum depths, and volume (Table 1) and the creation of a bottom contour map.

Contour Lines Expressed in 2- Foot Intervals
-

Lake water level above mean sea level is pending

Digital orthophotos by United States Geological Survey. All contours generated by Florida Center for Community Design and Research based on survey data provided by the Hillsborough County Lake Management Program.
