The lake assessments are created in partnership with Hillsborough County and the Florida Center for Community Design and Research  
**LAKE ASSESSMENT DOCUMENT**

East Lake      7/19/00      Watershed: Eastlake Area

# East Lake

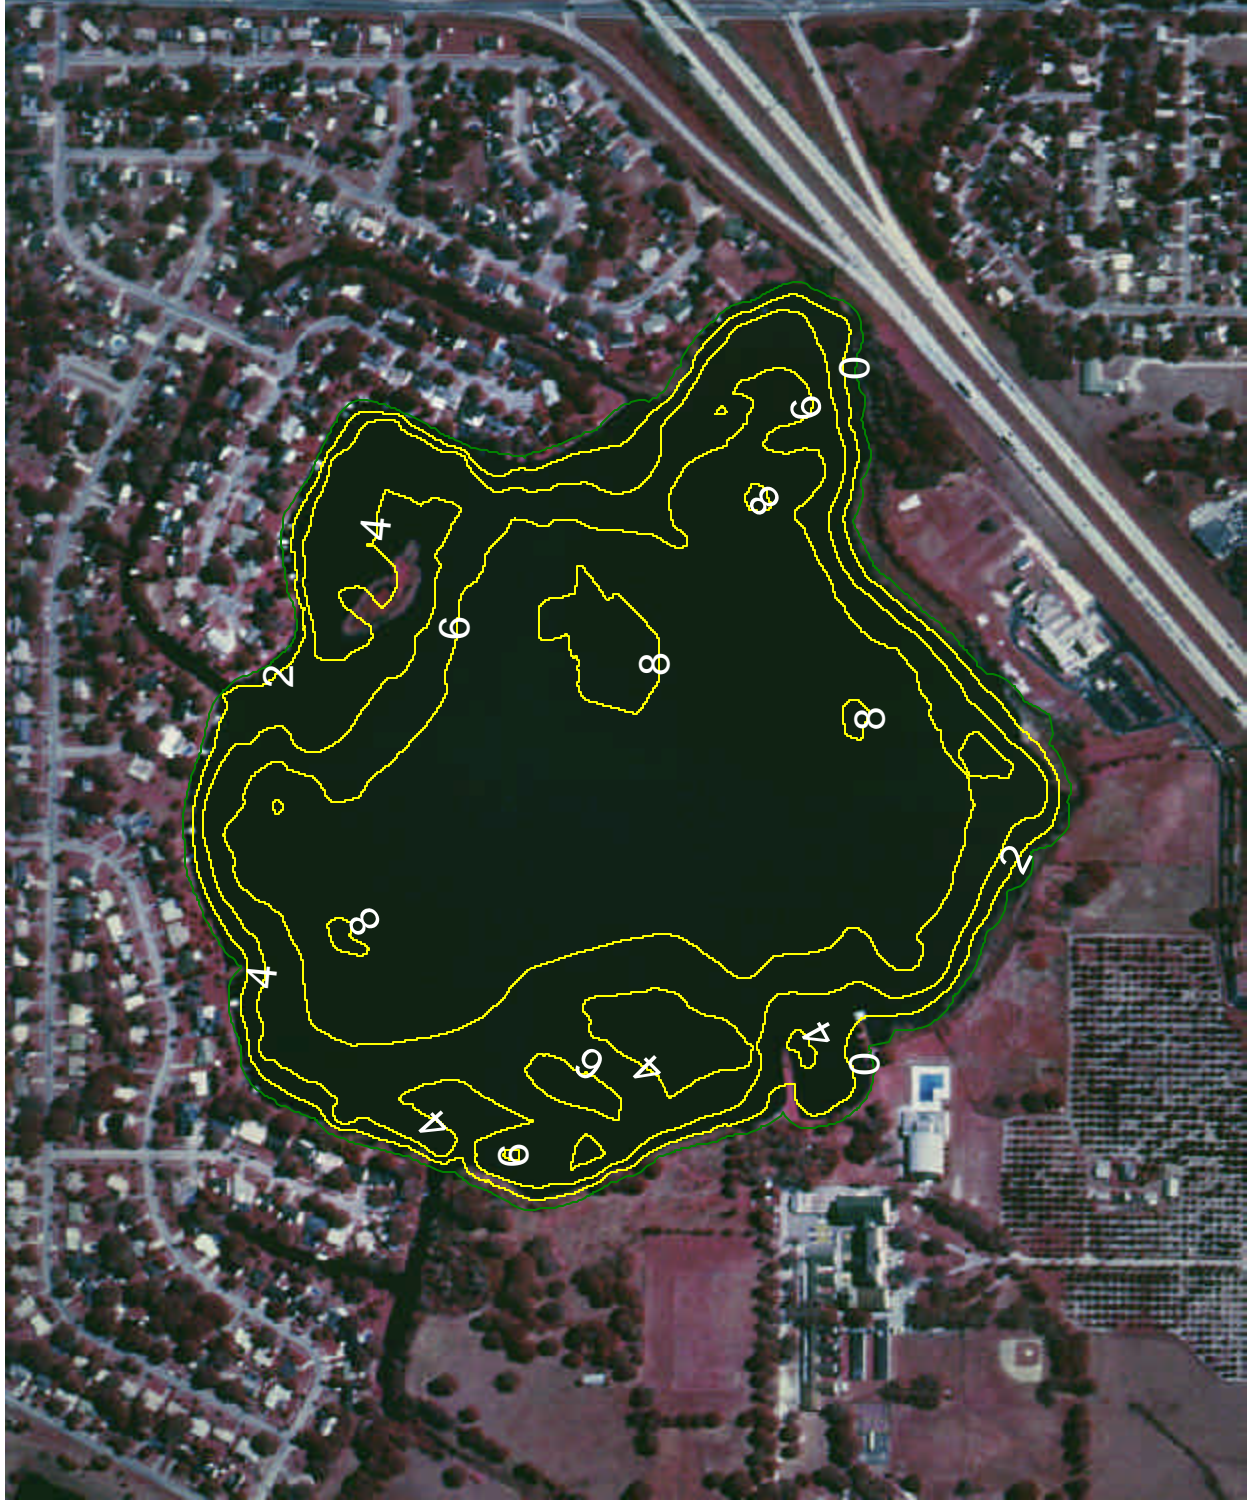
Contour Lines Expressed in 2- Foot Intervals
-

Survey date January 28, 1998.

Lake water level was 22.88 ft above Mean Sea Level when the lake was surveyed. Contours are expressed in absolute depth below this level.

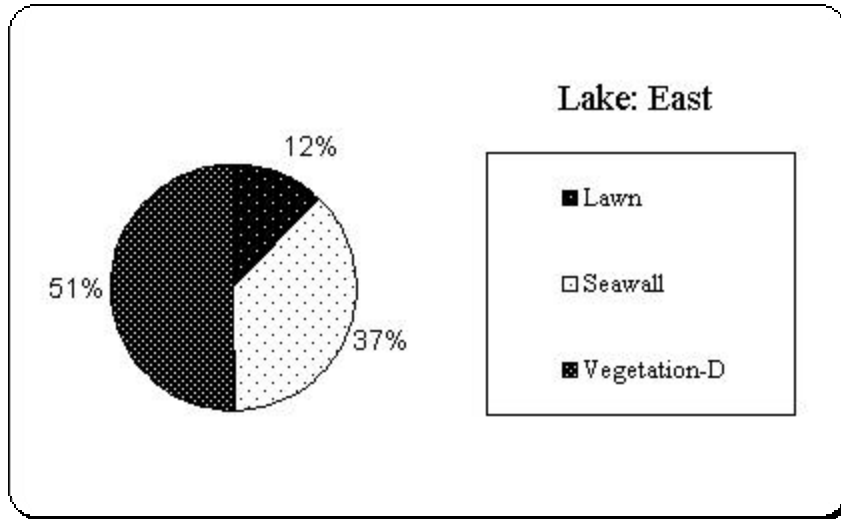
Percent of lake shore types

The shoreline is mapped by navigating the circumference of the lake and characterizing the adjacent shore using sophisticated GPS. Categories for characterization include: 1) Lawn 2) Seawall 3) Beach, Bare Soil 4) Undisturbed Vegetation (*Vegetation-U*) 5) Disturbed Vegetation (*Vegetation-D*) 6) Impervious Surface and 7) Ornamentals, etc. The result is an estimate of the percent of each type of shoreline per lake. This information assists in the interpretation of the aquatic plant survey as an indicator of relative habitat quality.
