The lake assessments are created in partnership with Hillsborough County and the Florida Center for Community Design and Research  
**LAKE ASSESSMENT DOCUMENT**

Lake Hiawatha      4/14/99      Watershed: Anclote

**I. Physical Data – Area, Depth, Volume, & Bottom Contours**

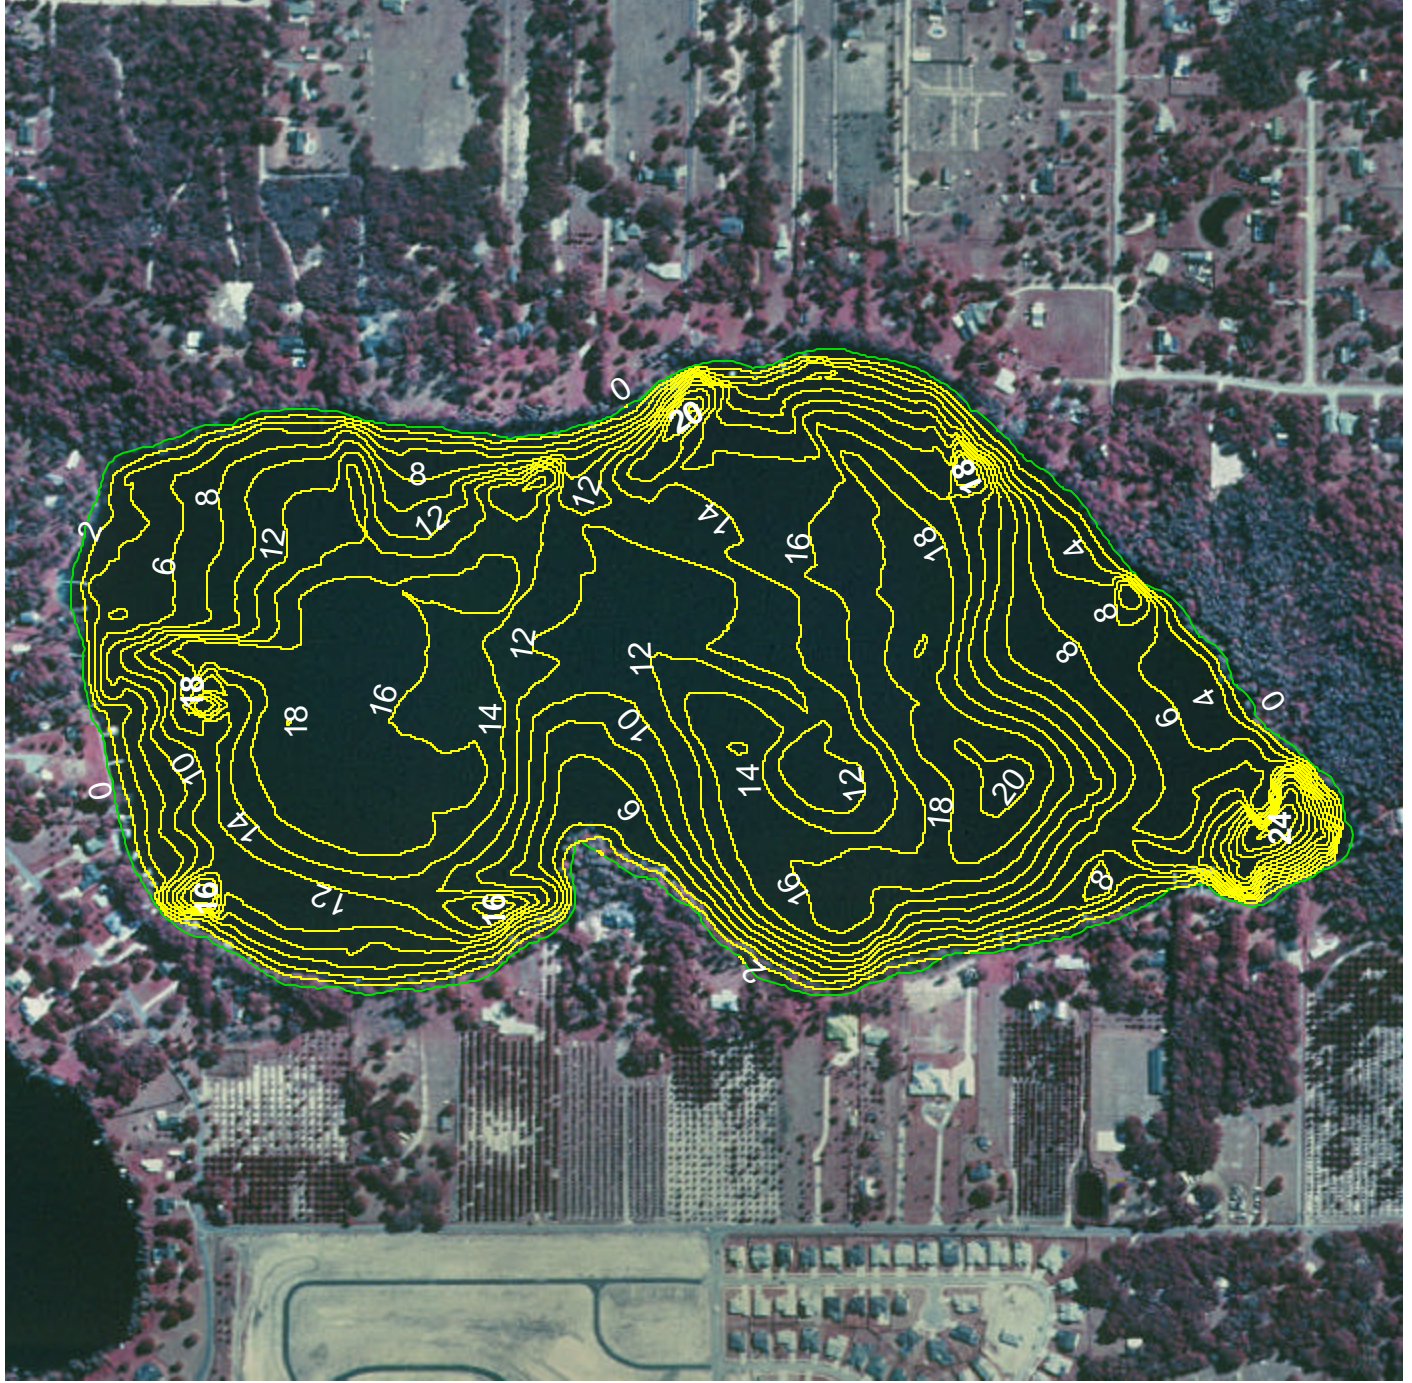
# Lake Hiawatha

Contour Lines Expressed in 2-Foot Intervals
-

Survey Date: April 14, 1999

Lake water level was 48.38 ft above sea level when the lake was surveyed. Contours are expressed in absolute depth below this level.

Digital orthophotos by United States Geological Survey. All contours generated by Florida Center for Community Design and Research based on survey data provided by the Hillsborough County Lake Management Program.

The bottom of the lake was mapped using a sophisticated Global Positioning System (GPS) to determine the boat’s position, and a depth-finder to provide depth associated with that measured position. The result is an estimate of your lake’s area, mean and maximum depths, and volume (Table 1) and the creation of a bottom contour map.

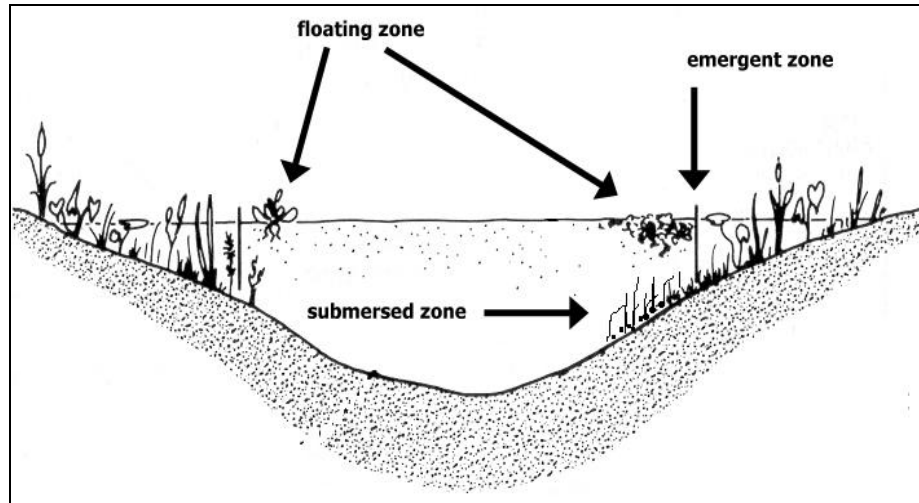
In addition to an overall survey of the types of plants on a lake, an estimate of the standing crop (biomass) of the lake has been obtained for many lakes. This was done by calculating the average weight of the vegetation within a quarter-meter square quadrat tossed haphazardly into three zones (see Figure) at each sampling site around the lake: (1) the emergent zone, (2) the floating zone and (3) the submersed zone. The average weight of the plants (Table 4) from all sampling sites and the dominant type of vegetation (Table 5) are provided. If data tables are not shown, no standing crop estimates were obtained for this lake.
