The lake assessments are created in partnership with Hillsborough County and the Florida Center for Community Design and Research
LAKE ASSESSMENT DOCUMENT

Lake Maurine 11/20/01 Watershed: Double Branch Creek

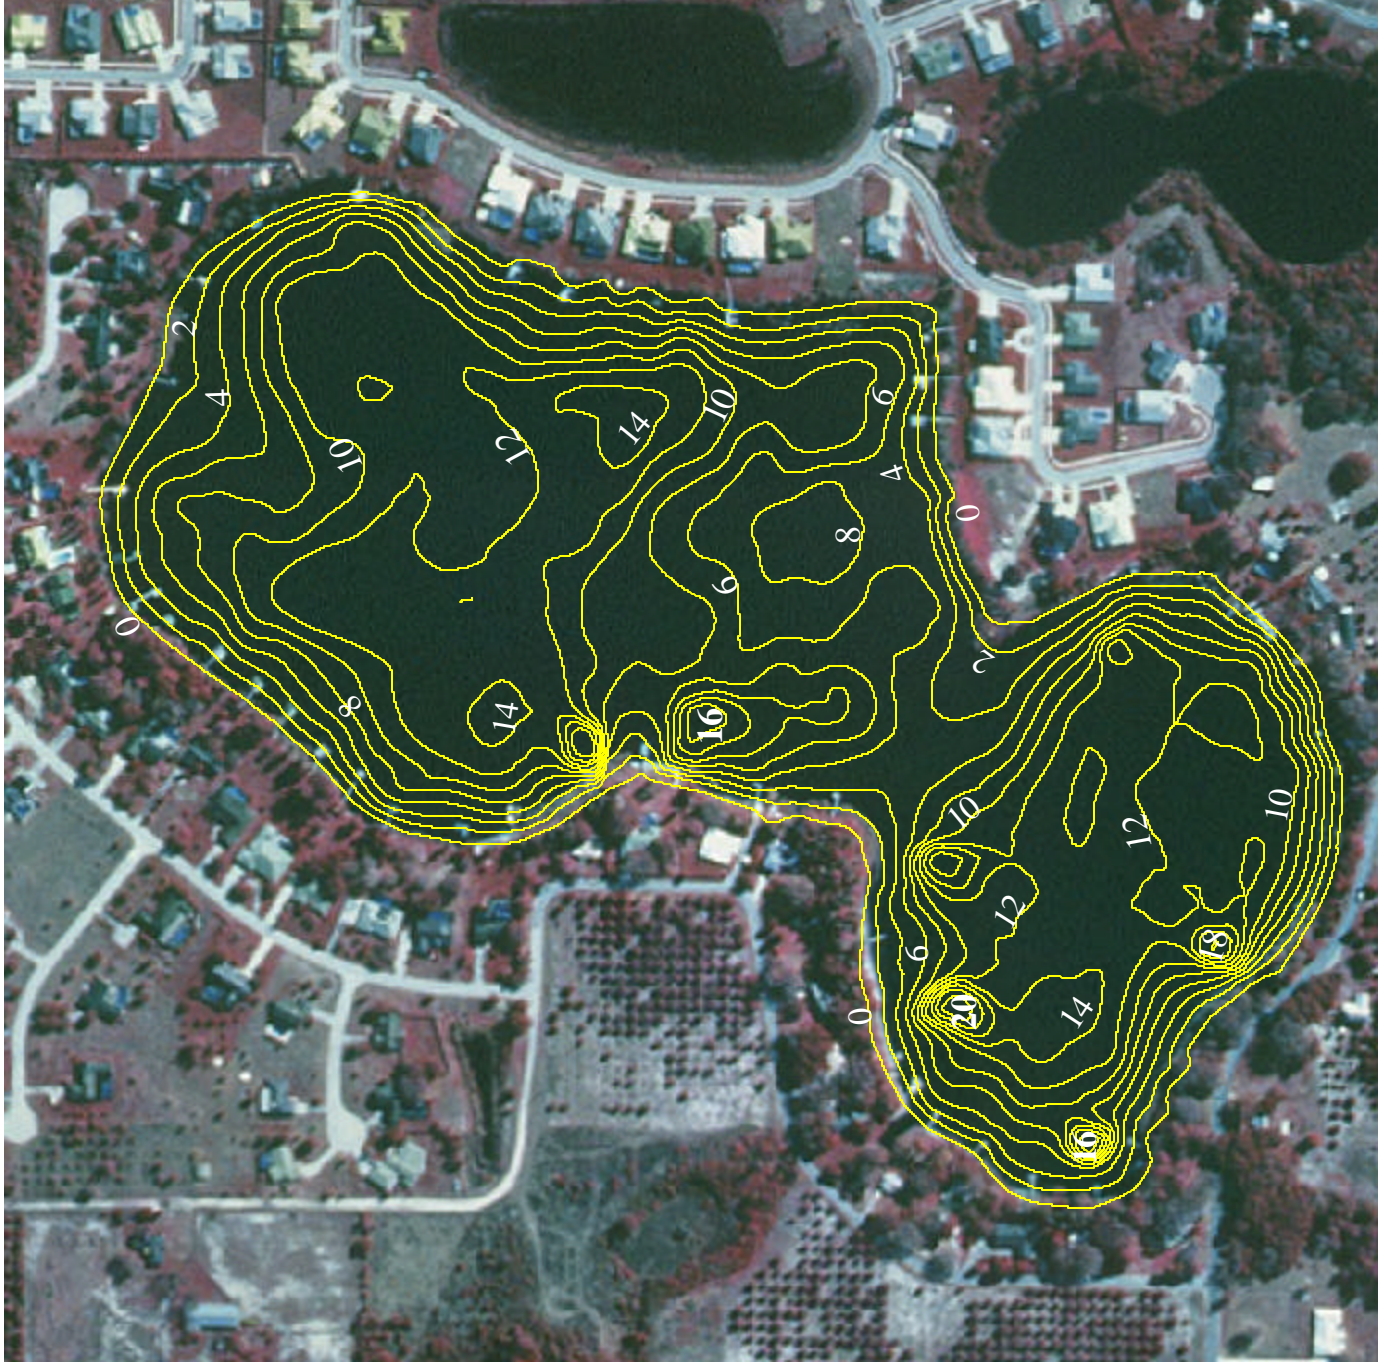
Lake Maurine

Contour Lines
Expressed in
2-Foot Intervals

Survey Date: July 1, 1999

Lake water level was 31.8 ft above sea level when the lake was surveyed. Contours are expressed in absolute depth below this level.

Digital orthophotos by United States Geological Survey. All contours generated by Florida Center for Community Design and Research based on survey data provided by the Hillsborough County Lake Management Program.

The bottom of the lake was mapped using a sophisticated Global Positioning System (GPS) to determine the boat’s position, and a depth-finder to provide depth associated with that measured position. The result is an estimate of your lake’s area, mean and maximum depths, and volume (Table 1) and the creation of a bottom contour map.

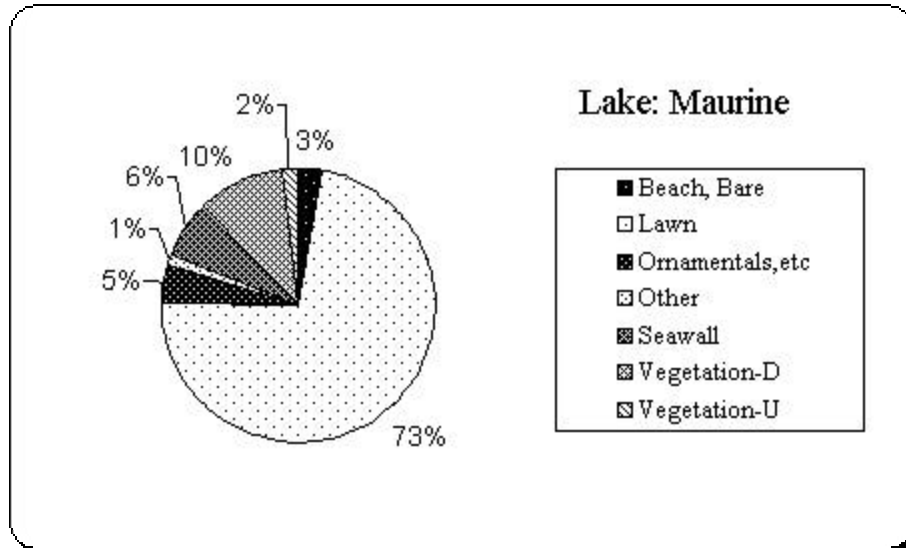
Percent of lake shore types

The shoreline is mapped by navigating the circumference of the lake and characterizing the adjacent shore using sophisticated GPS. Categories for characterization include: 1) Lawn 2) Seawall 3) Beach, Bare Soil 4) Undisturbed Vegetation (*Vegetation-U*) 5) Disturbed Vegetation (*Vegetation-D*) 6) Impervious Surface and 7) Ornamentals, etc. The result is an estimate of the percent of each type of shoreline per lake. This information assists in the interpretation of the aquatic plant survey as an indicator of relative habitat quality.
