LAKE ASSESSMENT REPORT FOR JUNE LAKE IN HILLSBOROUGH COUNTY, FLORIDA

Date Assessed: June 30, 2009

Assessed by: David Eilers, Cheran Williams, Brian Rosegger

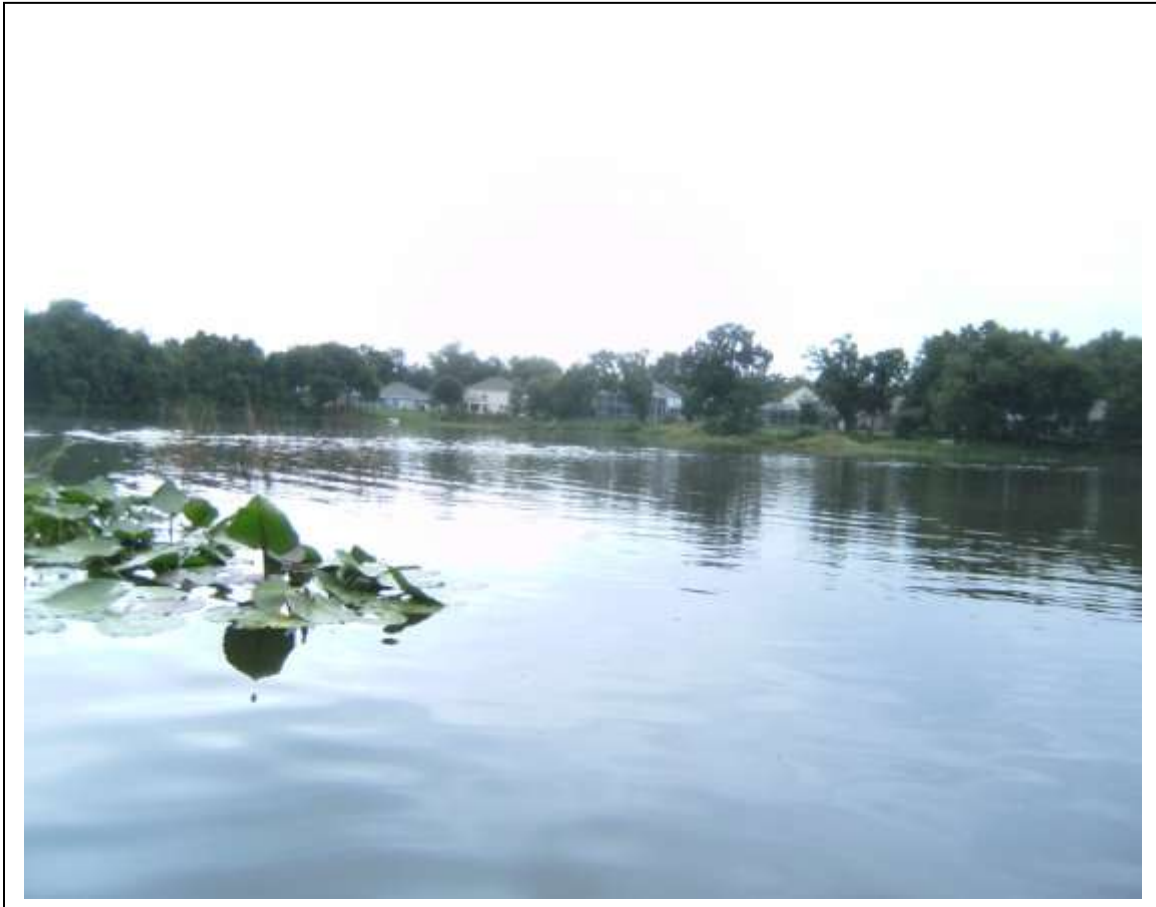
Figure 1. Photo of June Lake, taken June 30, 2009.

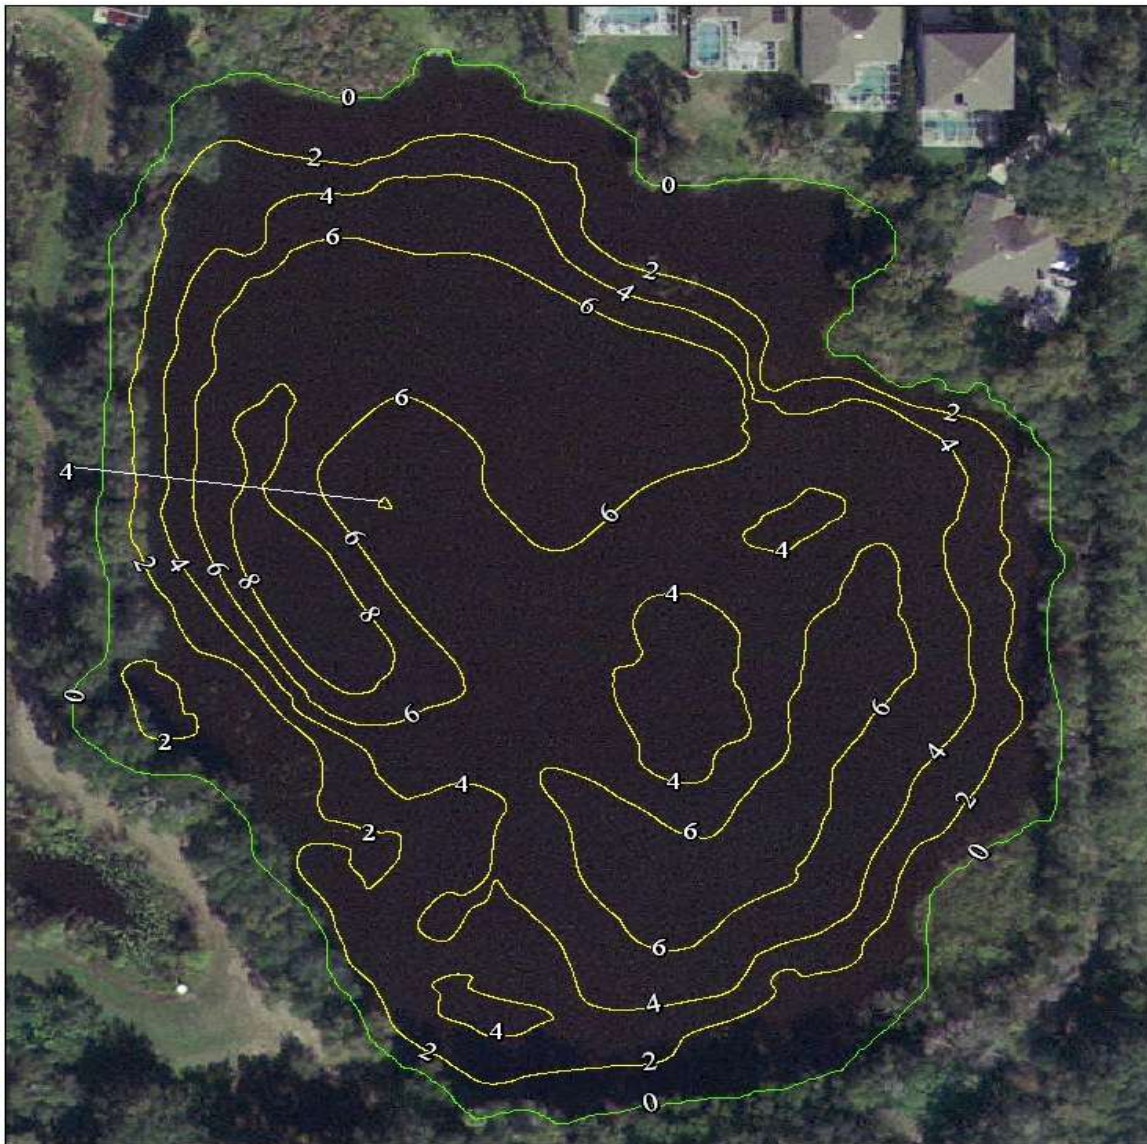
Survey Date: June 30, 2009
Lake water level was not determined (lacking gauge).
Contours are expressed in absolute depth
below this level.

Perimeter 2,271.95 ft,
Area 5.96 Acres
Mean Depth 3.97 ft,
Volume 24.12 Acre-ft, (7,860,229.01 gallons);
Deepest point 9.26 ft

Figure 1. Contour map for June Lake. The mapping technique used in 2009 employs a standard DGPS for horizontal position and a fathometer for depth.

Bathymetric Mapⁱⁱ. Table 1 provides the lake's morphologic parameters in various units. The bottom of the lake was mapped using a Lowrance LCX 28C HD Wide Area Augmentation System (WAAS)ⁱⁱⁱ enabled Global Positioning System (GPS) with fathometer (bottom sounder) to determine the boat's position, and bottom depth in a single measurement. The result is an estimate of the lake's area, mean and maximum depths, and volume and the creation of a bottom contour map (Figure 2). Besides pointing out the deeper fishing holes in the lake, the morphologic data derived from this part of the assessment can be valuable to overall management of the lake vegetation as well as providing flood storage data for flood models.

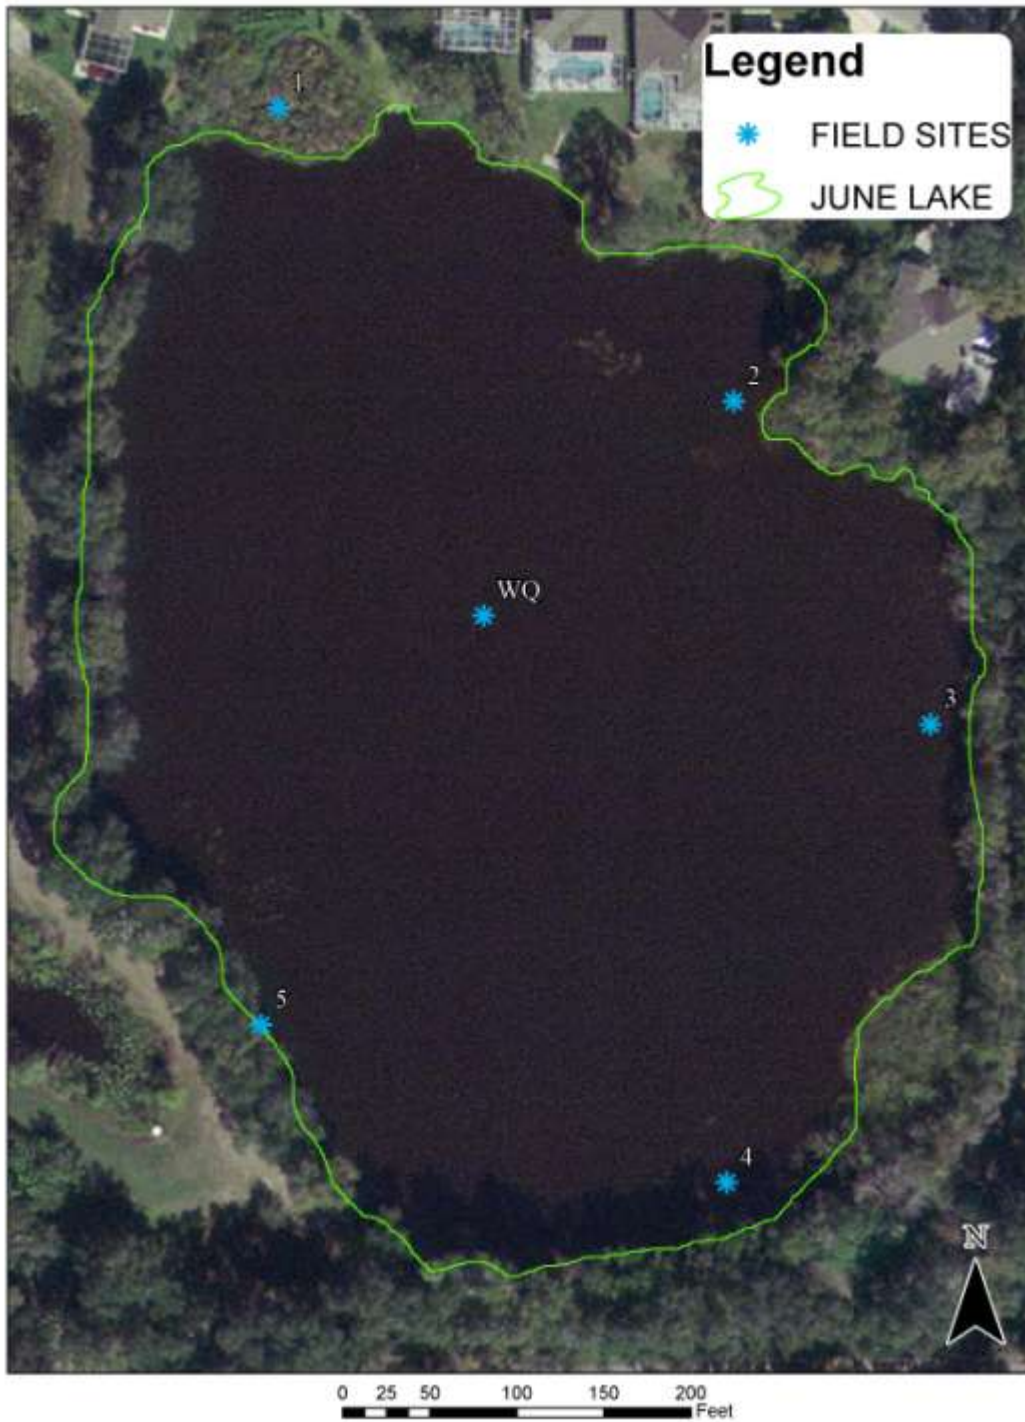
Figure 3. 2007 six-inch resolution aerial photograph showing location of vegetation assessment sites on June Lake. Major emergent and floating vegetation zones as well as structures are also observable in this aerial.

The lake's apparent vegetative cover and shoreline detail are evaluated using the latest lake aerial photograph as shown in Figure 3 and by use of WAAS enabled GPS. Submerged vegetation is determined from the analysis of bottom returns from the Lowrance 28c HD combined GPS/fathometer described earlier. As depicted in Figure 3, five vegetation assessment sites were chosen for intensive sampling based on the *Lake Assessment Protocol* (copy available on request) for a lake of this size. The site positions are set using GPS and then loaded into a GIS mapping program (ArcGIS) for display. Each site is sampled in the three primary vegetative zones (emergent, submerged and floating).^{iv} The latest high resolution aerial photos are used to provide shore details (docks, structures, vegetation zones) and to calculate the extent of surface vegetation coverage. The primary indices of submerged vegetation cover and biomass for the lake, percent area coverage (PAC) and percent volume infestation (PVI), are determined by transiting the lake by boat and employing a fathometer to collect "hard and soft return" data. These data are later analyzed for presence and absence of vegetation and to determine the height of vegetation if present. The PAC is determined from the presence and absence analysis of 100 sites in the lake and the PVI is determined by measuring the difference between hard returns (lake bottom) and soft returns (top of vegetation) for sites (within the 100 analyzed sites) where plants are determined present (Figure 6).

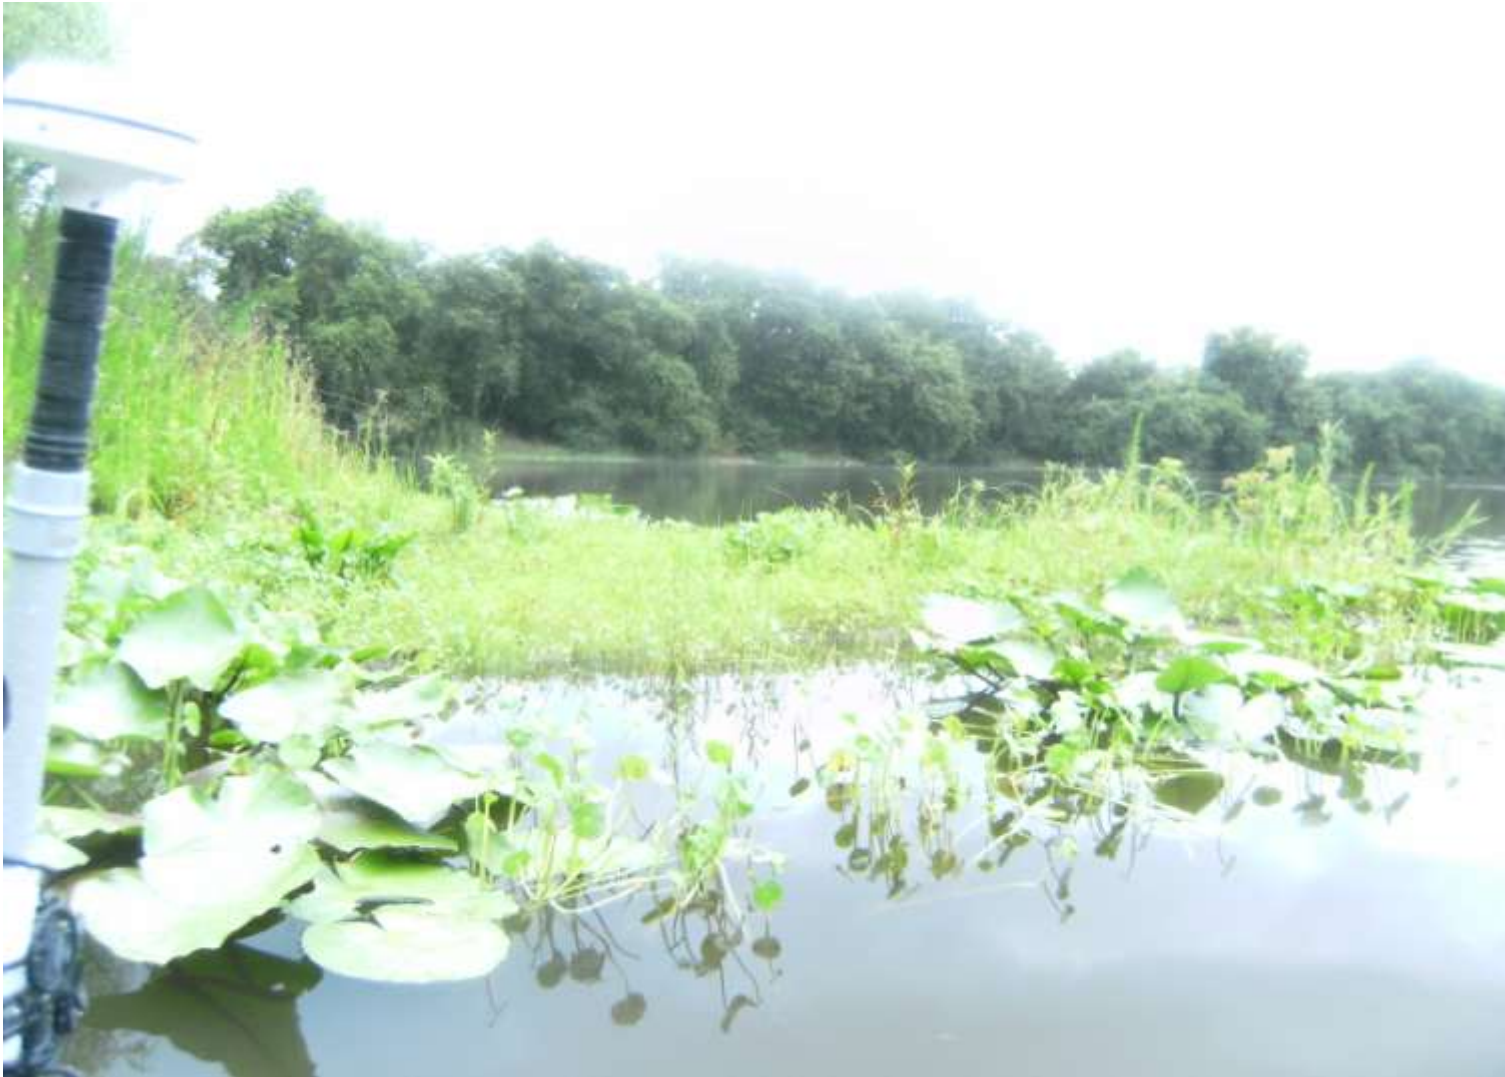
Figure 4. Photograph of Spatterdocks and Pennyworts, on June Lake. DESCRIPTION: This photograph, taken from vegetation site 4, shows floating vegetation such as the larger Spatterdocks (*Nuphar lutea var. advena*) at the left and the “penny-sized” Pennyworts (*Hydrocotyl umbellata*) in the center.

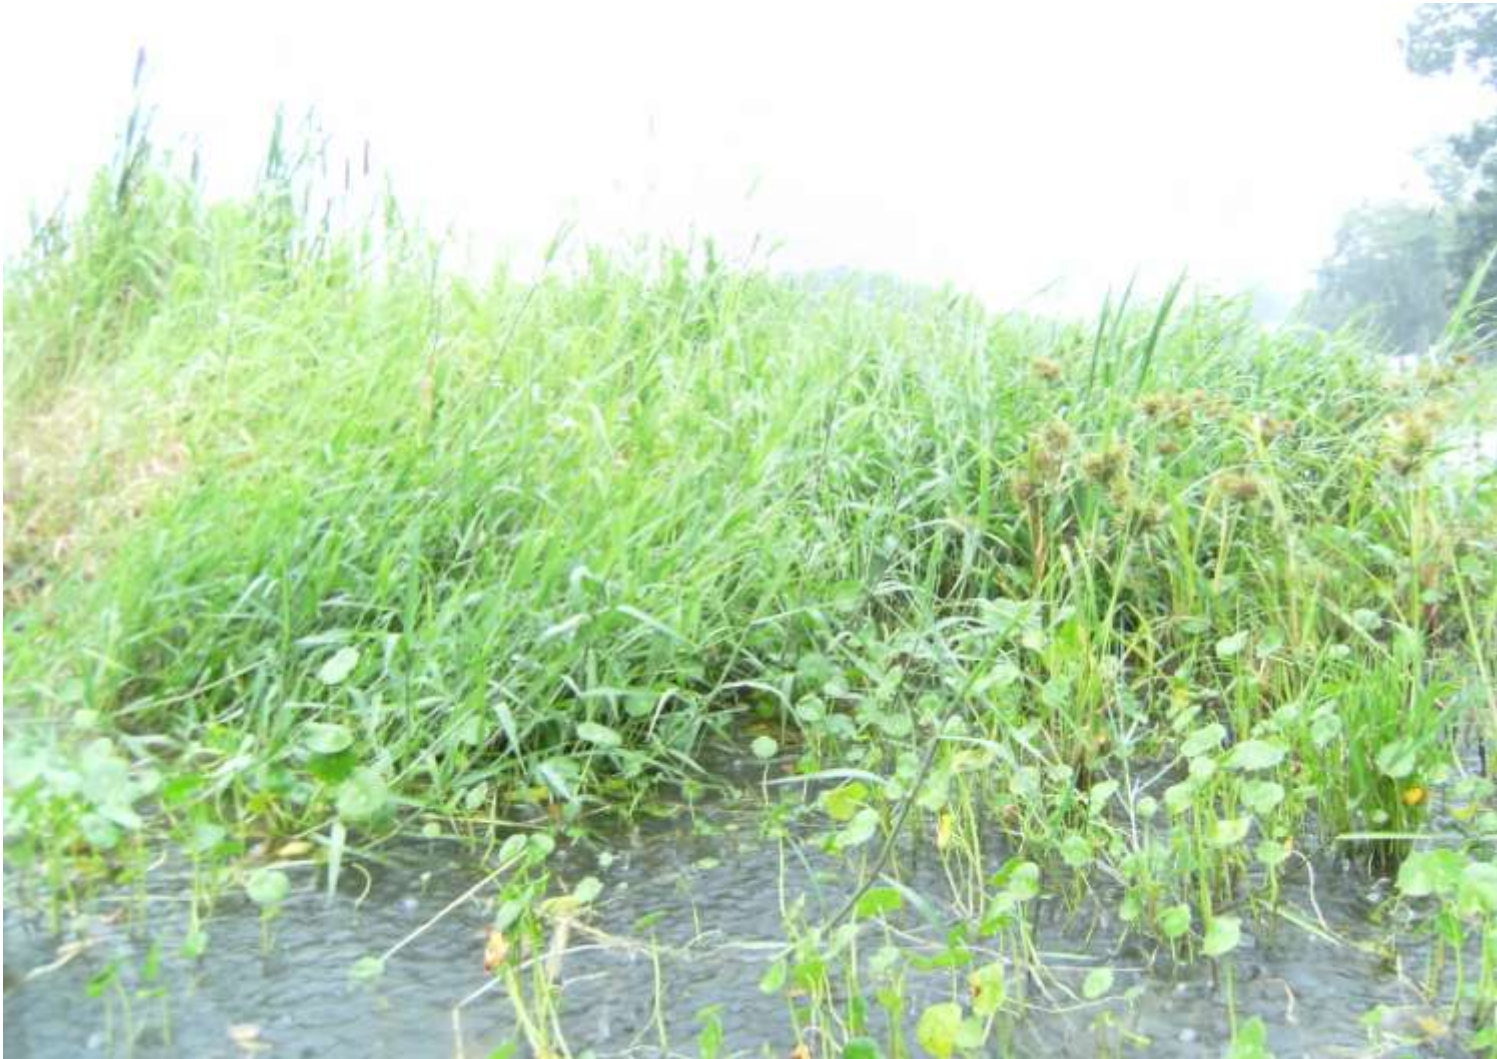
Figure 5. Photograph of Para Grass, Fragrant Flatsedge, and Pennywort, on June Lake. DESCRIPTION: The foreground of the photo shows the floating Pennywort (*Hydrocotyl umbellata*), the right shows the Fragrant flatsedge (*Cyperus odoratus*), and the background of the photo is Para grass (*Urochloa mutica*).

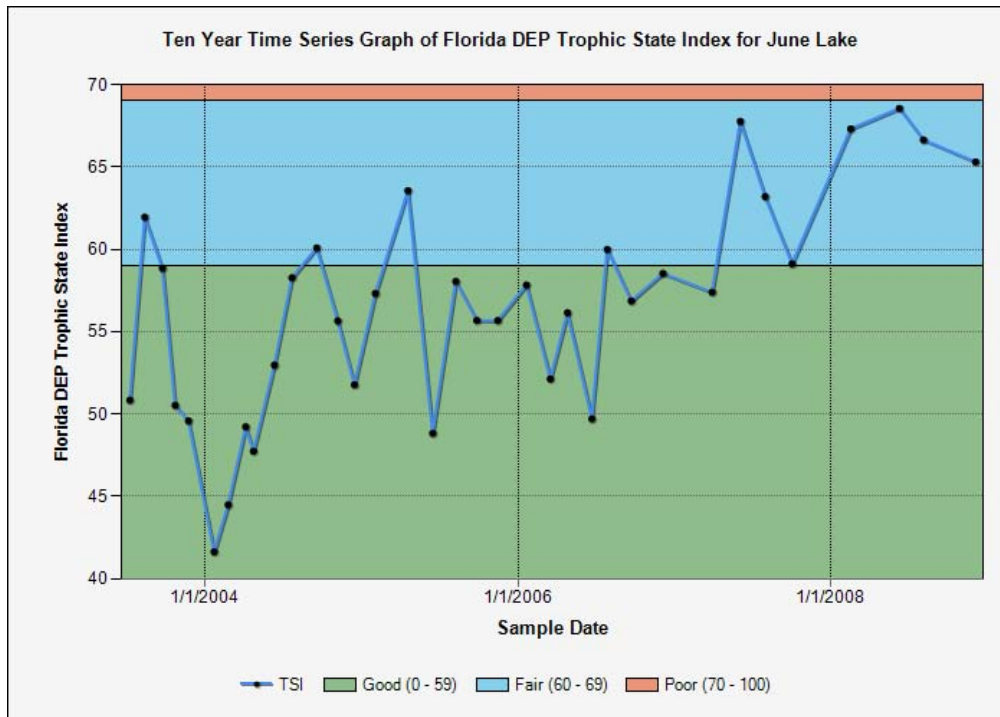
Figure 6. Recent Trophic State Index (TSI) graph from Hillsborough Watershed Atlas. For the latest data go to:

Note: The graph above includes benchmarks for using verbal descriptors of "good", "fair" and "poor". The verbal descriptors for these benchmarks are based on an early determination by stakeholders of the generally acceptable and understood terms for describing the state of lakes. The same benchmarks are used for nutrient graphs (Nitrogen and Phosphorus), chlorophyll graphs and trophic state index (TSI) graphs. The TSI is a calculated index of lake condition based on nutrient and chlorophyll (a) concentrations (please see "Learn more about Trophic State Index"). The benchmarks are established based on the TSI range that relates to a specific descriptor. The source for the TSI concentration relationships is the Florida Water Quality Assessment, 1996, 305(b) (Table 2-8).

A critical element in any lake assessment is the long-term water chemistry data set. The primary source of water quality trend data for Florida Lakes is the Florida LAKEWATCH volunteer and the Florida LAKEWATCH water chemistry data. Hillsborough County is fortunate to have a large cadre of volunteers who have collected lake water samples for significant time period. These data are displayed and analyzed on the Water Atlas as shown in Figure 6 for Lake June. Additional data, when available, is also included on the Water Atlas; however, the LAKEWATCH data remains the primary source. Lake June shows a disturbing trend towards higher trophic states. The lake has long term (2004-2008) nitrogen to phosphorus ratio (N/P) of 24 which makes it a balanced system in terms of nutrient limitation. It seems to respond, that is algal growth responds, more to nitrogen concentration in the water than phosphorus. When chlorophyll (a), indicator of algal concentration, is plotted against total phosphorus concentration (TP) there is no significant correlation ($r=0.12$) while when plotted against nitrogen there is a significant relationship ($r=0.75$). The nitrogen increase explains 57% or the change in algal growth. The graph in Figures 7 and 8 shows the change in total phosphorus (TP), Secchi depth and TSI (7) and TN and Chlorophyll (a) in Figure 8. It should be noted that the August 2009 sample taken in conjunction with the lake assessment should a much different relationship of nitrogen to phosphorus. This is discussed later in the report. Lake June is a clear lake (color 37 PCU) and must maintain a TSI below 40 to not be considered impaired. Sampling data indicates enough violations of this standard to be considered impaired.

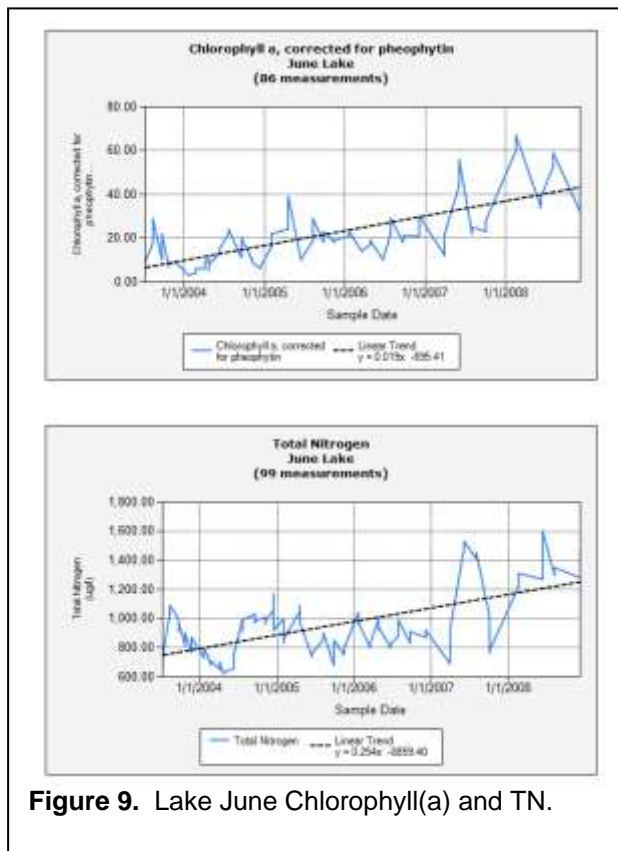
Figure 9. Lake June Chlorophyll(a) and TN.
