# LAKE ASSESSMENT REPORT FOR LAKE KELL IN HILLSBOROUGH COUNTY, FLORIDA

Date Assessed: July 2, 2009

Assessed by: David Eilers, Cheran Williams, and Brian Rosegger

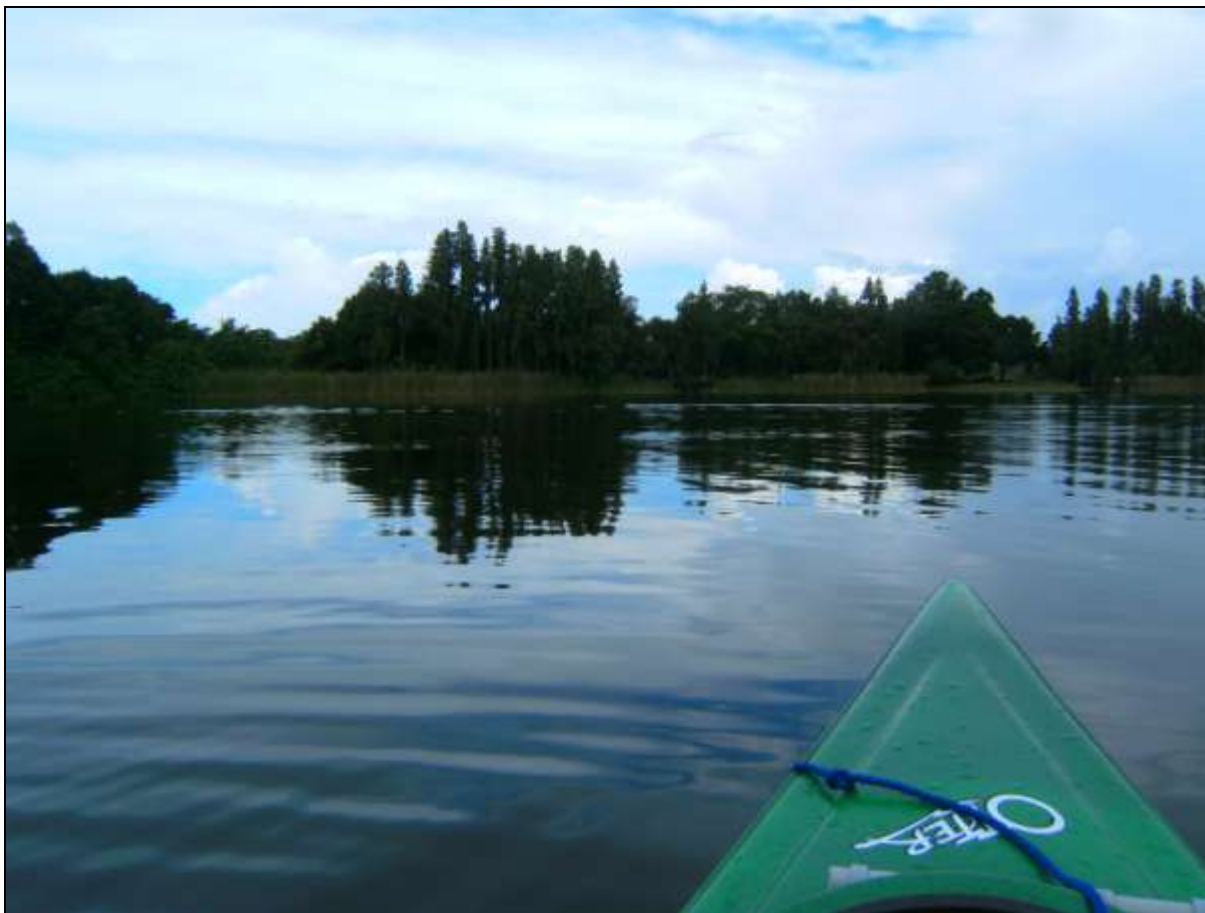
**Figure 1. Photo of Lake Kell, taken July 2, 2009.**

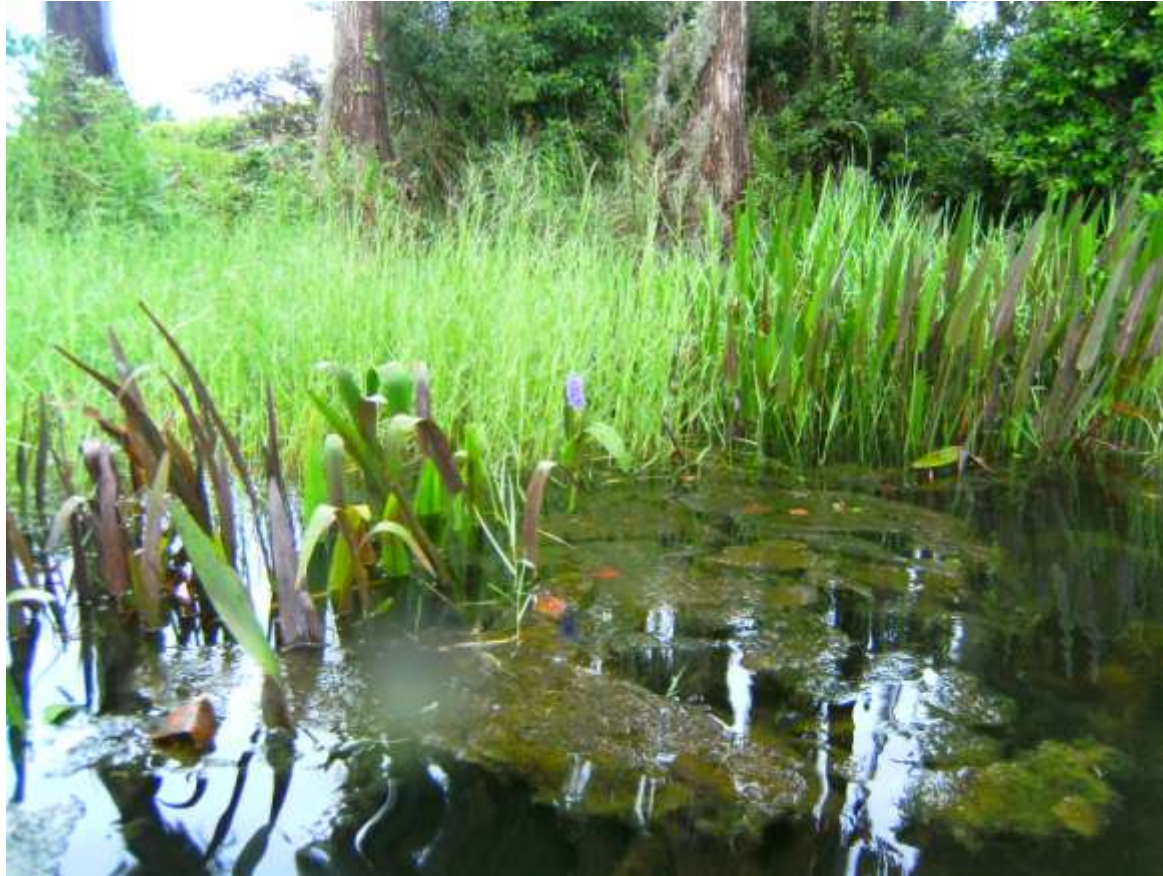
**Figure 4.** Photograph of vegetation on Lake Kell. Algal mats (*Algal spp.*) are in the foreground with the purple flowered Pickerel Weed (*Pontederia cordata*), and Torpedo Grass (*Panicum repens*) on the left.

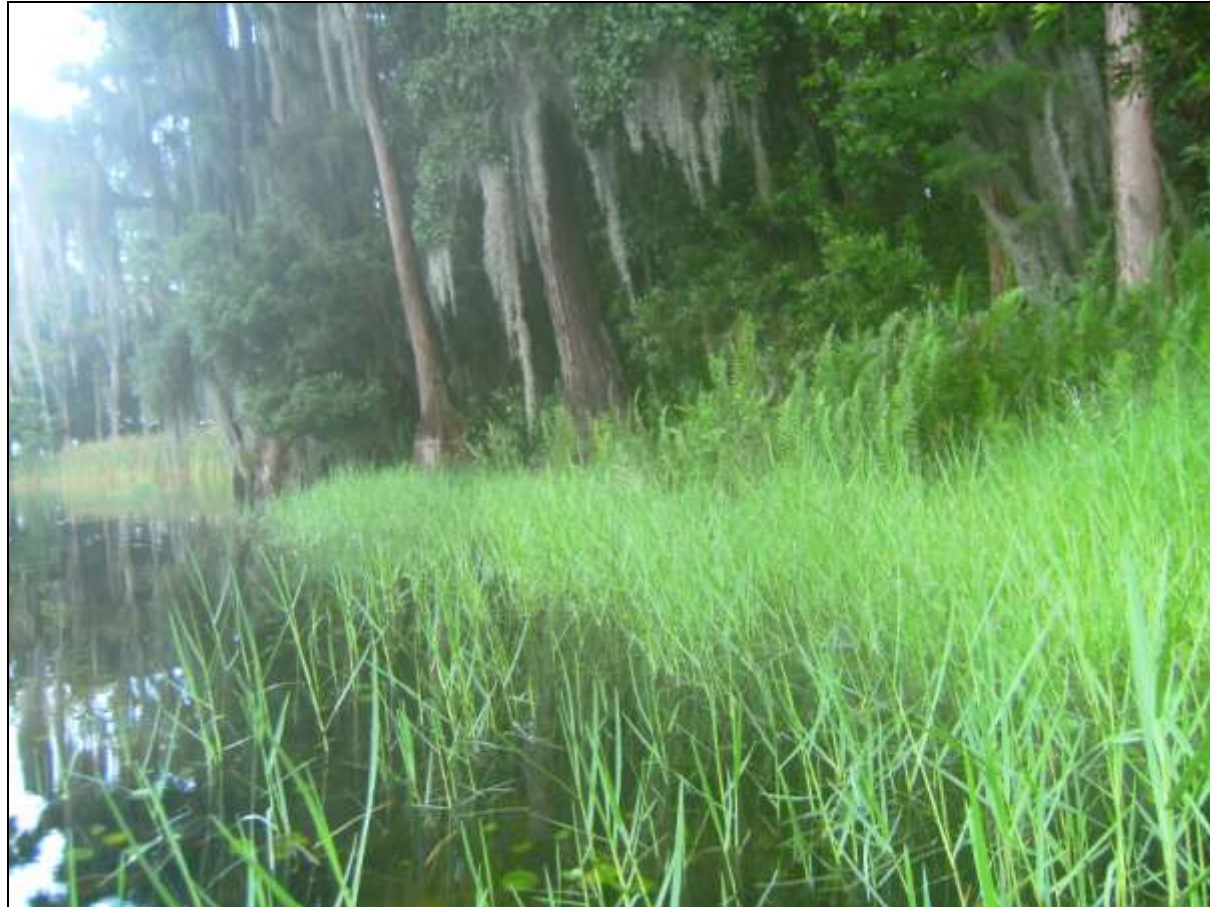
**Figure 5.** Photograph of emergent vegetation at field sample site one including: Torpedo grass (*Panicum repens*), Swamp fern (*Blechnum serrulatum*), Pennywort (*Hydrocotyl umbellata*), Dahoon Holly (*Ilex cassine*) and Bald Cypress (*Taxodium distichum*).

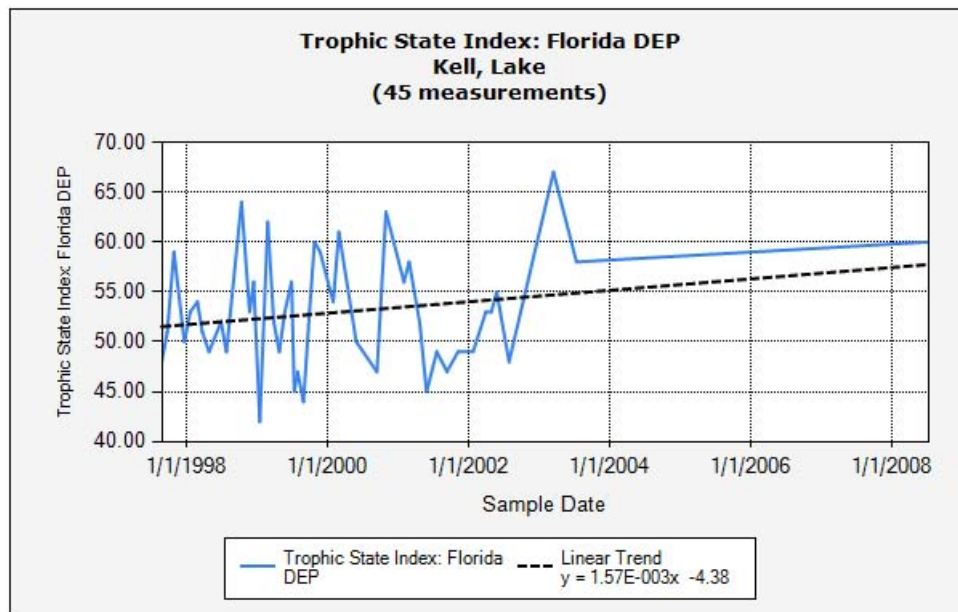
**Figure 6.** Recent Trophic State Index (TSI) graph from Hillsborough Watershed Atlas. For the latest data go to:

Note: The graph above shows the trend through 2008 when the lake was sampled by Hillsborough County. The trend is up indicating reduced water quality. The TSI is a calculated index of lake condition based on nutrient and chlorophyll (a) concentrations (please see "[Learn more about Trophic State Index](#)"). The benchmarks are established based on the TSI range that relates to a specific descriptor. The source for the TSI concentration relationships is the [Florida Water Quality Assessment, 1996, 305\(b\)](#) (Table 2-8).

The trophic state index (TSI) calculated from the sample data (53.33) is within the values shown in the figure above and may indicate a moderating trend. This value would still suggest the lake is impaired. To better understand the lake's water quality, it is imperative that a volunteer be recruited to sample the lake.
