Lake Assessment Report for Lake Harvey in Hillsborough County, Florida

Date Assessed: May 20, 2011

INTRODUCTION

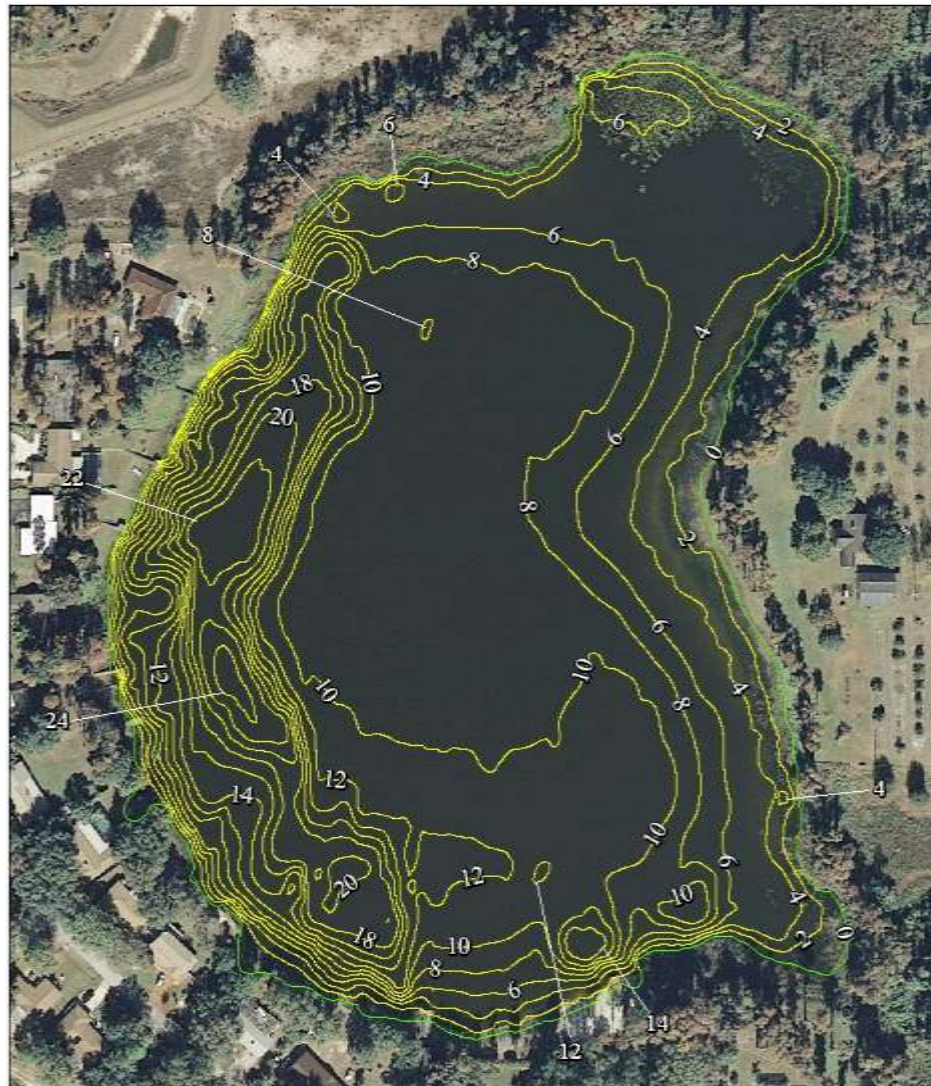
Figure 2. 2011 2-Foot Bathymetric Contour Map for Lake Harvey

Survey Date: May 20, 2011
Lake water level was 60.62 ft above sea level at
time of the assessment NGVD29.
Contours are expressed in absolute depth
below this level.

Perimeter: 4,181.22 ft,
Area: 19.89 Acres
Mean Depth: 8.12 ft,
Volume: 175.3 Acre-ft, (57,120,801.95 gallons);
Deepest point: 24.68 ft

Bathymetric Mapⁱⁱ. Table 1 provides the lake's morphologic parameters in various units. The bottom of the lake was mapped using a Lowrance LCX 28C HD Wide Area Augmentation System (WAAS)ⁱⁱⁱ enabled Global Positioning System (GPS) with fathometer (bottom sounder) to determine the boat's position, and bottom depth in a single measurement. The result is an estimate of the lake's area, mean and maximum depths, and volume and the creation of a bottom contour map (Figure 2). Besides pointing out the deeper fishing holes in the lake, the morphologic data derived from this part of the assessment can be valuable to overall management of the lake vegetation as well as providing flood storage data for flood models.

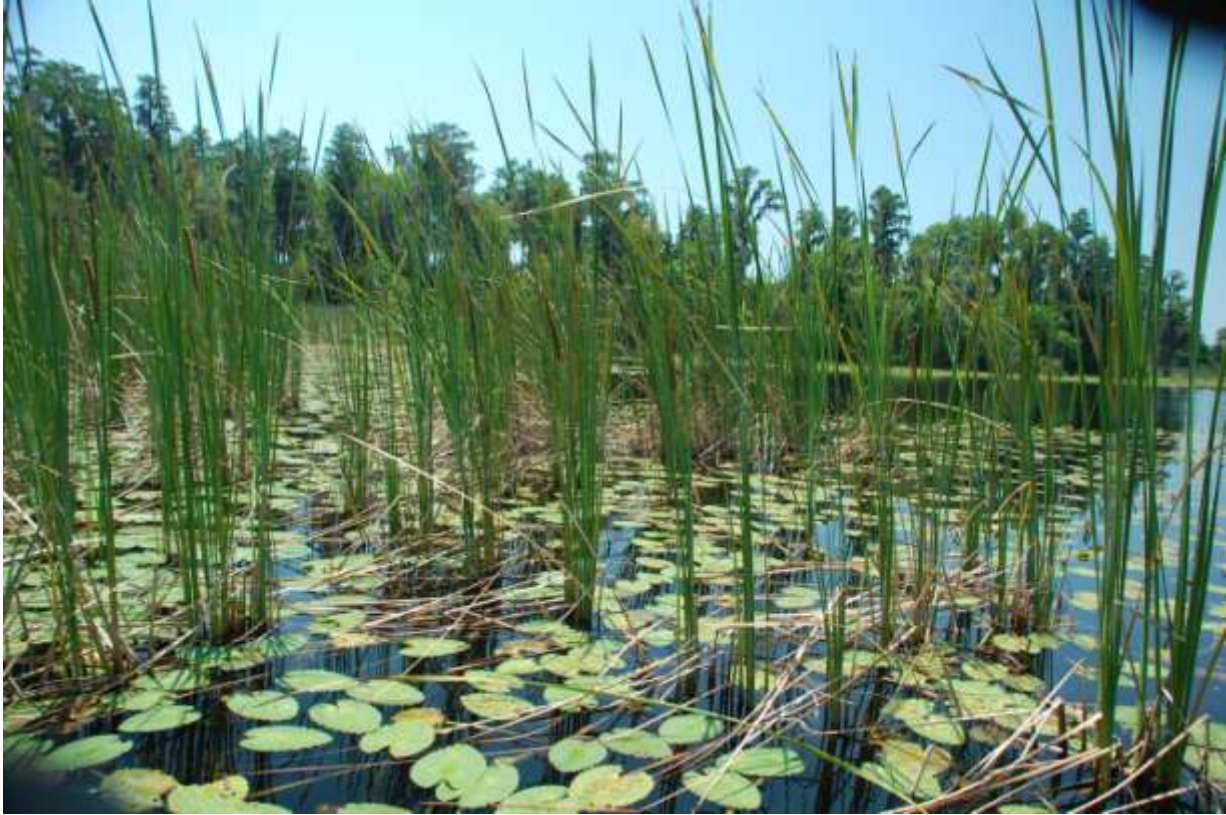
Figure 4. The floating leaved vegetation zone along Lake Harvey featuring the native species *Nuphar advena* and *typha spp.*

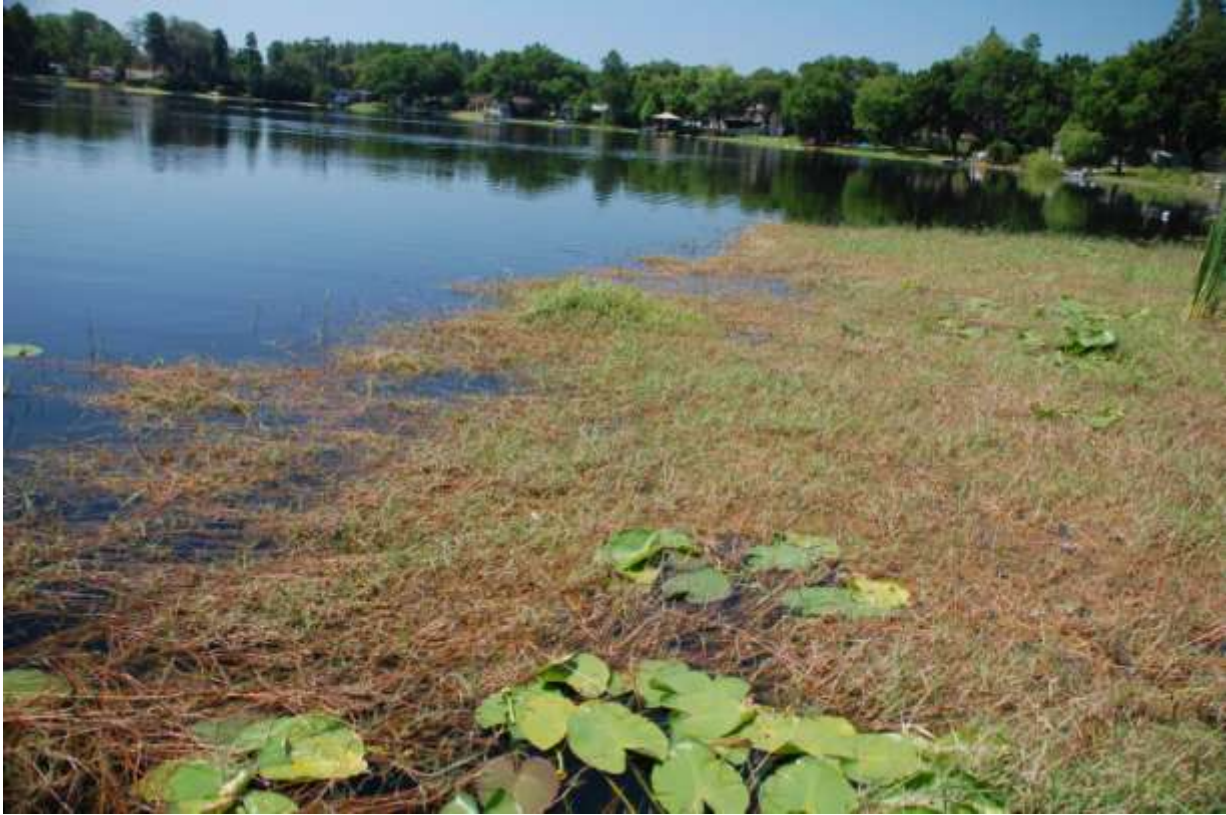
Figure 5. The emergent vegetation zone on Lake Harvey was dominated by a dense mat of *Panicum repens*, a non-native invasive species.

This LVI value could be improved by active vegetation management techniques such as invasive species removal, native plantings and allowing a shoreline fringe vegetation to become established along the waterline in the residential areas. Of primary concern in the submerged vegetation communities is the presence and abundance of *Hydrilla verticillata* near the canal connecting to Lake Virginia. If left unmanaged, this species has the ability to dominate much of the lakes littoral zone causing shifts in the species composition of the submerged vegetation communities and potentially forming a monoculture. Another concern of the vegetation community is the dominance of *Panicum repens* along much of the residential shorelines.

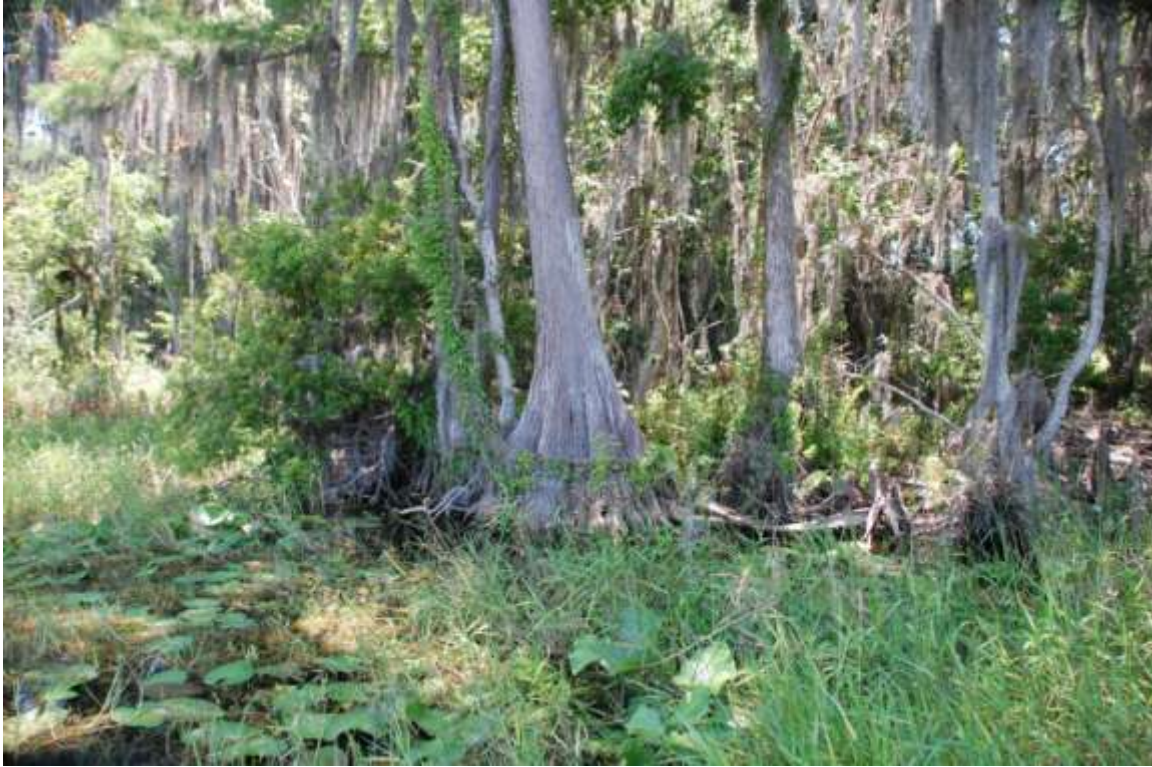
Figure 6. On sections of Lake Harvey the shoreline emergent vegetation remains largely unaltered and features native trees, such as *Taxodium distichum*.

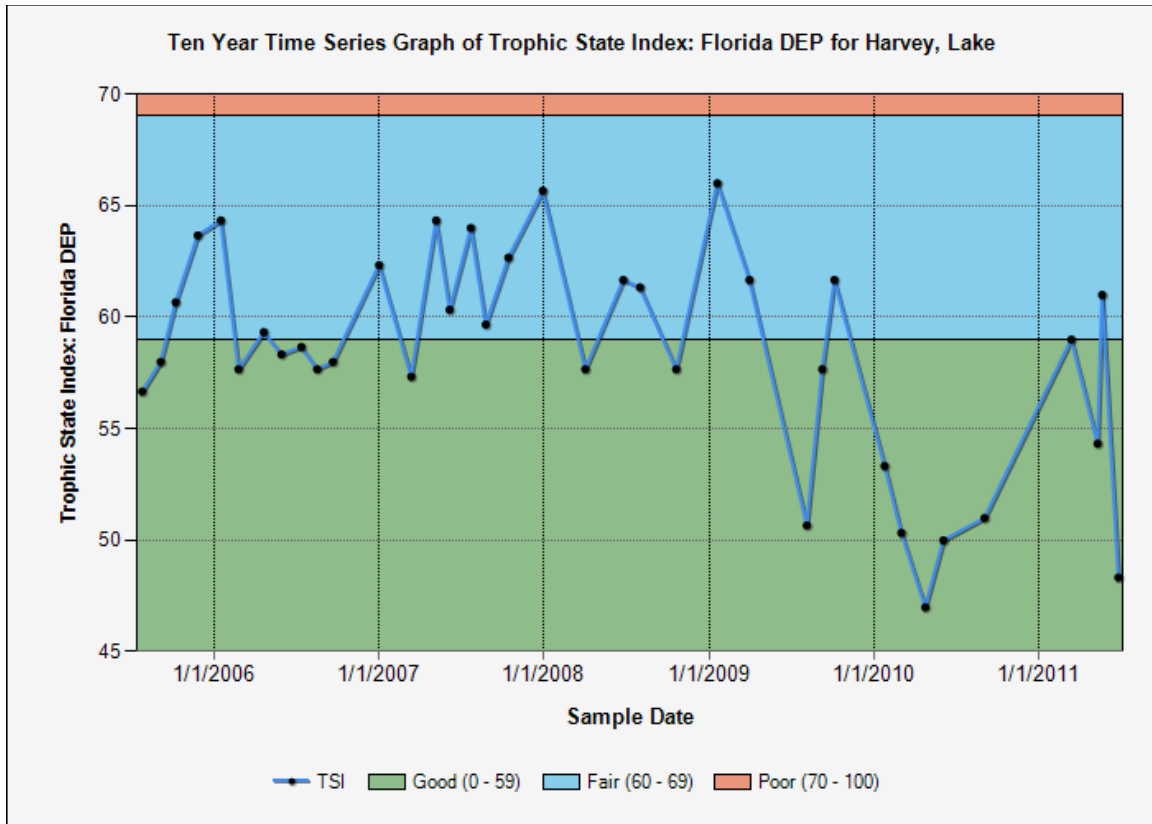
Figure 7. Recent Trophic State Index (TSI) graph for Lake Harvey^{vi}

These data are displayed and analyzed on the Water Atlas as shown in Figure 7, Figure 8, and Figure 9 for Lake Harvey. The figures are graphs of: (1) the overall trophic state index (TSI)¹, which is a method commonly used to characterize the productivity of a lake, and may be thought of as a lake's ability to support plant growth and a healthy food source for aquatic life; (2) the chlorophyll *a* concentration, which indicates the lake's algal concentration, and (3) the lake's Secchi Disk depth which is a measure of water visibility and depth of light penetration. These data are used to evaluate a lake's ecological health and to provide a method of ranking lakes and are indicators used by the US Environmental Protection Agency (USEPA) and the Florida Department of Environmental Protection (FDEP) to determine a lake's level of impairment. The chlorophyll *a* and Secchi Disk depth graphs include benchmarks which indicate the median values for the various parameters for a large number of Lakes in Florida expressed as percentiles.

The submerged vegetation communities of Lake Harvey assist in the reduction of phosphorous, nitrogen and chlorophyll-a in the water column. The TSI for Lake Harvey fluctuates near the 60 value of impairment for dark water lakes, which Lake Harvey is by the mean color value. Without this submerged vegetation, phosphorous and nitrogen values in the water column could raise enough to push the TSI threshold above the 60 TSI mark and classify it as impaired.
