Lake Assessment Report for Lake Taylor in Hillsborough County, Florida

Date Assessed: June 24, 2011

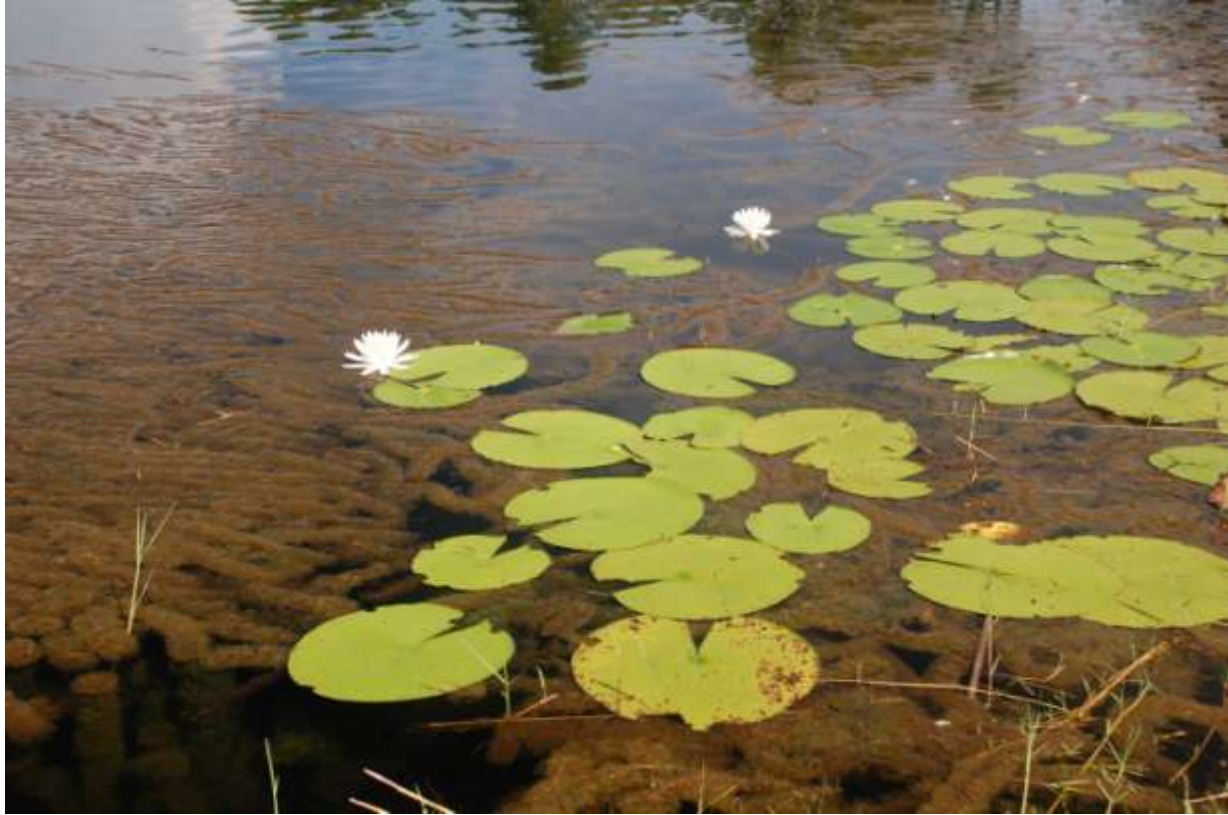
Figure 4. Lake Taylor's floating leaved vegetation was dominated by the native species, *Nymphaea odorata*.

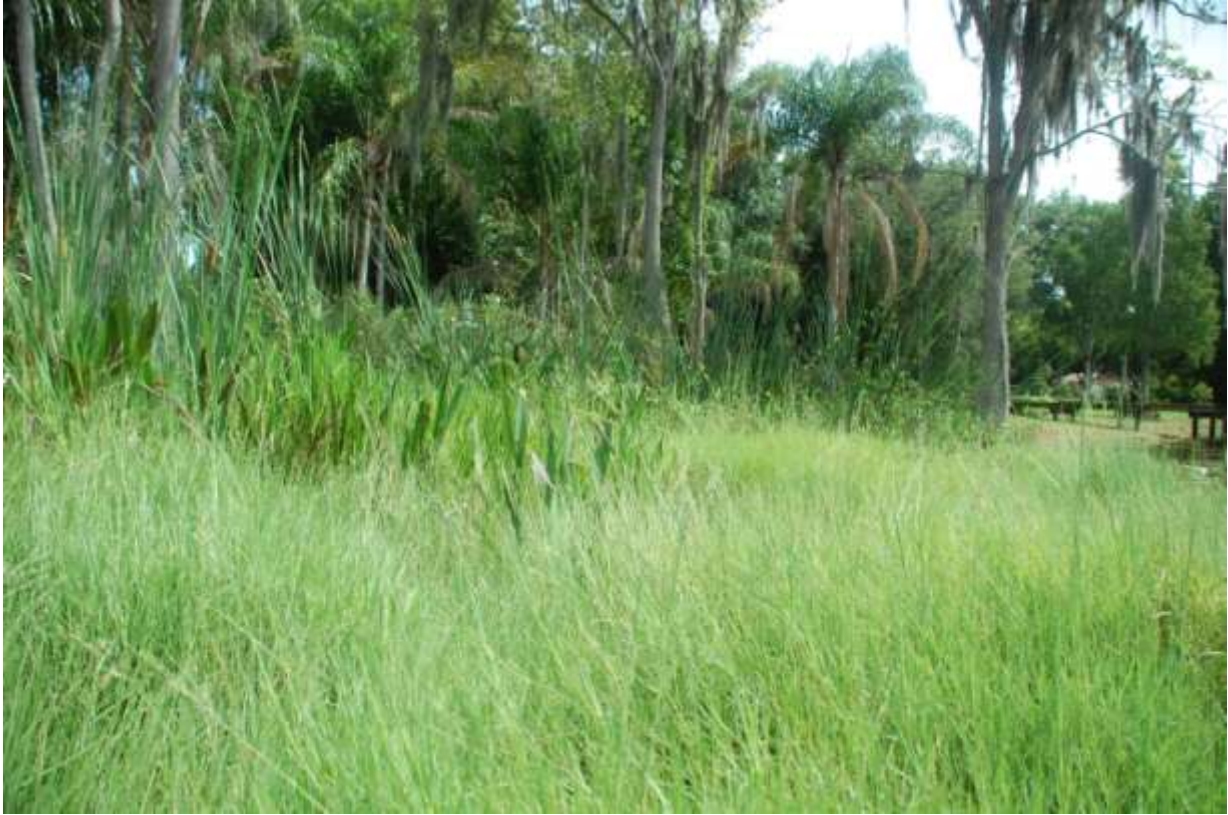
Figure 5. The emergent vegetation zone on Lake Taylor, pictured here is the dominance of a non-native invasive species *Panicum repens*.

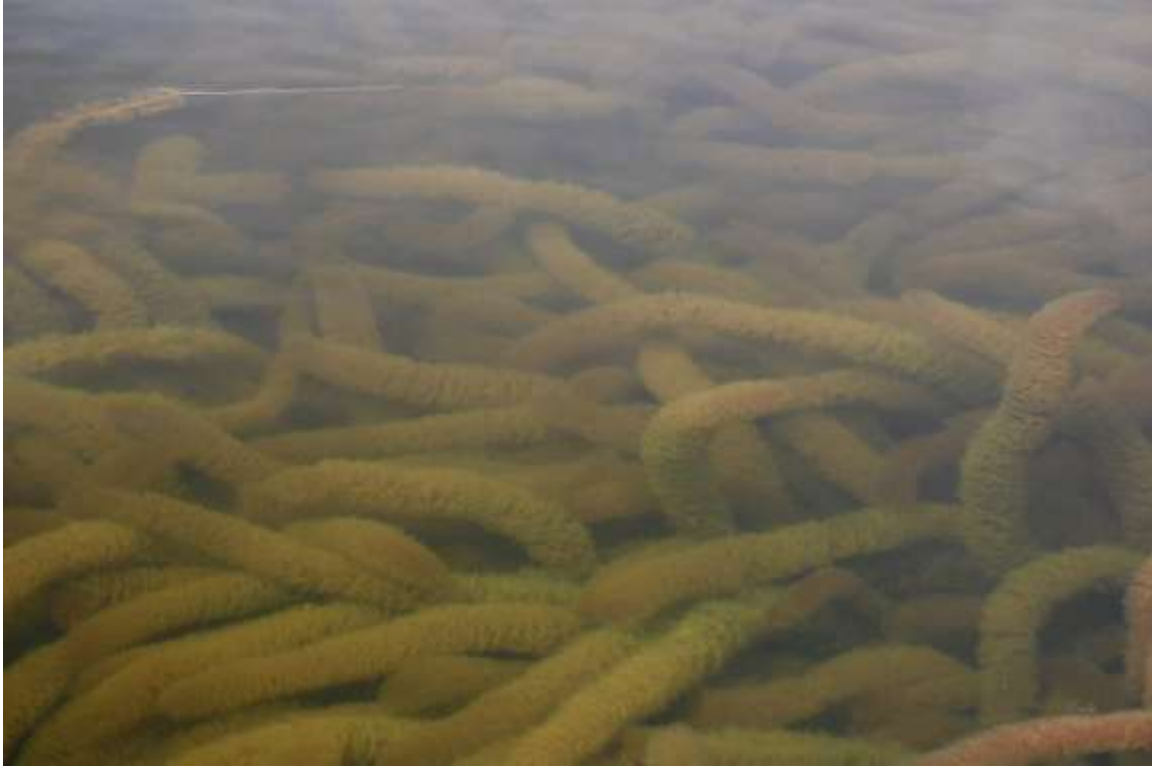
Figure 6. The submerged vegetation of Lake Taylor was dominated by the native species *Myriophyllum heterophyllum*. Although native, this species was present in pest proportions covering most of the lake to 15' of depth.

The submerged vegetation community dominated by *Myriophyllum heterophyllum* has reached a density where recreational activities in much of the lake have been hindered. Active vegetation management practices should be implemented in Lake Taylor to control this population. However, care should be taken to ensure that the entire biomass is not killed and allowed to decay due to the large amount of nutrients that would be released. Techniques such as manual removal would be best suited to ensure that the community remains functioning and to prevent a non-native invasive species such as *Hydrilla verticillata* from dominating.

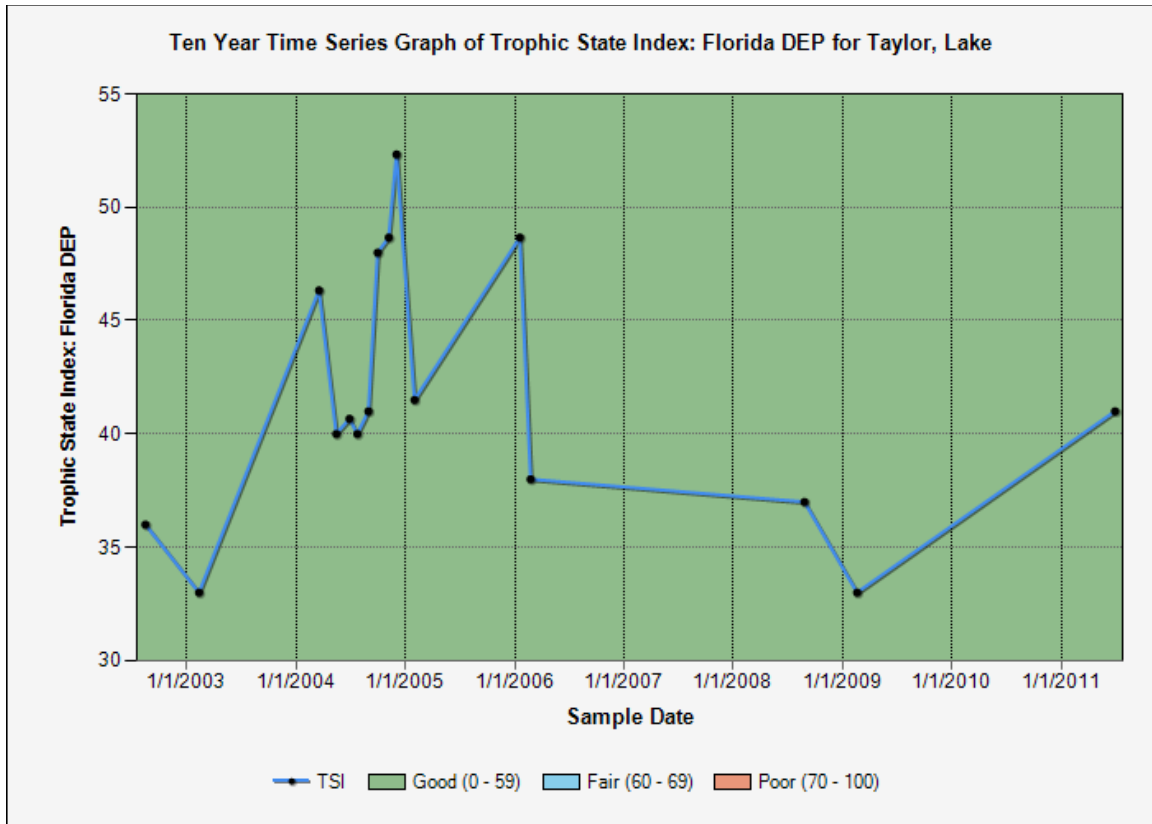
These data are displayed and analyzed on the Water Atlas as shown in Figure 7, Figure 8, and Figure 9 for Lake Taylor. The figures are graphs of: (1) the overall trophic state index (TSI)¹, which is a method commonly used to characterize the productivity of a lake, and may be thought of as a lake's ability to support plant growth and a healthy food source for aquatic life; (2) the chlorophyll *a* concentration, which indicates the lake's algal concentration, and (3) the lake's Secchi Disk depth which is a measure of water visibility and depth of light penetration. These data are used to evaluate a lake's ecological health and to provide a method of ranking lakes and are indicators used by the US Environmental Protection Agency (USEPA) and the Florida Department of Environmental Protection (FDEP) to determine a lake's level of impairment. The chlorophyll *a* and Secchi Disk depth graphs include benchmarks which indicate the median values for the various parameters for a large number of Lakes in Florida expressed as percentiles.

Figure 7. Recent Trophic State Index (TSI) graph for Lake Taylor^{vi}

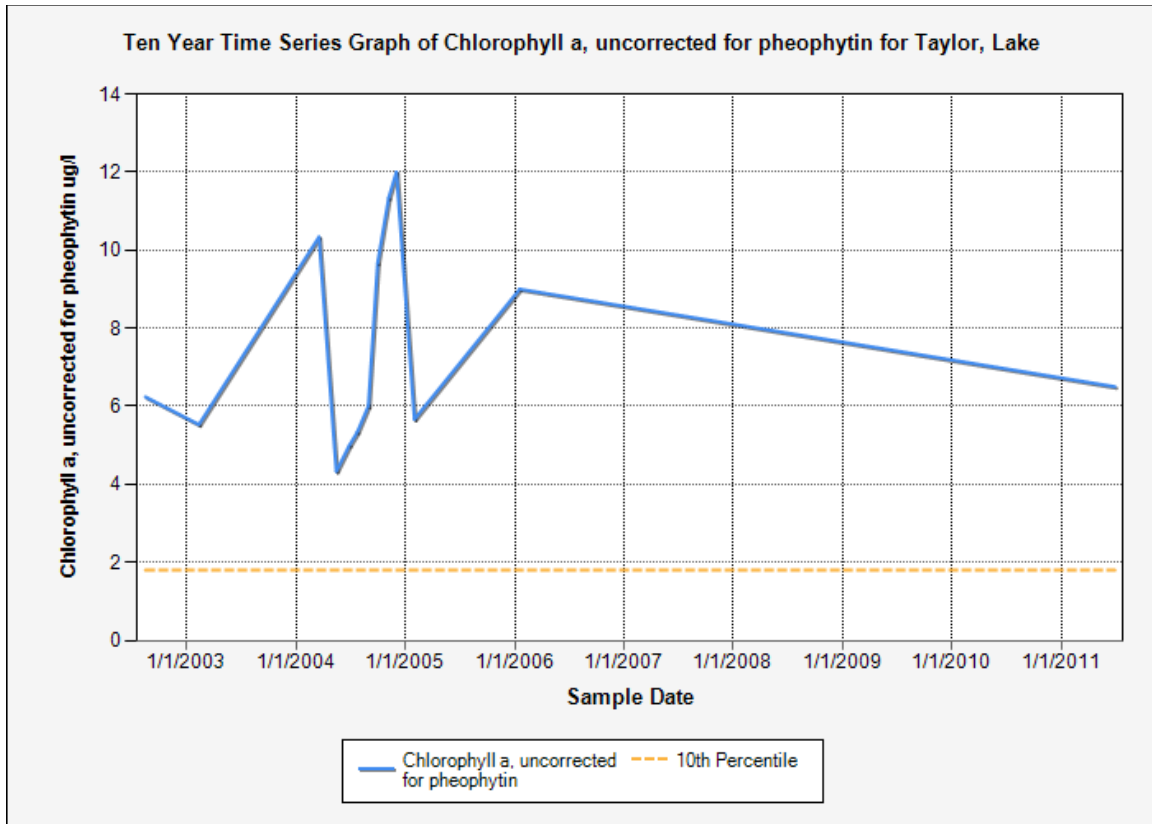
Figure 8. Recent Chlorophyll a graph for Lake Taylor^{vii}

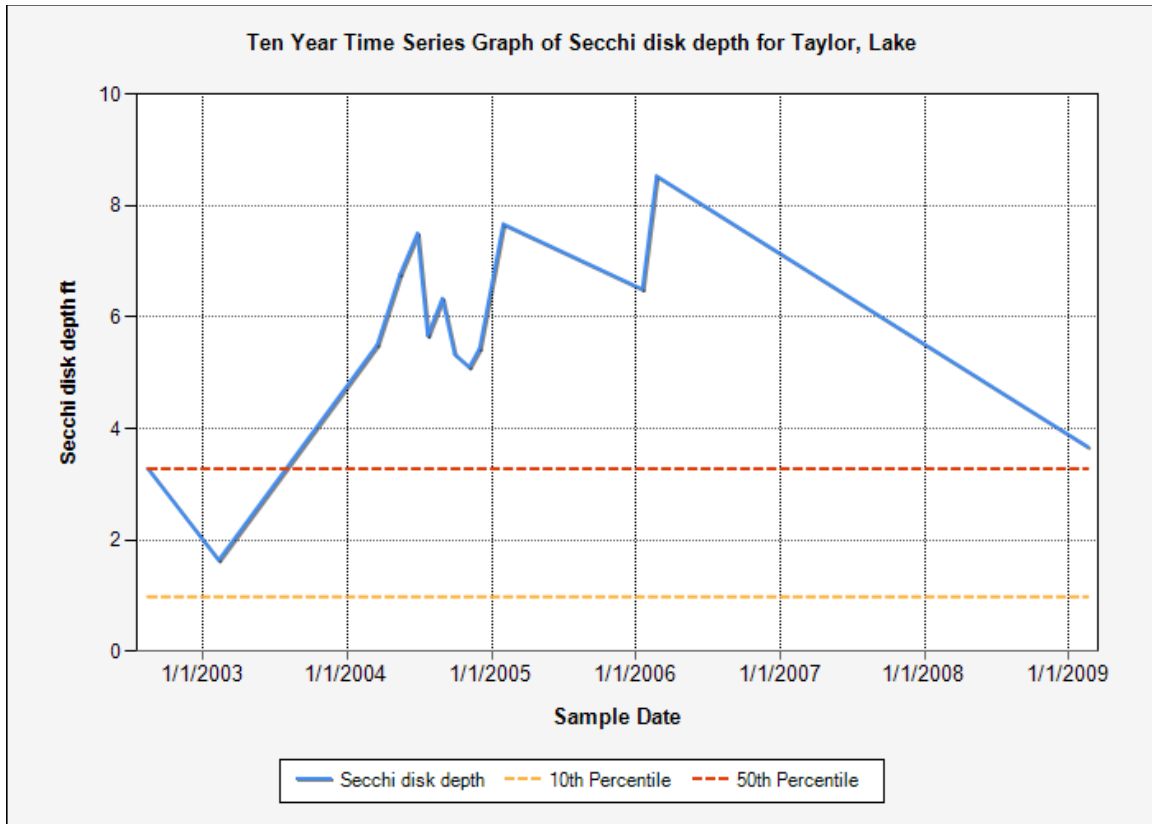
Figure 9. Recent Secchi Disk graph for Lake Taylor^{viii}
