# LAKE ASSESSMENT REPORT FOR WALDEN LAKE IN HILLSBOROUGH COUNTY, FLORIDA

Date Assessed: June 25, 2009

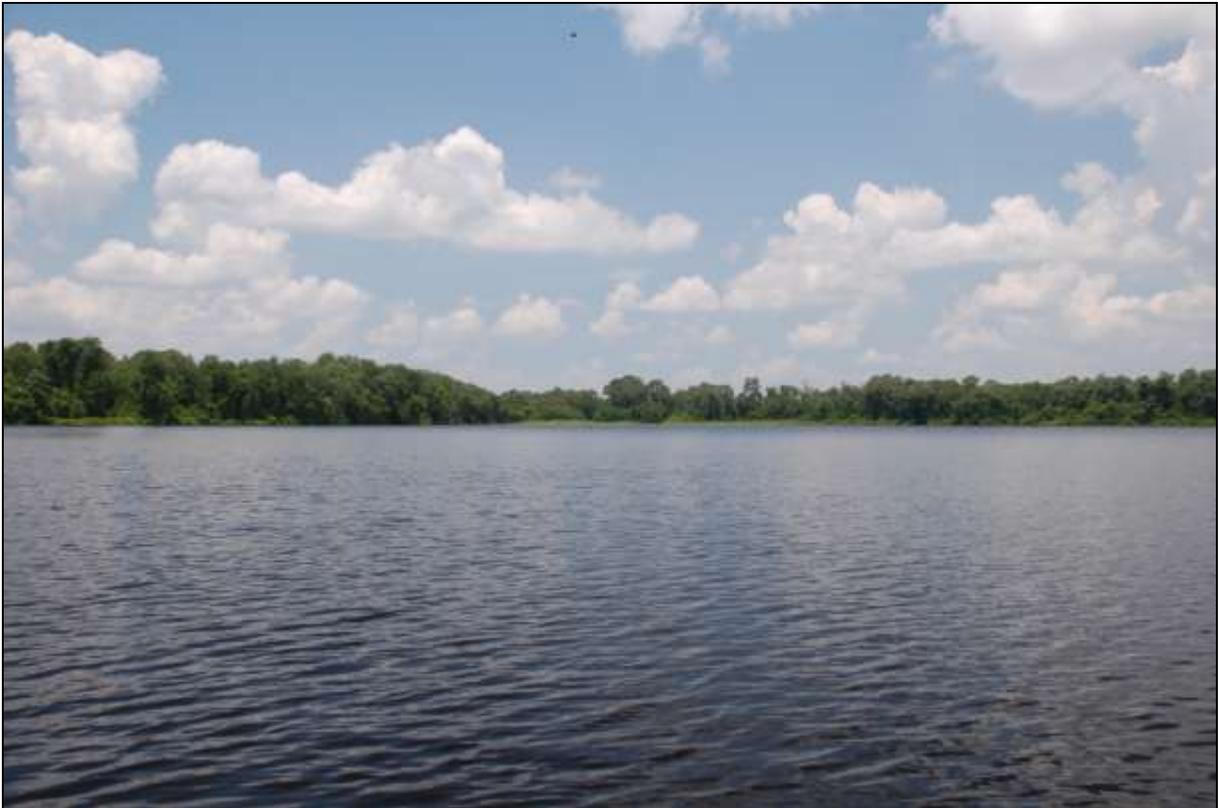
**Figure 1. Photo of Walden Lake, taken June 24, 2009.**

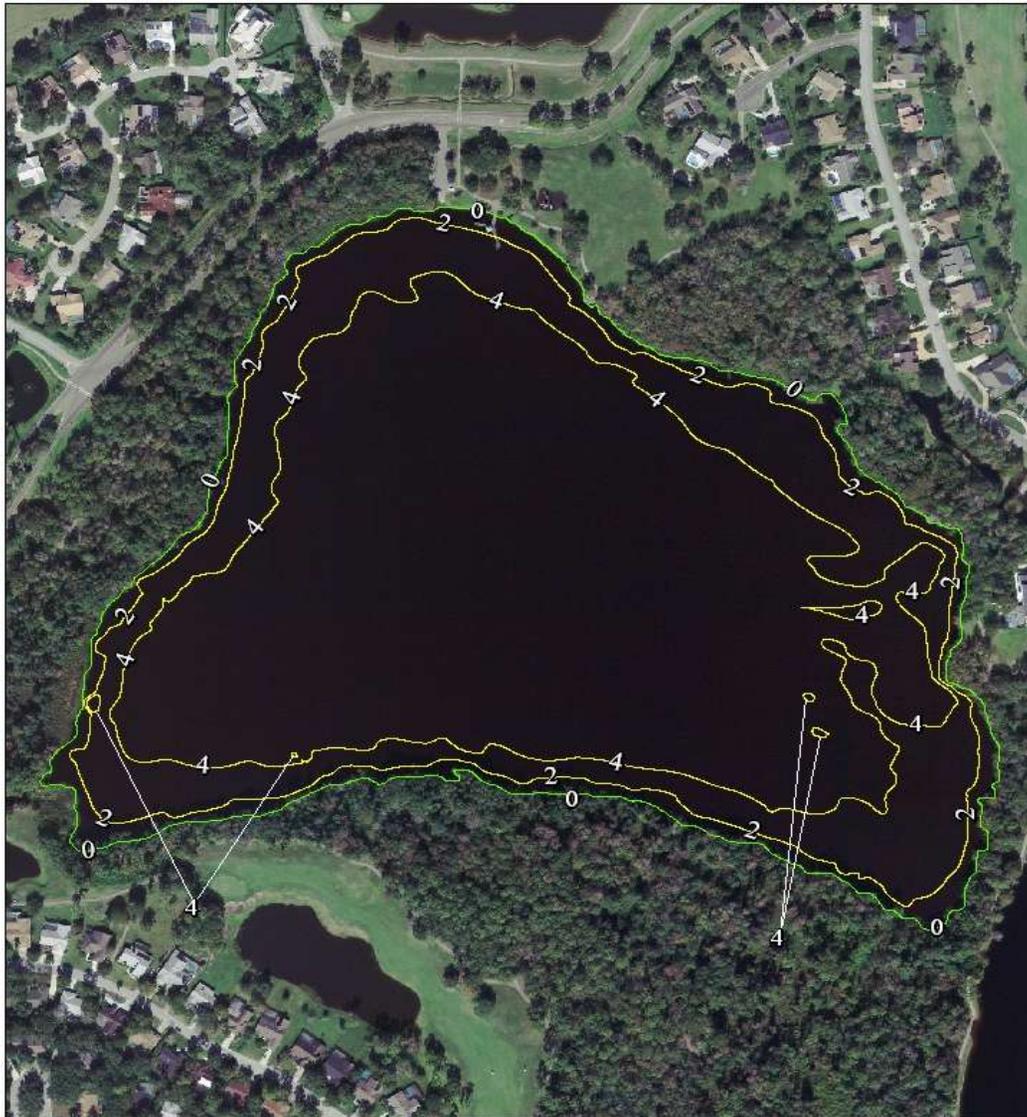
# Walden Lake

Contour Lines  
Expressed in  
2-Foot Intervals

Survey Date: June 24, 2009  
Lake water level was 12.74 ft  
above sea level at time of assessment.  
Contours are expressed in absolute depth  
below this level.

Perimeter 8,141.54 ft;  
Area 63.36 Acres  
Mean Depth 3.68 ft;  
Volume 245.41 Acre-ft, (79,967,260.23 gallons);  
Deepest point 5.96 ft

**Figure 1.** Contour map for Walden Lake. The mapping technique used in 2009 employs a standard DGPS for horizontal position and a fathometer for depth.

**Bathymetric Map<sup>ii</sup>.** Table 1 provides the lake’s morphologic parameters in various units. The bottom of the lake was mapped using a Lowrance LCX 28C HD Wide Area Augmentation System (WAAS)<sup>iii</sup> enabled Global Positioning System (GPS) with fathometer (bottom sounder) to determine the boat’s position, and bottom depth in a single measurement. The result is an estimate of the lake’s area, mean and maximum depths, and volume and the creation of a bottom contour map (Figure 2). Besides pointing out the deeper fishing holes in the lake, the morphologic data derived from this part of the assessment can be valuable to overall management of the lake vegetation as well as providing flood storage data for flood models.

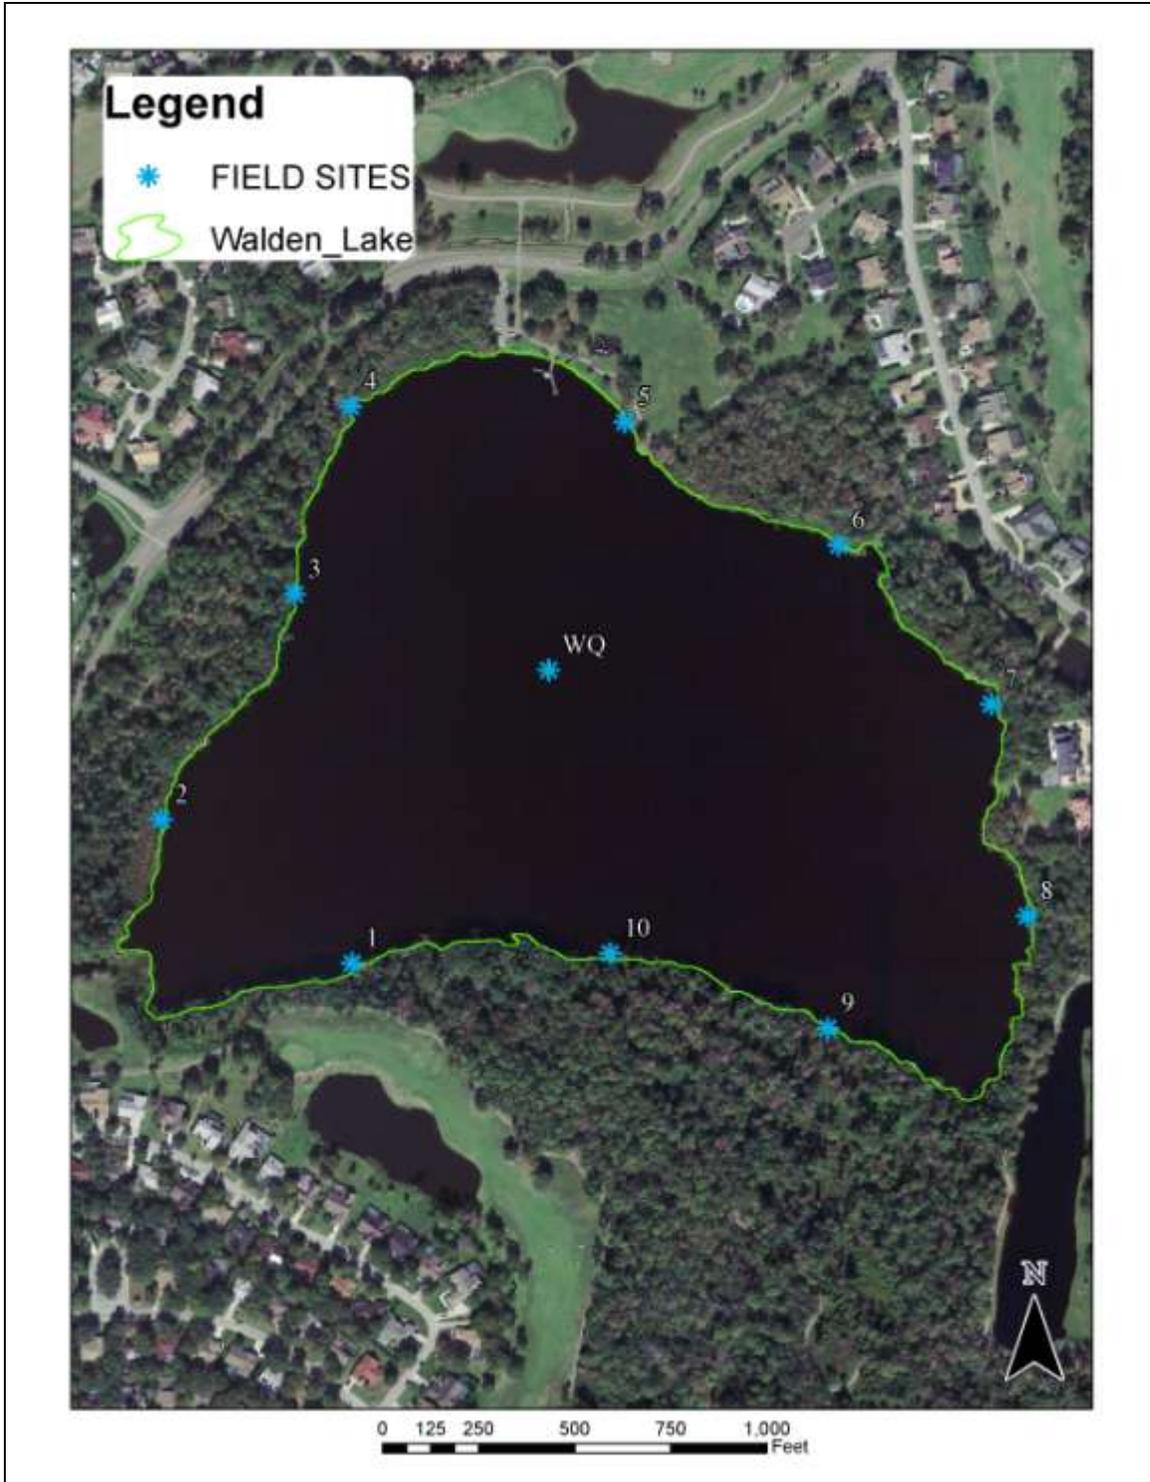
**Figure 3.** 2007 six-inch resolution aerial photograph showing location of vegetation assessment sites on Walden Lake. Major emergent and floating vegetation zones as well as structures are also observable in this aerial.

The lake's apparent vegetative cover and shoreline detail are evaluated using the latest lake aerial photograph as shown in Figure 3 and by use of WAAS enabled GPS. Submerged vegetation is determined from the analysis of bottom returns from the Lowrance 28c HD combined GPS/fathometer described earlier. As depicted in Figure 3, ten vegetation assessment sites were chosen for intensive sampling based on the *Lake Assessment Protocol* (copy available on request) for a lake of this size. The site positions are set using GPS and then loaded into a GIS mapping program (ArcGIS) for display. Each site is sampled in the three primary vegetative zones (emergent, submerged and floating).<sup>iv</sup> The latest high resolution aerial photos are used to provide shore details (docks, structures, vegetation zones) and to calculate the extent of surface vegetation coverage. The primary indices of submerged vegetation cover and biomass for the lake, percent area coverage (PAC) and percent volume infestation (PVI), are determined by transiting the lake by boat and employing a fathometer to collect "hard and soft return" data. These data are later analyzed for presence and absence of vegetation and to determine the height of vegetation if present. The PAC is determined from the presence and absence analysis of 100 sites in the lake and the PVI is determined by measuring the difference between hard returns (lake bottom) and soft returns (top of vegetation) for sites (within the 100 analyzed sites) where plants are determined present (Figure 6).

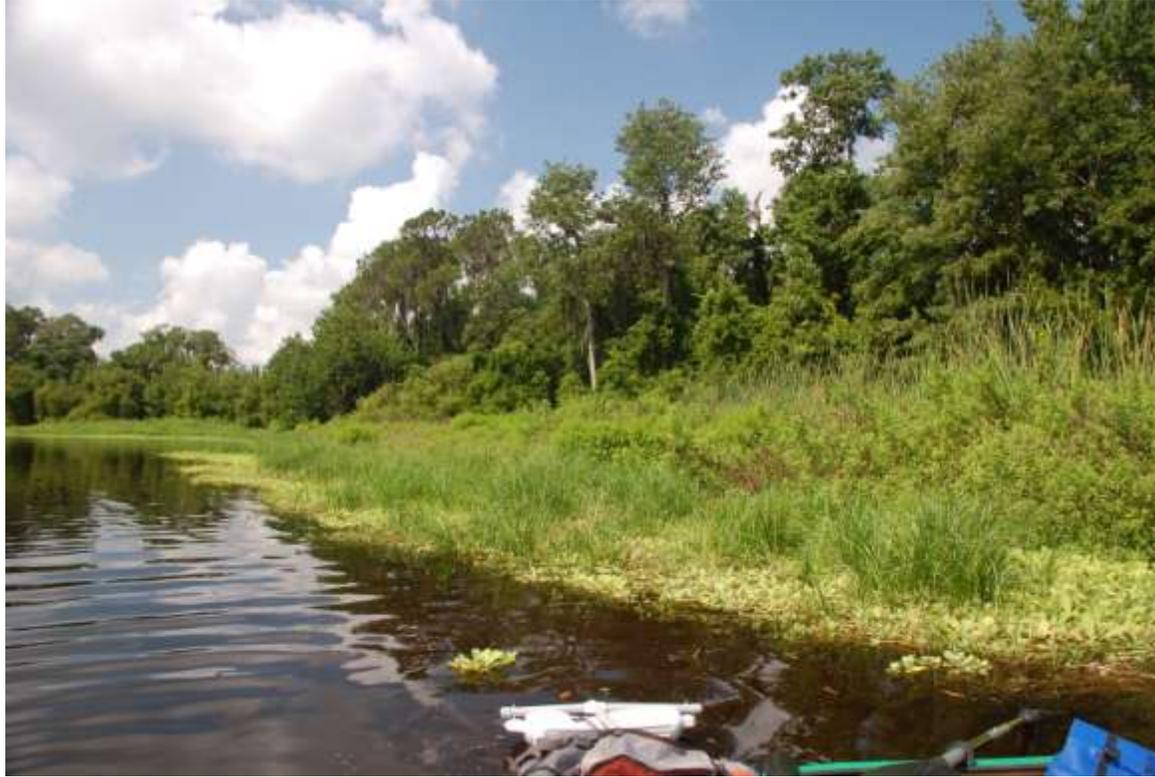
**Figure 4.** Photograph of vegetation on Walden Lake. Water lettuce (*Pistia stratioides*) is the floating plant. The grass is a sedge species (*Cyperus spp.*). Behind the sedges but before the Cattails (*Typha spp.*) is the highly invasive Peruvian Primrosewillow (*Ludwigia peruviana*).

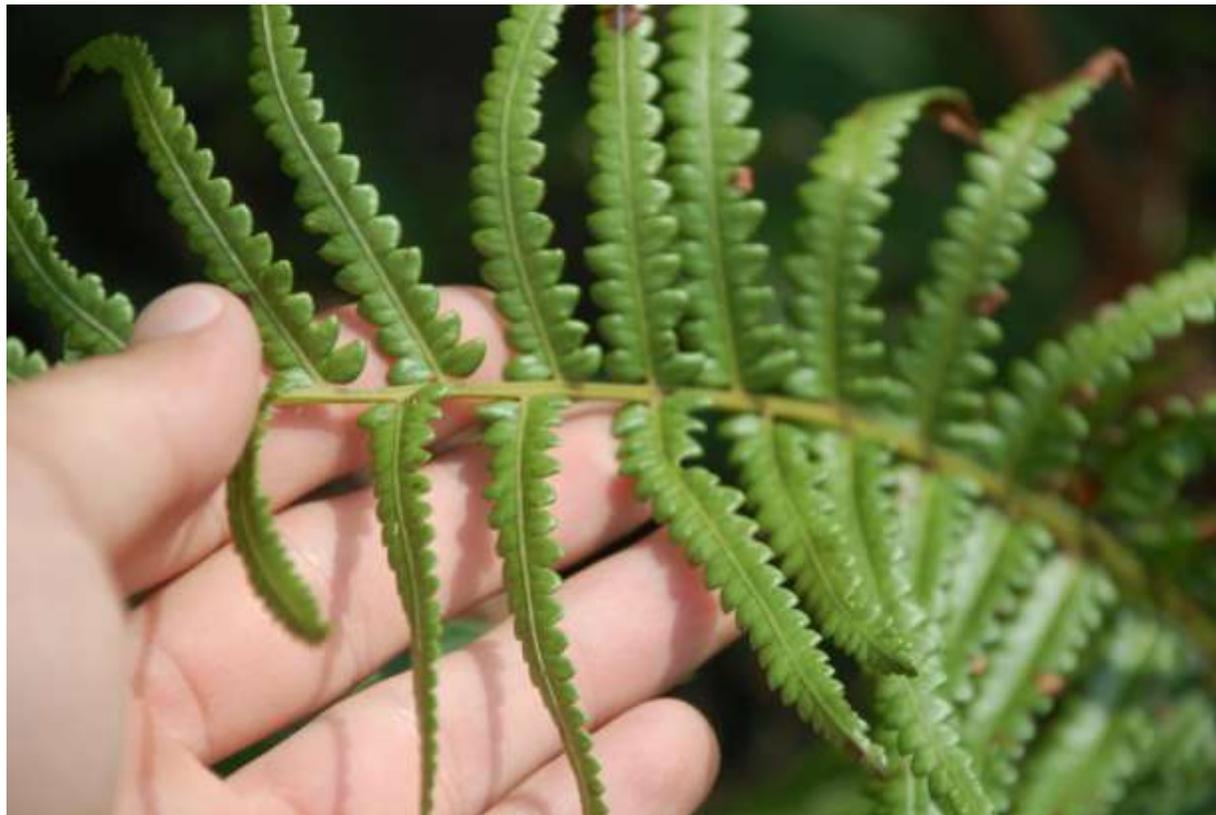
**Figure 5.** Photograph of Cinnamon Fern (*Osmunda cinnamomea*), which occurred at 40% of the sampled sites.

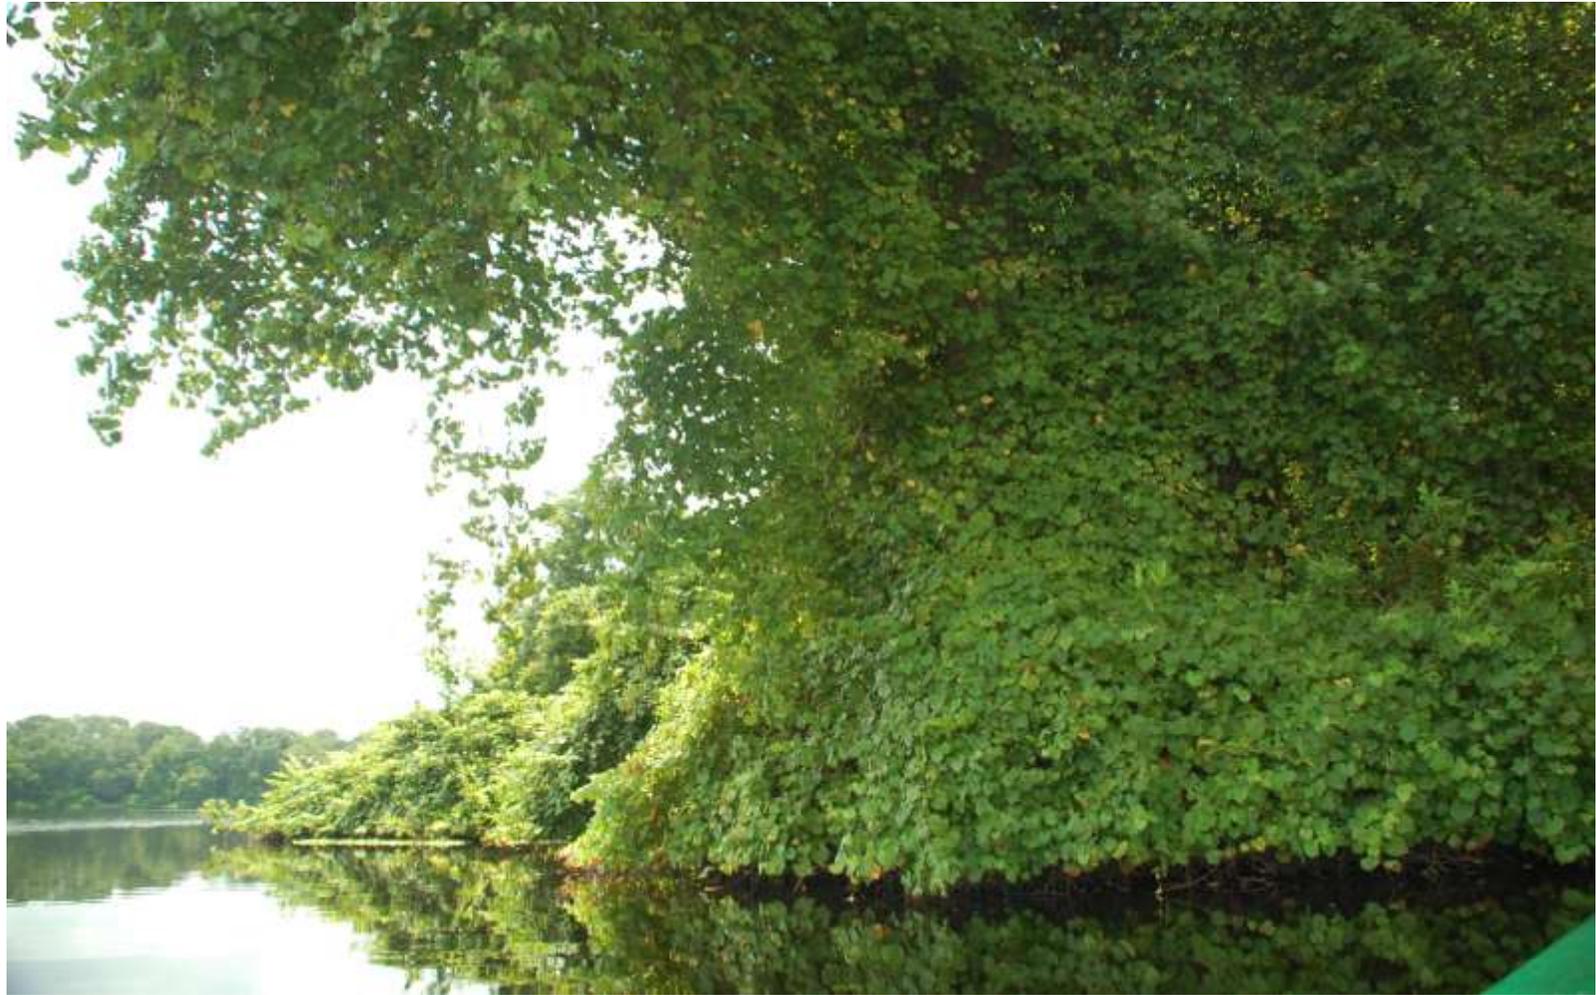
**Figure 6.** This photograph shows emergent vegetation from sample site number 10. Notice that growth of Sweetbay magnolias (*Magnolia virginiana*) and Swamp ferns (*Blechnum serrulatum*) are severely limited by overgrowth of the Muscadine Grape Vine (*Vitis rotundifolia*).

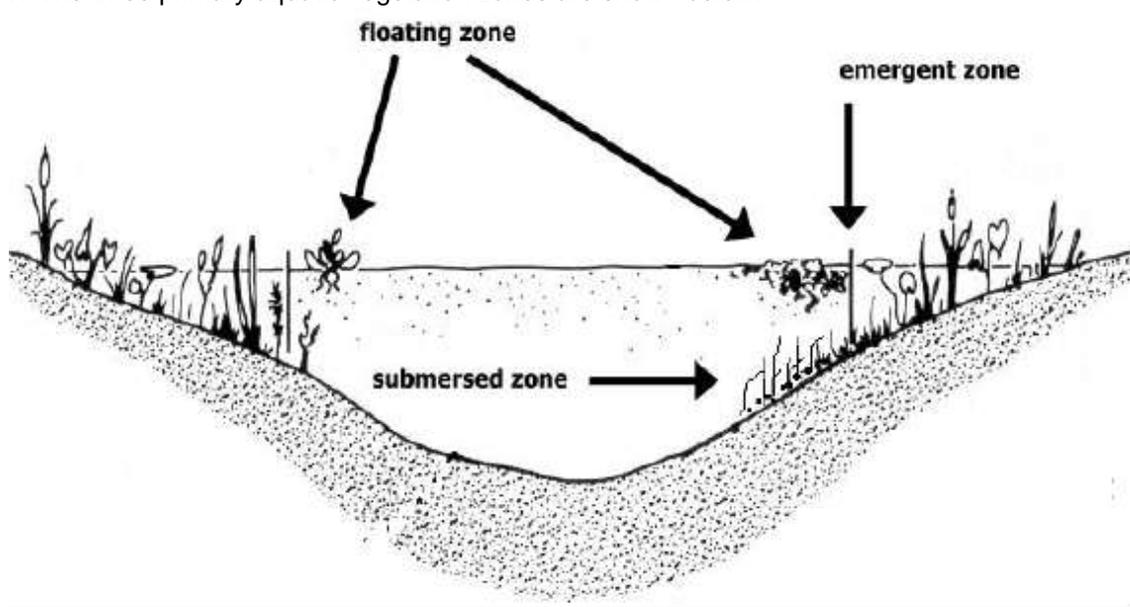
iv The three primary aquatic vegetation zones are shown below:
