Impact of Hurricanes on Pinellas County, Florida 1985

Richard A. Davis, Jr. and Margaret Andronaco

TECHNICAL PAPER NO. 51
May 1987
Price $3.00

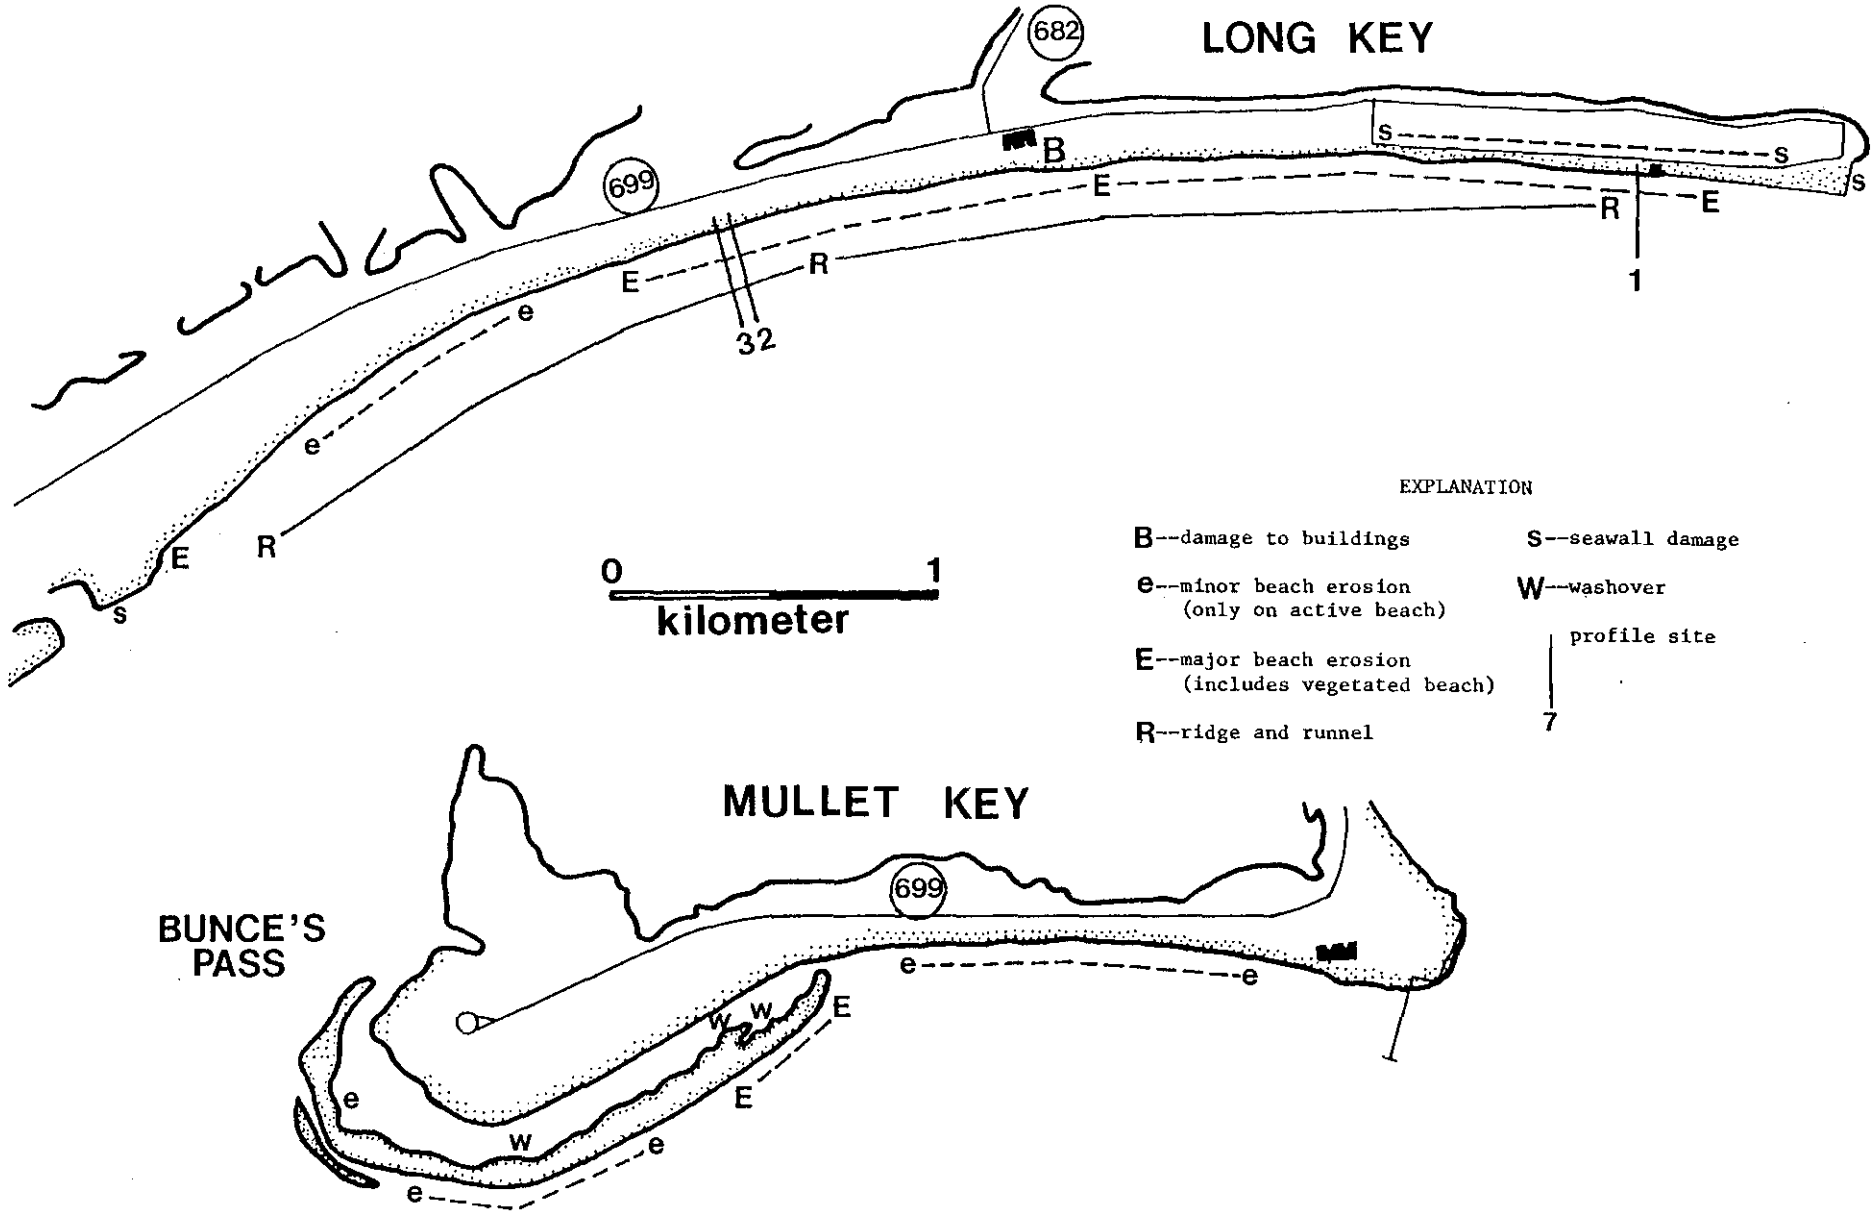
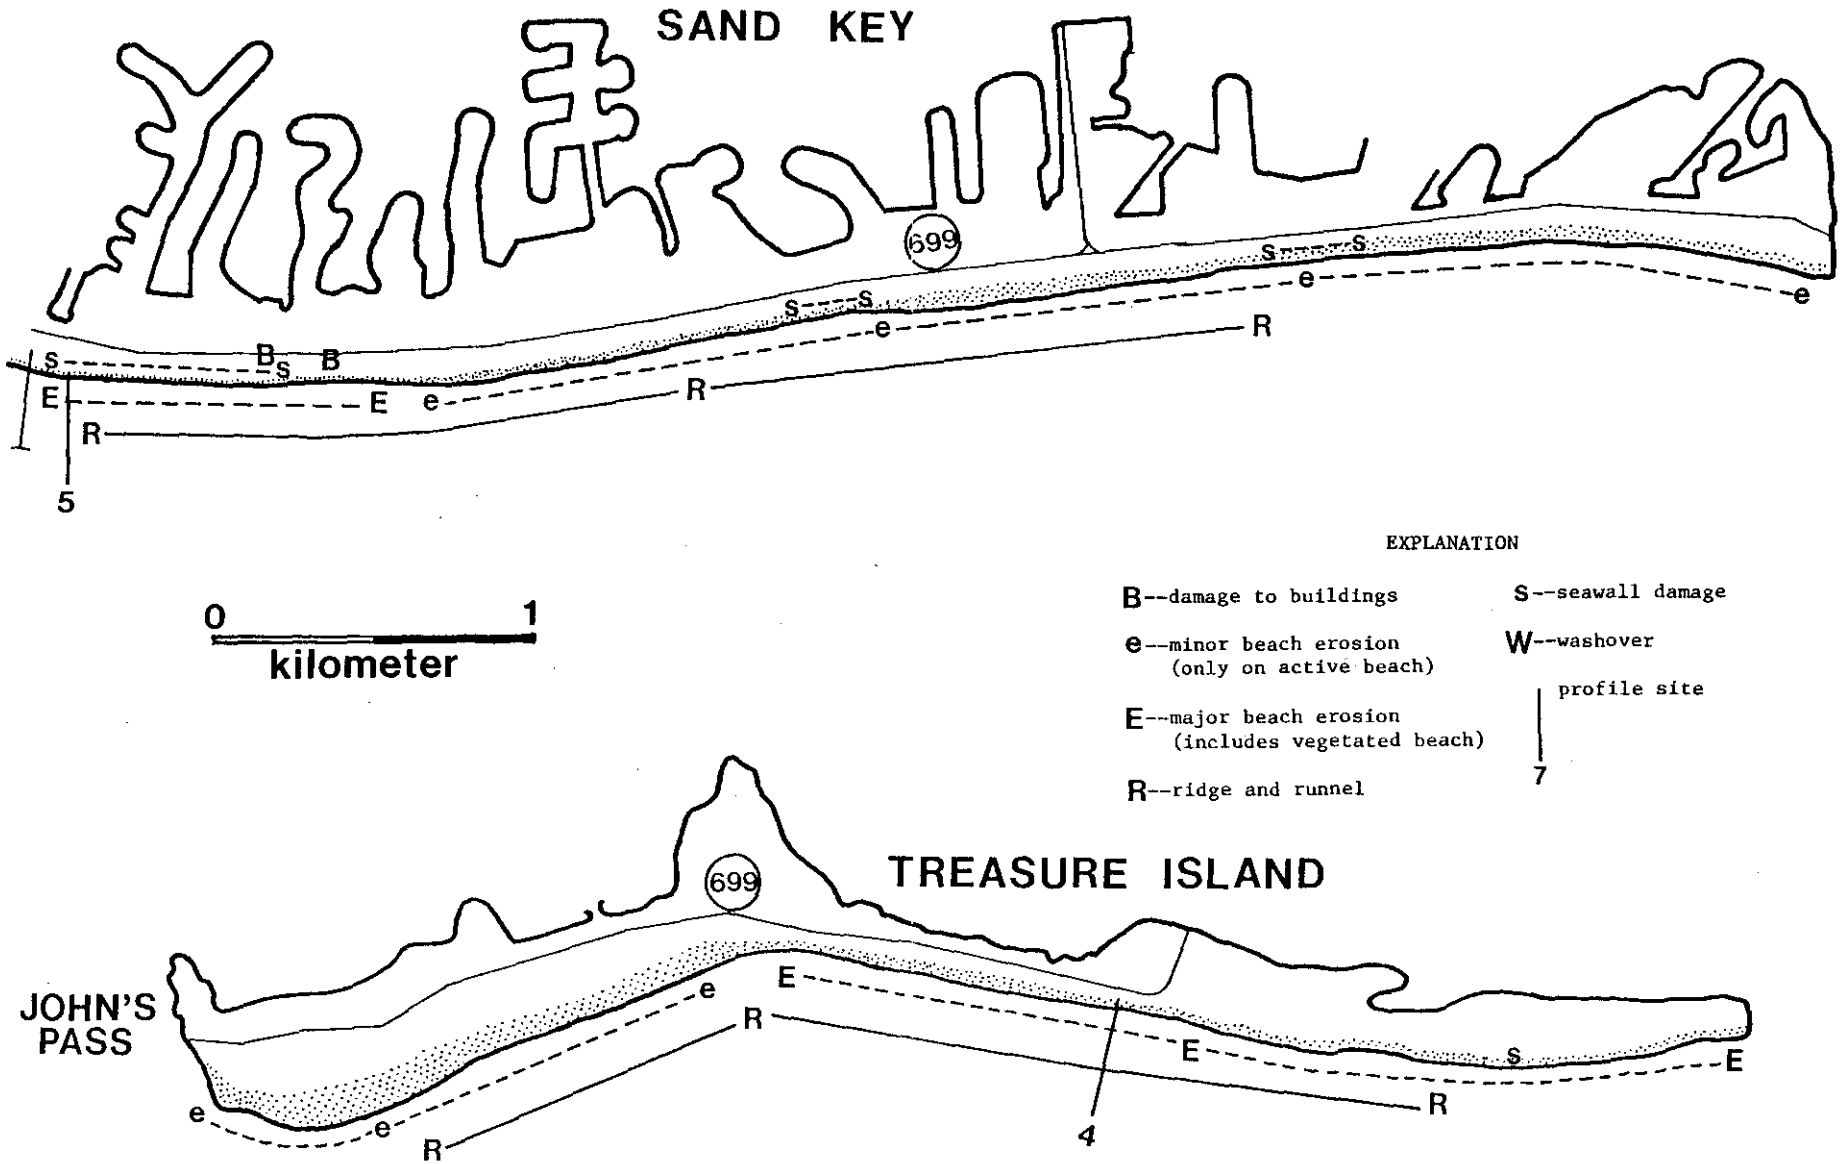
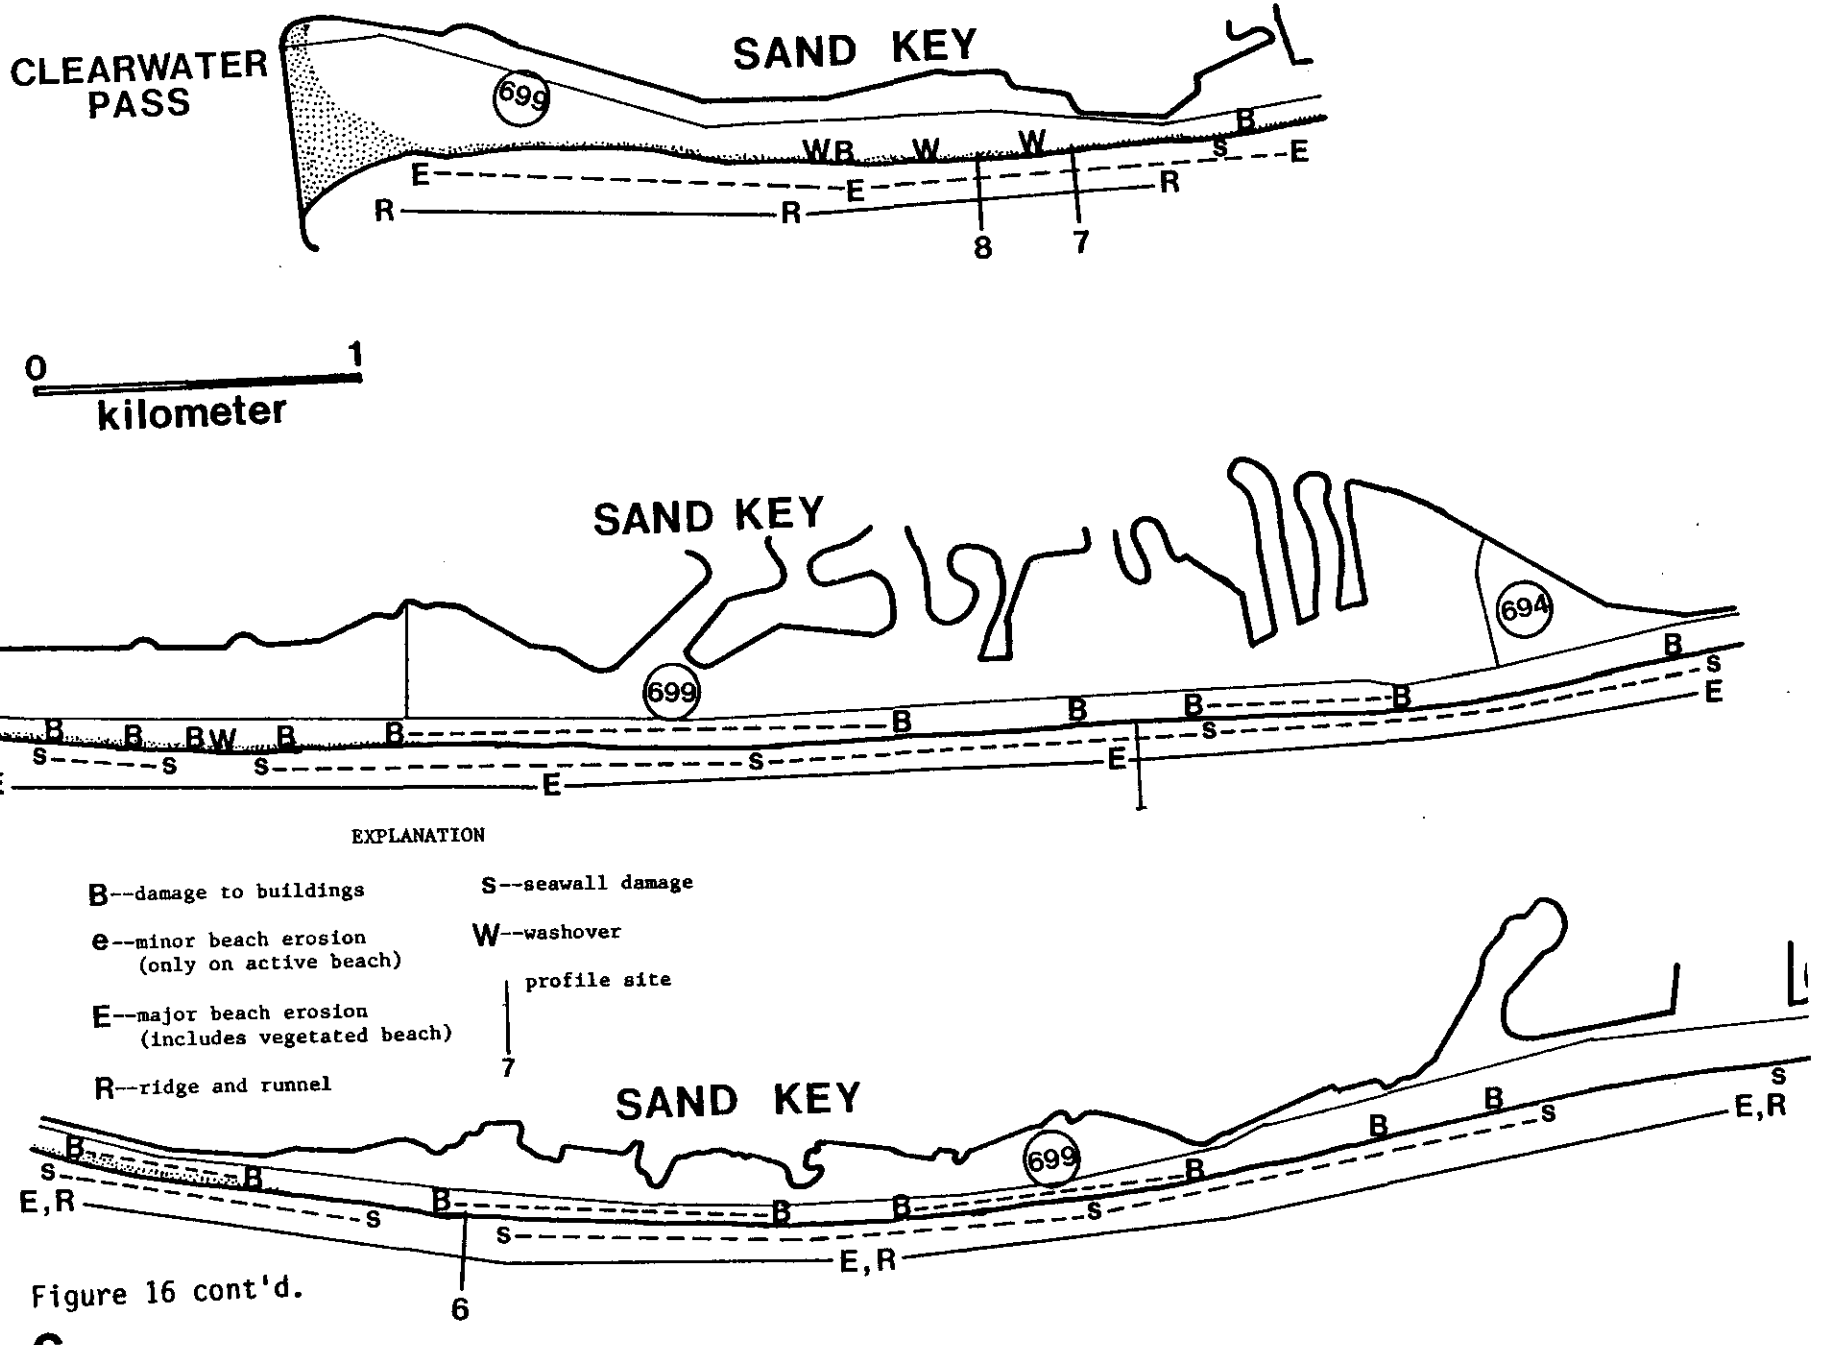
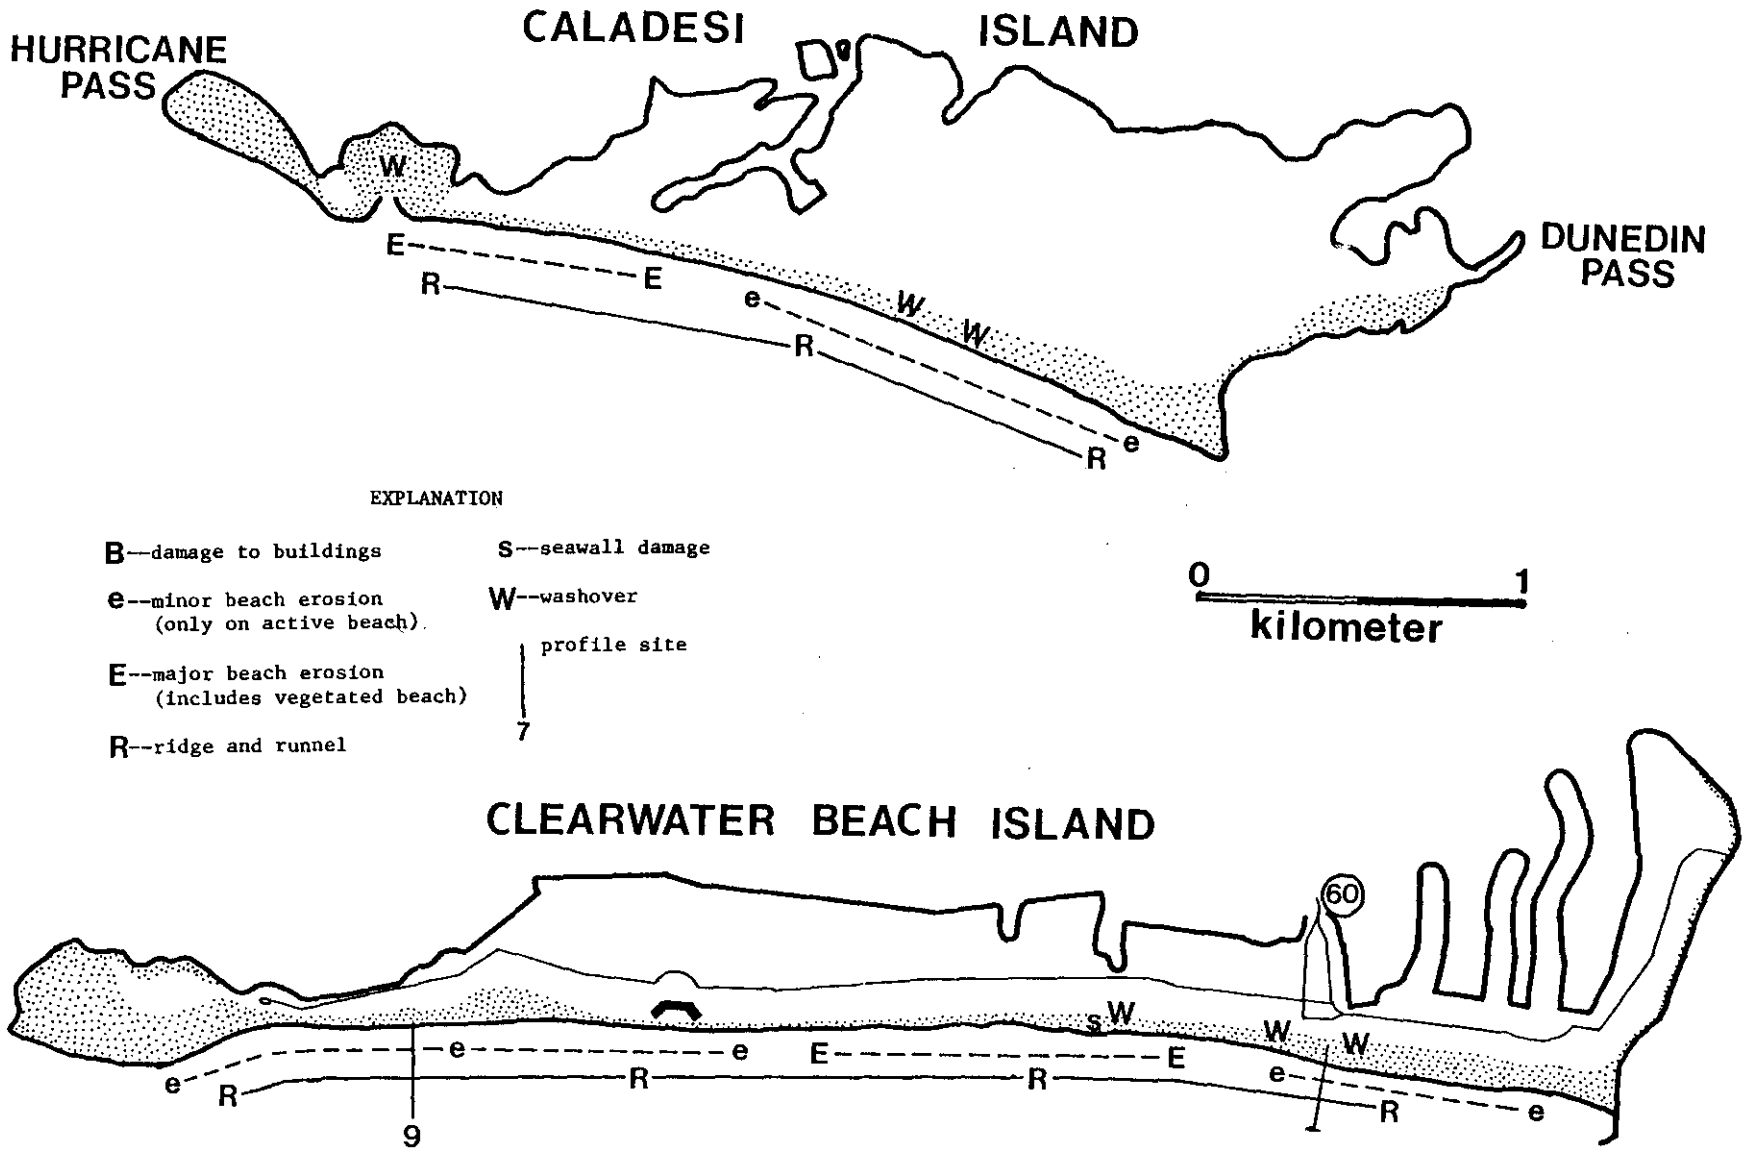
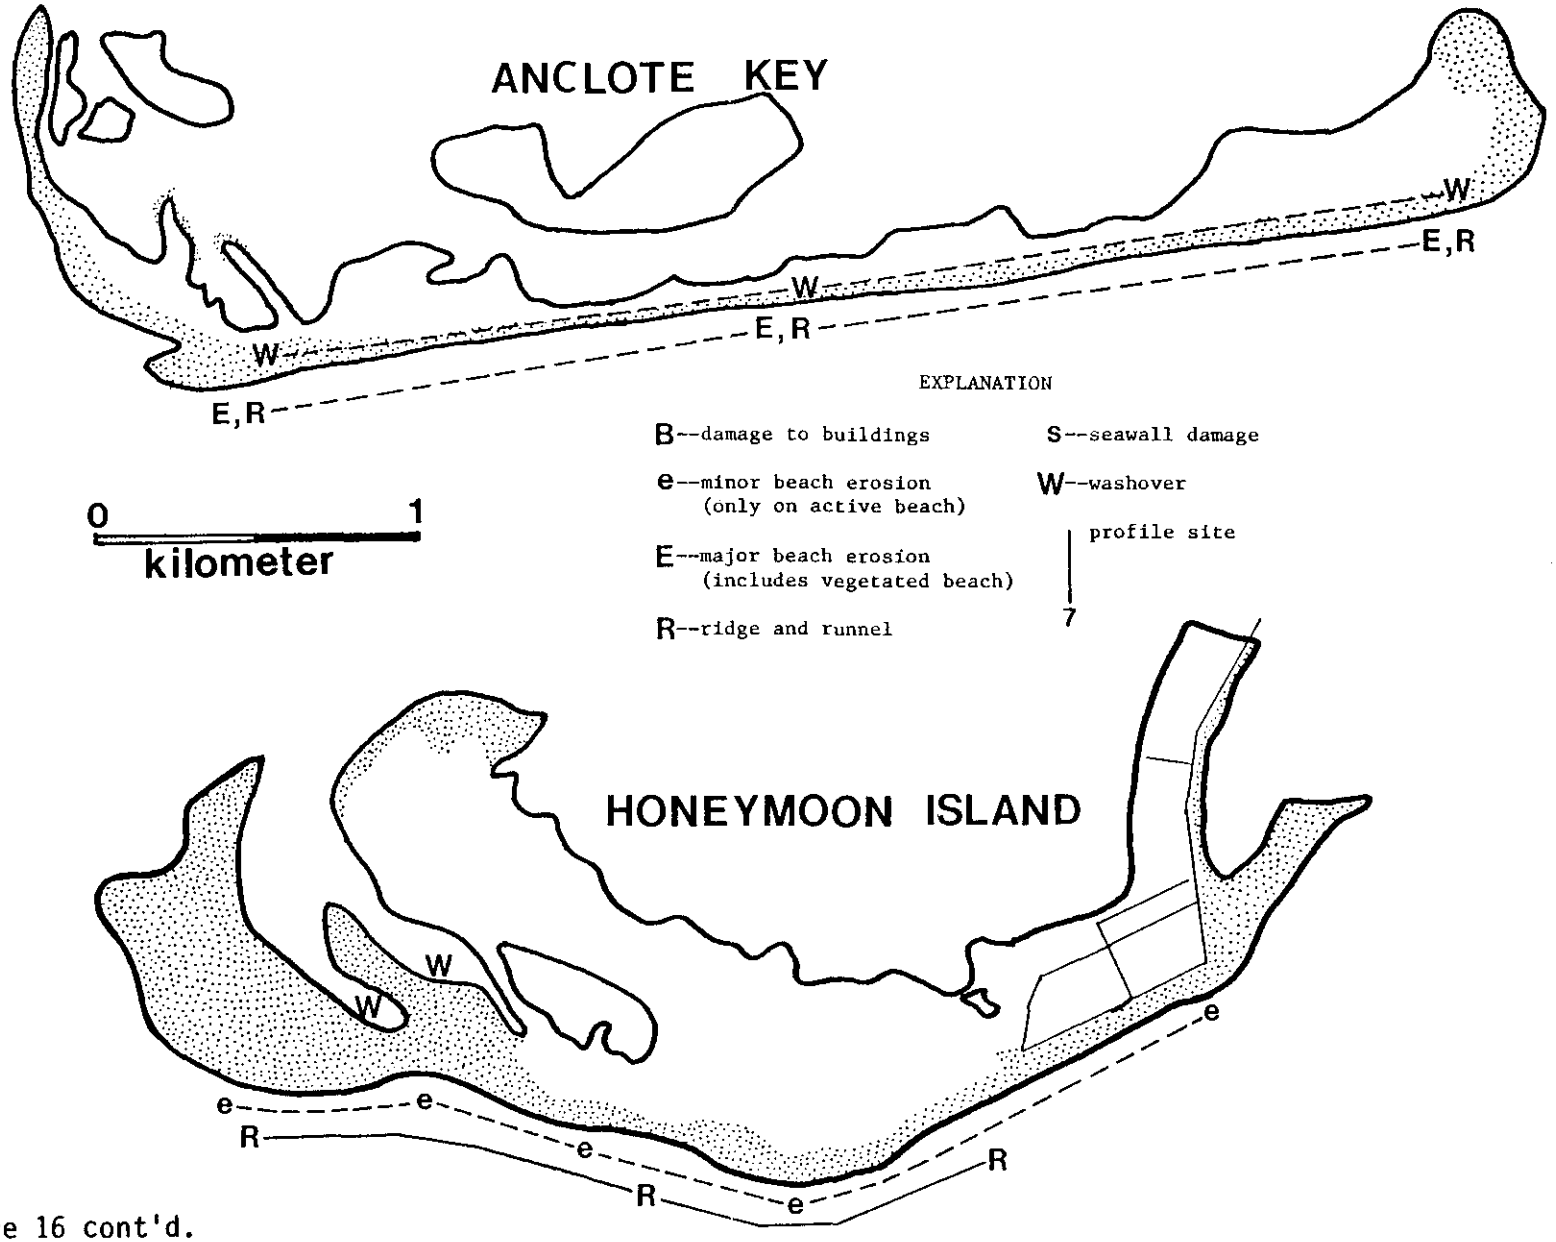
Figure 16a-e - Maps of the Pinellas County barrier islands showing beach changes and damage as the result of Hurricane Elena.

Erosion was essentially continuous throughout the Gulf beaches of Pinellas although the severity ranged rather widely (figure 16). Extensive development of ridge and runnel morphology was also associated with the post-storm beach profiles (figure 17). The most extensive and severe erosion took place on the southern two-thirds of Long Key and Treasure Island, central and northern Sand Key, most of Anclote Key and small reaches of Clearwater Beach Island, Caladesi Island and Mullet Key (figure 16).

Damage to seawalls or similar protection structures was extensive but was confined to a rather small portion of the coast. The seawall on southern Long Key at Pass-a-Grille was damaged to the point that it had to be replaced (see Appendix A). The remainder of Long Key and all of Treasure Island was essentially free from seawall damage. The most extensive and severe damage to hardened shorelines was on Sand Key, locally in the southern portion and continuously beginning at North Redington Beach and continuing through Bellaire Beach on the north (figure 16). Most of the seawall-type structures along this reach were completely destroyed or were damaged to the point that major repair was necessary. Very little seawall damage took place in the City of Clearwater and to the north. Data from the DNR study (Balsillie, 1985) show that although there was considerable damage to seawalls and other protective structures, there was about 30 % less erosion at beaches that were fronting such structures. This study showed that a total of 4.55 km of vertical seawalls was destroyed or heavily damaged and another 3.46 km sustained minor damage.

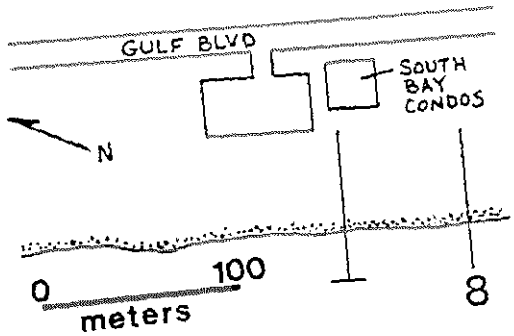
The initial profile after Hurricane Elena displayed a well developed ridge and runnel but without the great relief displayed by Loc. 7 a few hundred meters to the south. Although the relief on this ridge was near 1 m it did permit some overtopping during high tide conditions and consequently there was a bit of lanward migration (Appendix A). The most significant change to this profile took place as the result of Hurricane Juan. The ridge that had persisted for the previous several weeks had migrated onto the upper beach and a new but smaller ridge had developed lower on the profile. The resulting profile showed considerable accretion in the backbeach area. This ridge migrated onto the beach quickly and after Hurricane Kate another small ridge was present. This feature also welded onto the beach quickly.

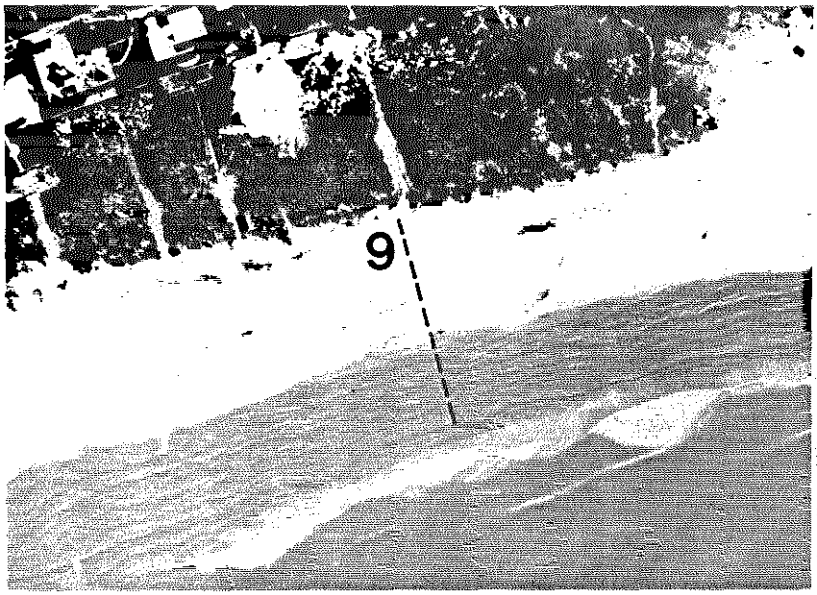
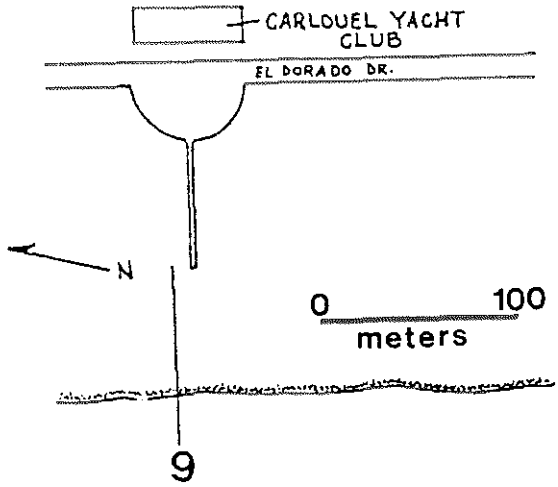
Immediately after Hurricane Elena there was a ridge and runnel as well as a large ephemeral bar on this profile. Although its relief was similar to that on profile #7 it was lower on the profile. Water covered the bar during high tide conditions and caused a slight shoreward migration. After Juan, this profile displayed a markedly different appearance. The ridge had migrated up onto the beach and a new ridge and runnel was present. This broad ridge showed some shoreward migration and persisted through the passage of Hurricane Kate (Appendix A).
