Sediment Management Plan For the Watersheds of Clearwater Harbor and Saint Joseph Sound

Prepared for:
Pinellas County
Department of Environment
and Infrastructure

April, 2012

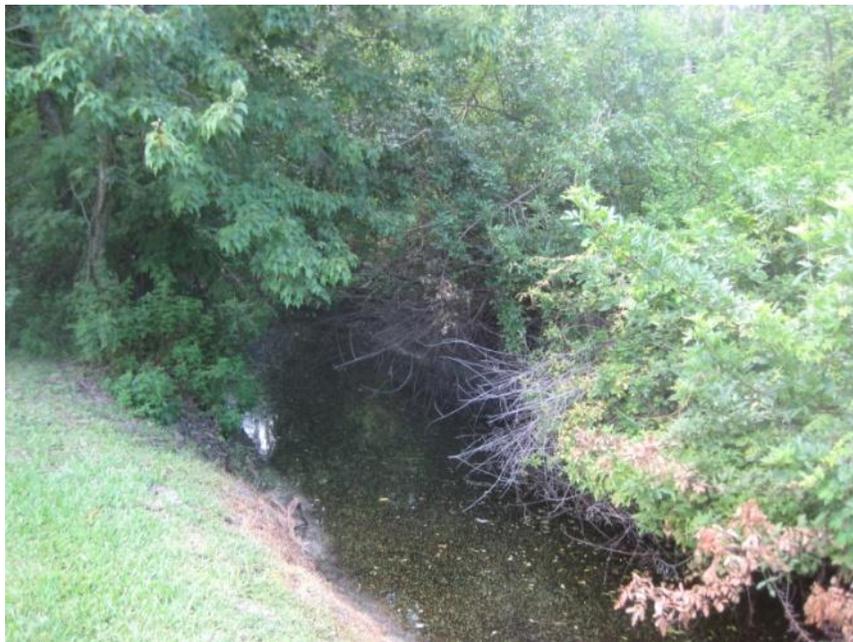
Figure 4-6. Site Klosterman 3 looking upstream.

Site Klosterman 3 was on the Innisbrook Resort grounds near the stream headwaters. The stream was channelized with grassed side slopes (Figures 4-5 and 4-6). Soft sand with fine-grained material had accumulated to a depth of 10 inches upstream of the road crossing and had shoaled to 14 inches deep downstream of the Old Post Road culvert. Although potential issues with sediment accumulation were noted, the stream was on private property and its maintenance may not be a County responsibility

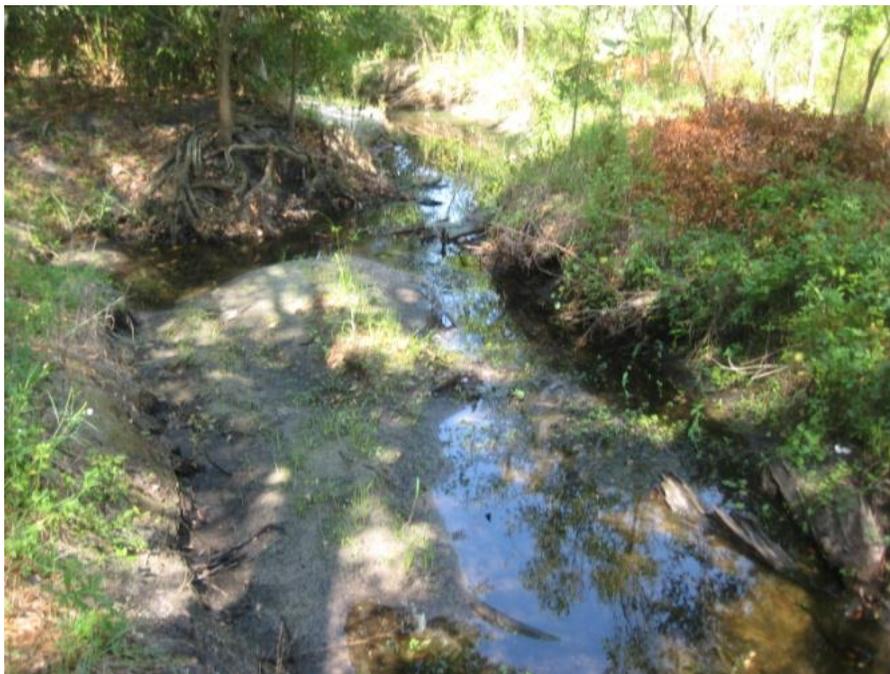
Figure 4-9. Site Bee 1 looking downstream.

Site Bee 1 is the most upstream site, and is located just west of Belcher Road south of Nebraska Ave. Loose silty sand sediment was observed to be approximately 6 inches deep, with significant shoaling as shown in Figure 4-9. Bank undercutting suggests high flow velocities.

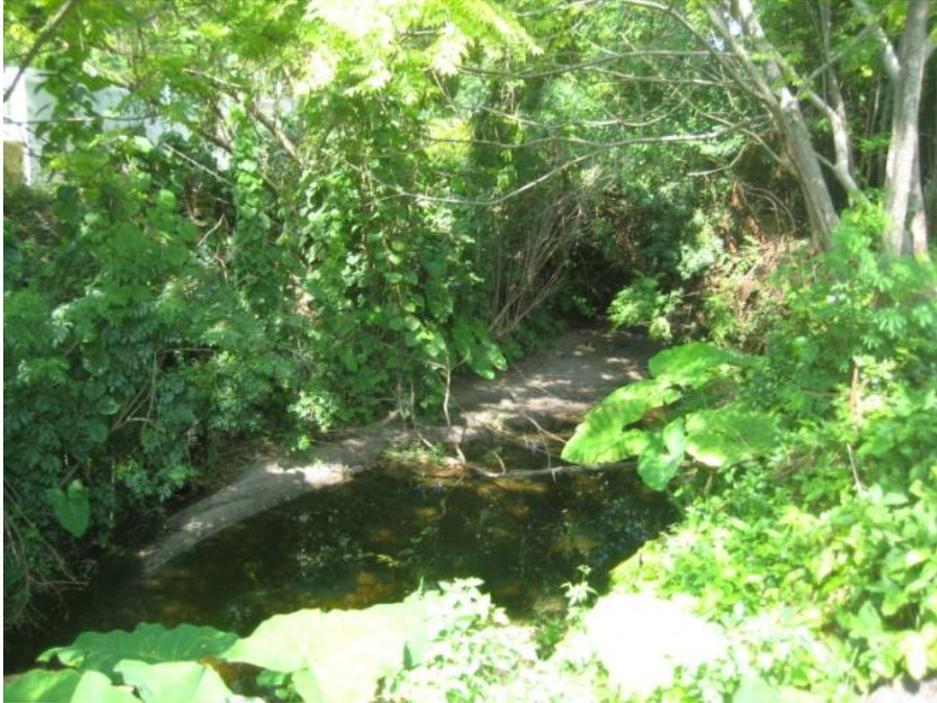
Figure 4-10. Site Bee 2 looking downstream.

Site Bee 2 is located at the 19th Street crossing south of Mary's Meadow Lane. Gabions have been installed on the channel bed, but not banks, upstream and downstream of the box culvert under 19th Street. Sand shoaling downstream of the road crossing (Figure 4-10) averaged about 7 inches deep, with apparent high fine-grained material content. This upper reach of the creek is not as steep as farther downstream, and channel morphometry indicates modest flow velocities.

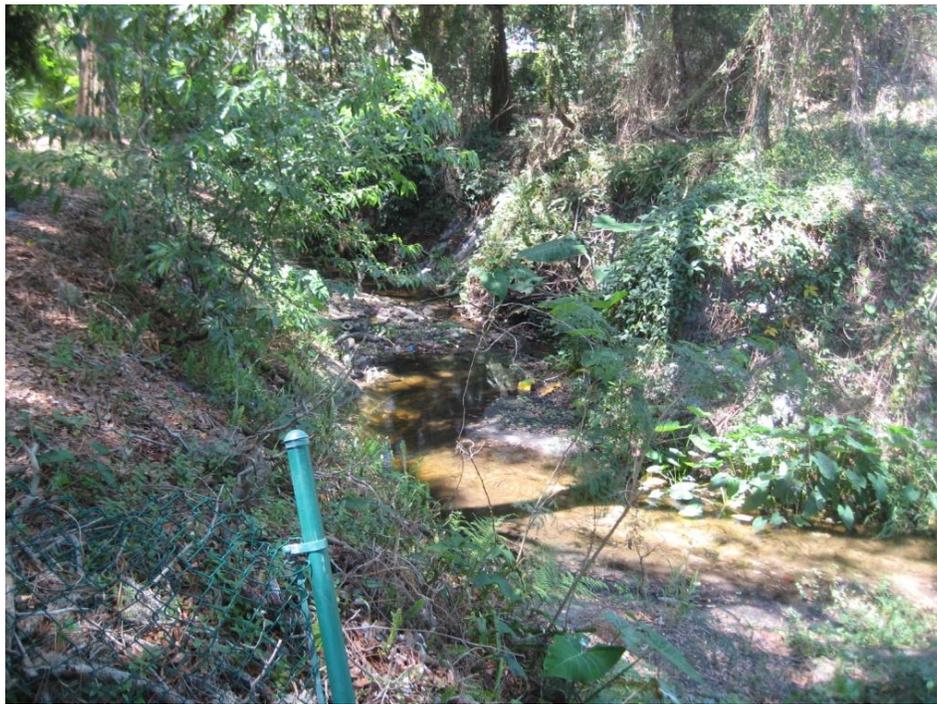
Figure 4-11. Site Bee 3 looking downstream.

Site Bee 3 is farther downstream at the 15th Street crossing, south of Ohio Avenue and north of Tampa Road. A review of a topographic map indicates that the reach downstream of site Bee 3 has a steeper slope than upstream, which would lead to higher in-stream velocities and higher erosion rates. Figure 4-11 shows the steep highly-incised channel banks. Only a thin spotty layer of loose soft sand, about 3 inches, was observed with most of the channel covered in rock and rubble. The relative lack of loose sediment and bank erosion indicates that stream flow likely reaches velocities sufficient to scour loose material and transport it downstream. The reach upstream at 15th Street was somewhat incised (Figure 4-12) but not to the extent seen in the downstream reach.

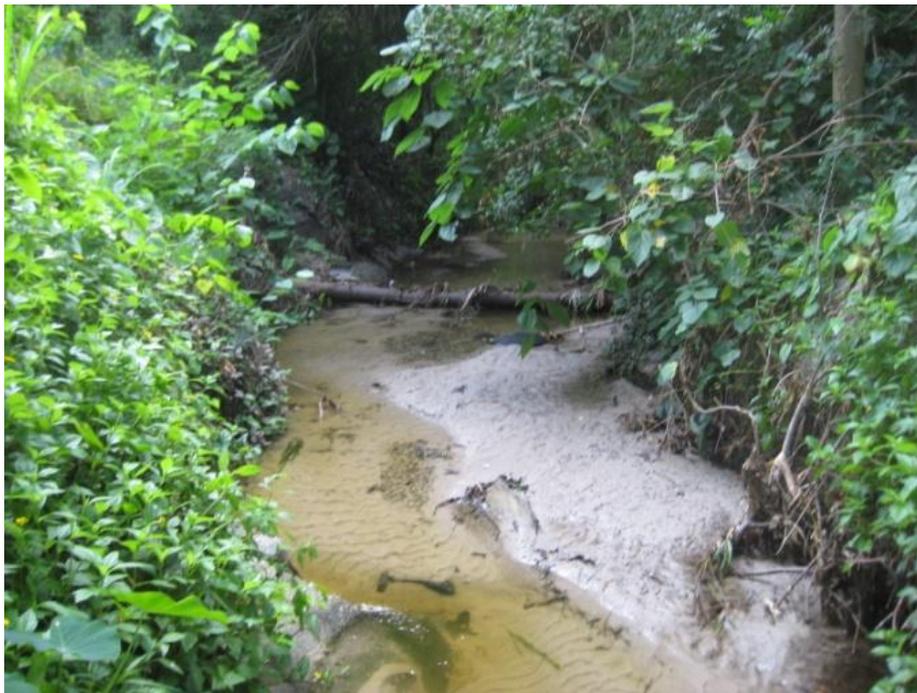
Figure 4-13. Site Bee 4 looking downstream.

Site Bee 4 is located at the downstream end of the steep portion of the creek, at Hidden Brook Drive north of Tampa Road. Figure 4-13 shows that the channel is incised but the vegetated banks indicate that bank erosion is not as high as upstream where the banks are bare in many areas. Soft sand shoals are evident at the site, indicating that flow velocities are likely not as high as upstream, allowing sediment to accumulate.

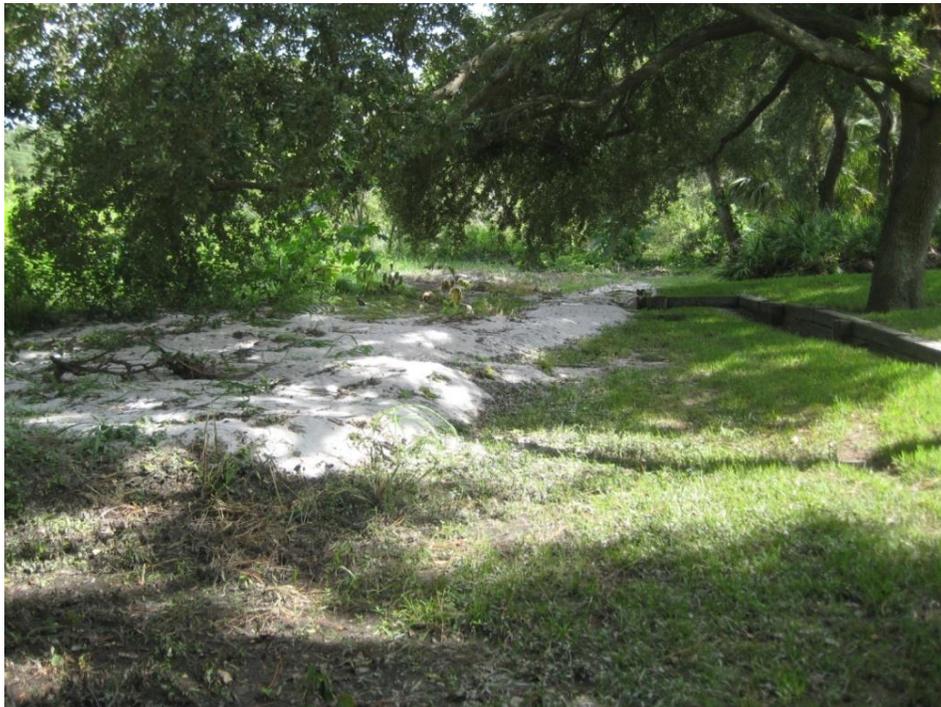
Figure 4-19. Site Curlew 3 - overbank shoaling after high flows.

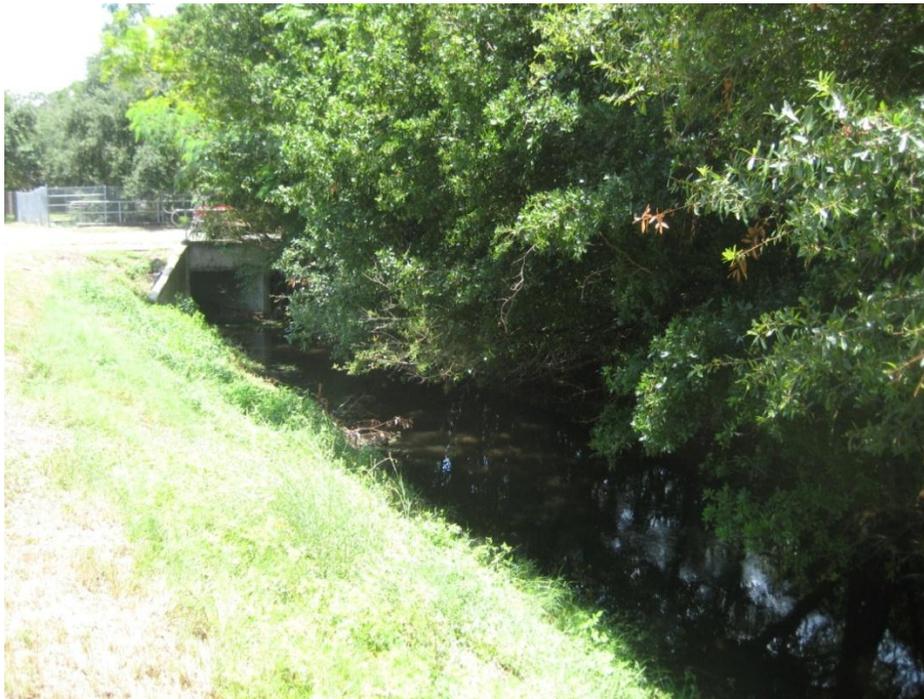
Figure 4-30. Site Curlew 13 looking downstream.

Site Curlew 13 is located east of Cypress Point Drive West, south of Cypress Point Drive North, about 0.4 miles west of Belcher Road. As seen in Figures 4-30, the north bank was overgrown but

the steep south grass bank was typically maintained with spotty bank erosion evident. A sand layer with black fine-grained material about 3 inches thick was encountered.

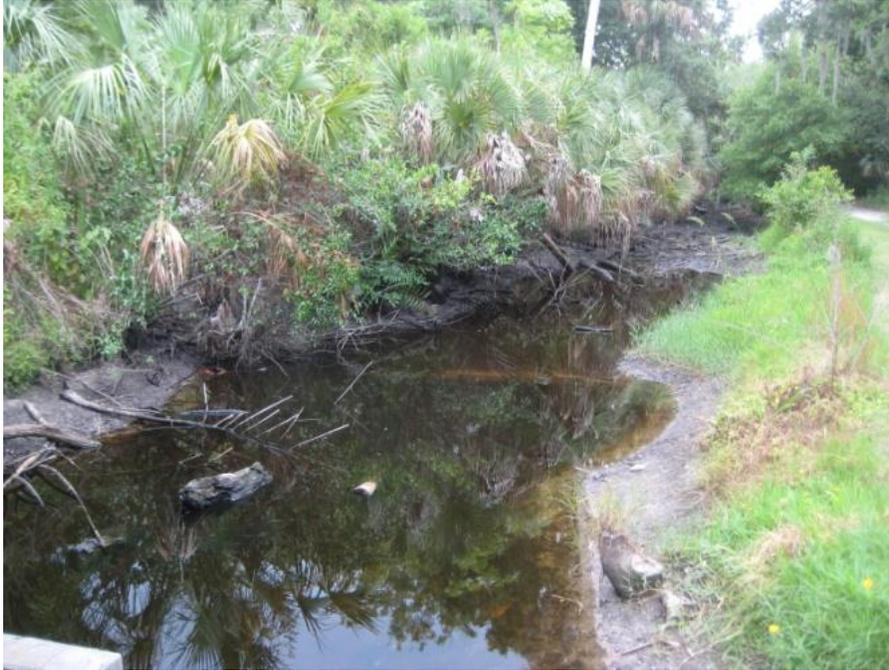
Figure 4-35. Site Cedar 3 looking upstream.

Site Cedar 3 is located in the park at Sugarberry Trail (Figure 4-35). There was substantial detritus in the shallow banked creek channel with a thin film of fine-grained silt on the bottom.

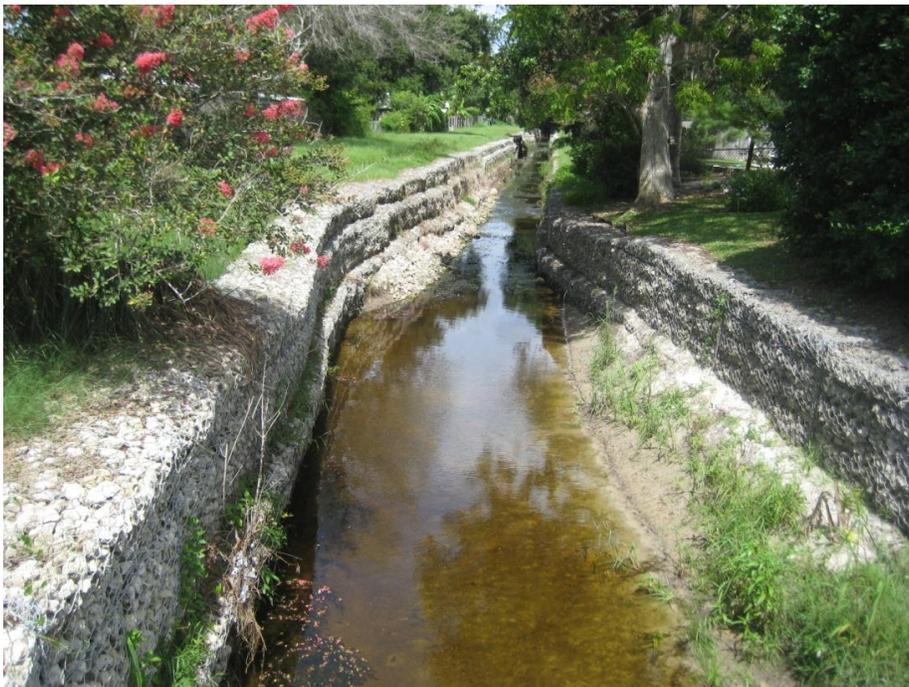
Figure 4-36. Site Cedar 4 looking upstream.

Site Cedar 4 is the most upstream site, located at the Pinehurst Road crossing (Figure 4-36). Although the channel is lined with gabions there is still sand shoaling evident.

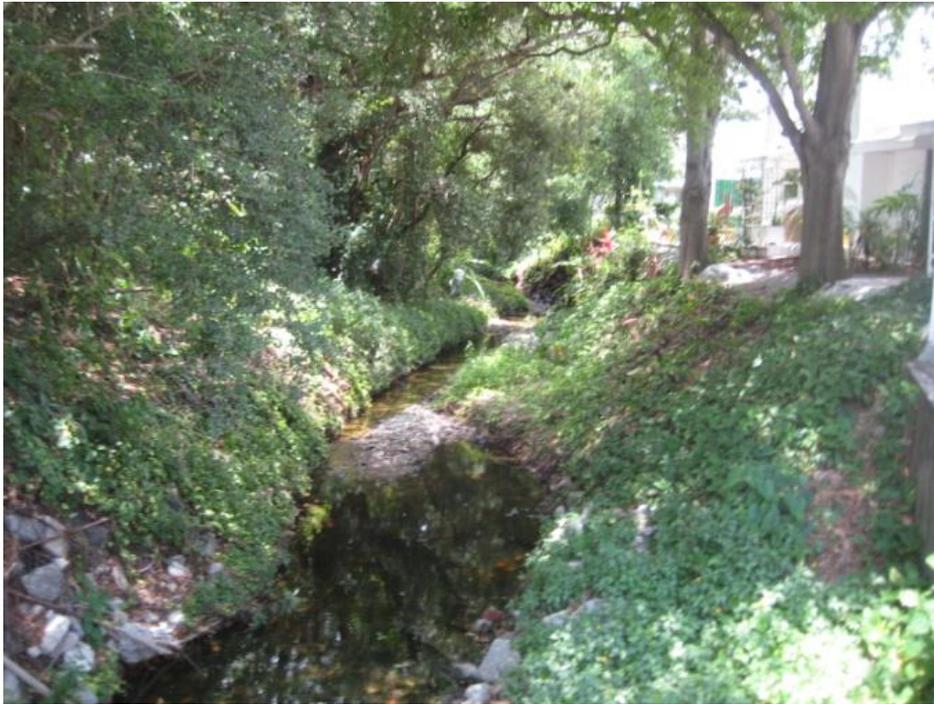
Figure 4-39. Site Stevenson 1 looking downstream.

Site Stevenson 1 is the farthest upstream, located at Bellevue Boulevard near South Evergreen Avenue. The channel was piped upstream of the site. The channel downstream had a gravel bed but did have a sandy shoal as shown in Figure 4-39. The downstream reach is subject to significant bank erosion. Local residents have had to use rip rap and rubble debris to slow erosion near homes.

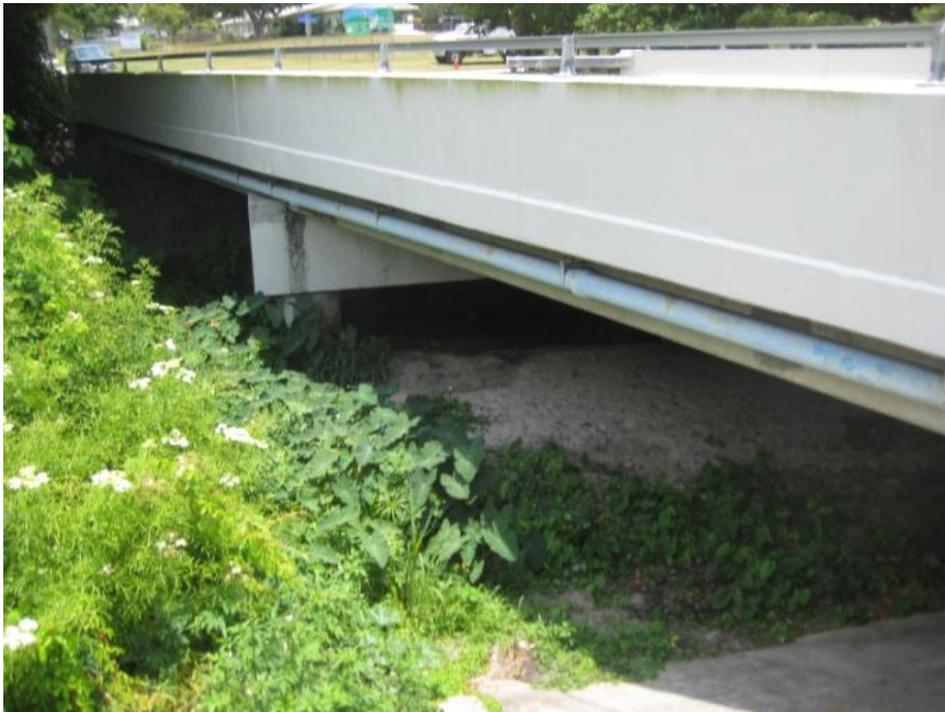
Figure 4-40. Site Stevenson 2 sand shoal under Lakeview Road bridge.

Site Stevenson 2 is located at the Lakeview Road bridge west of Hillcrest Drive. A large sand shoal had developed under the bridge as shown in Figure 4-40. The reach is channelized with a sediment layer of approximately 5 inches of loose sandy silt and patchy fine-grained sediment (Figure 4-41). Although sediment transport is evident it is likely of nearby origin, as a stormwater in-line pond about 0.7 miles upstream of this site should act as sediment sump for material originating farther upstream.

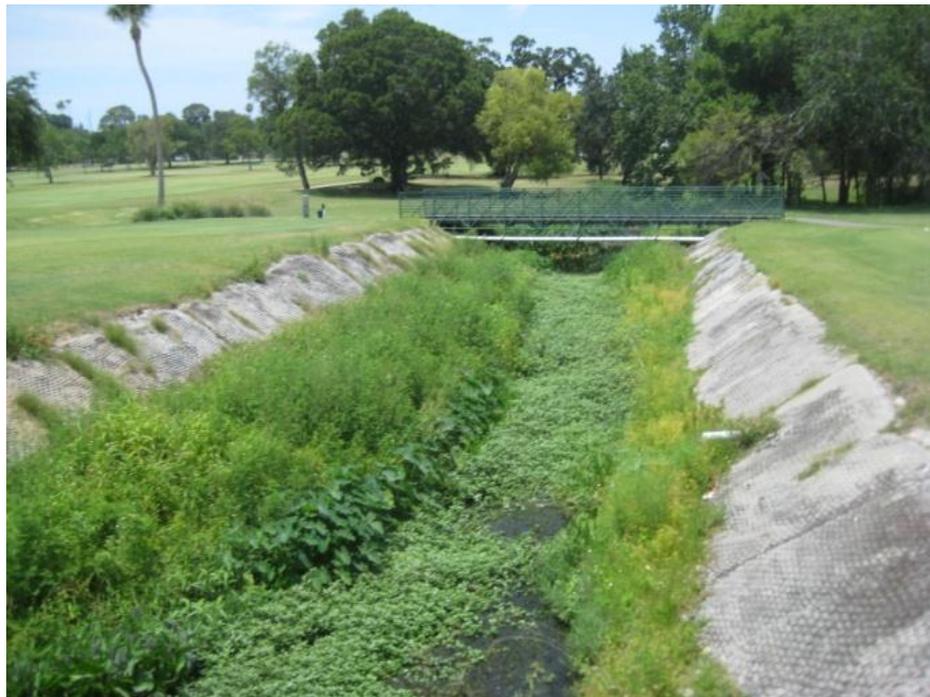
Figure 4-42. Site Stevenson 3 looking downstream.

Site Stevenson 3 is located at Drew Street east of Betty Lane (Figure 4-42). The channel is concrete-lined both north and south of the bridge but there was an average of 3 inches of silty and mucky

sand on the channel bottom. This reach receives high volumes of runoff from downtown Clearwater.

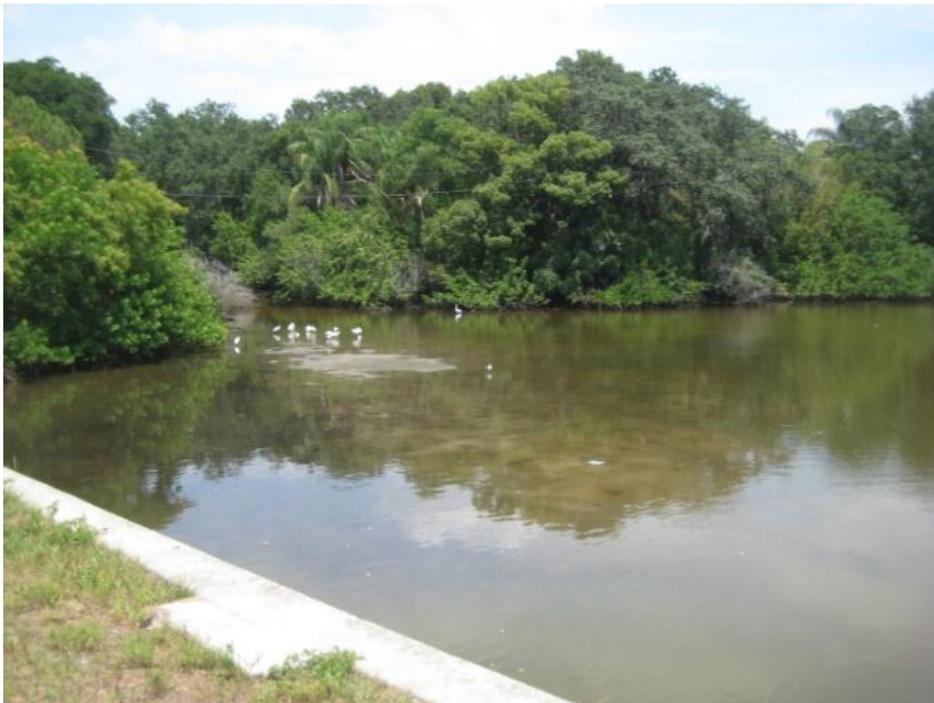
Figure 4-44. Site Stevenson 5 looking upstream (SE).

Site Stevenson 5 is located east of Betty Lane and south of Overlea Street, at a wide area of the channel where the main stem is joined by a tributary from the east. The channel widens, and significant sandy shoals were observed as shown in Figures 4-44.

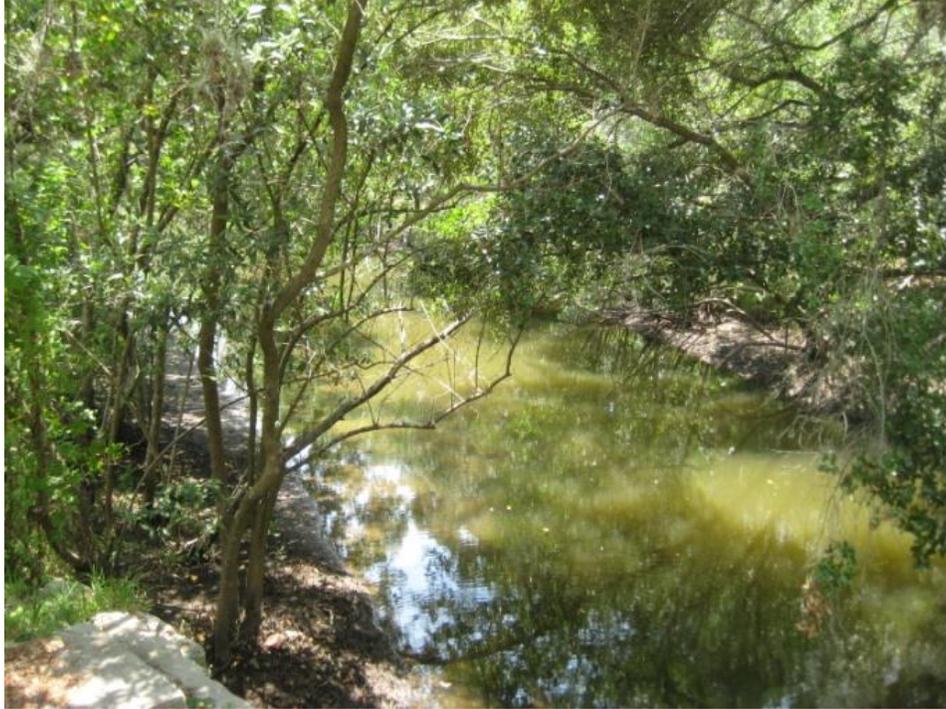
Figure 4-47. Site Spring Branch 1 looking upstream.

Site Spring Branch 1 is located at the Overbrook Avenue crossing near the stream mouth. The creek is tidal with shallow banks at this location and had a loose sand layer with substantial fine-grained content about 4 inches thick, as shown in Figure 4-47.

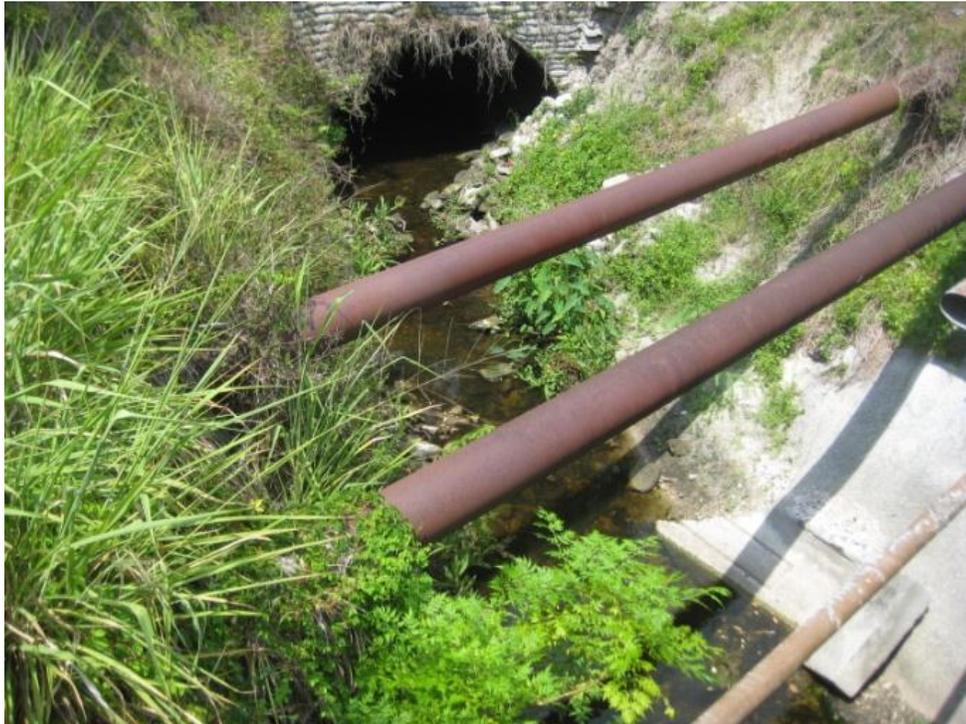
Figure 4-48. Site Spring Branch 2 looking upstream.

Site Spring Branch 2 is located at the Sunset Point crossing west of Betty Lane, shown in Figure 4-48. The site is located near Pinellas County water monitoring site 15-04. A section of the upstream channel is concrete-lined. The downstream reach has a gravel bed with minimal sediment.

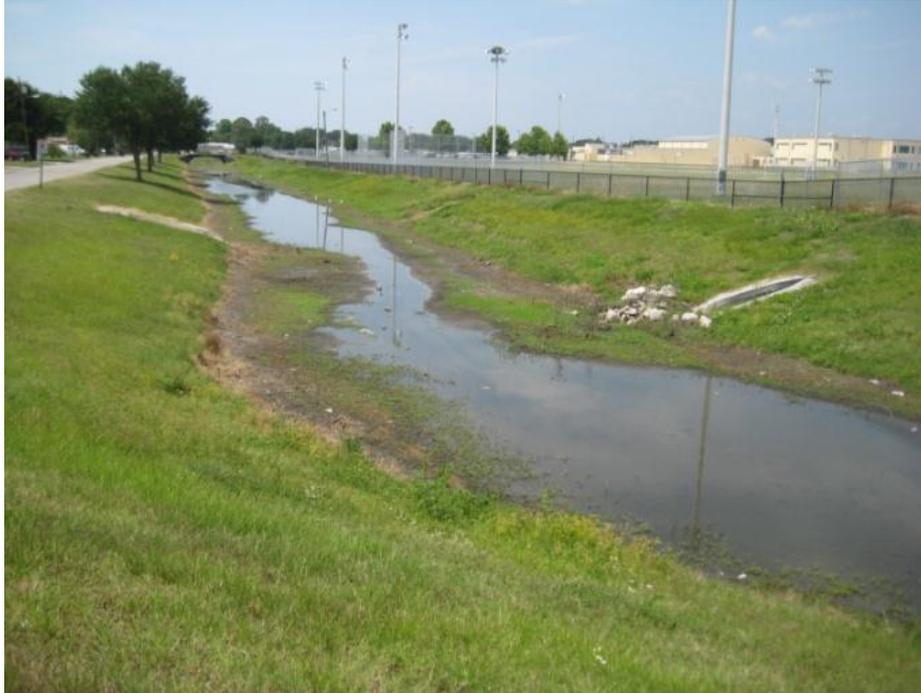
Figure 4-49. Site Spring Branch 3 looking upstream.

Site Spring Branch 3 is located north of Union Street west of the Dunedin Middle School. The channel is a shallow drainage swale with grassed banks with a thin layer of silty sand in the channel bed as shown in Figure 4-49. Water was stagnant at the time of inspection.

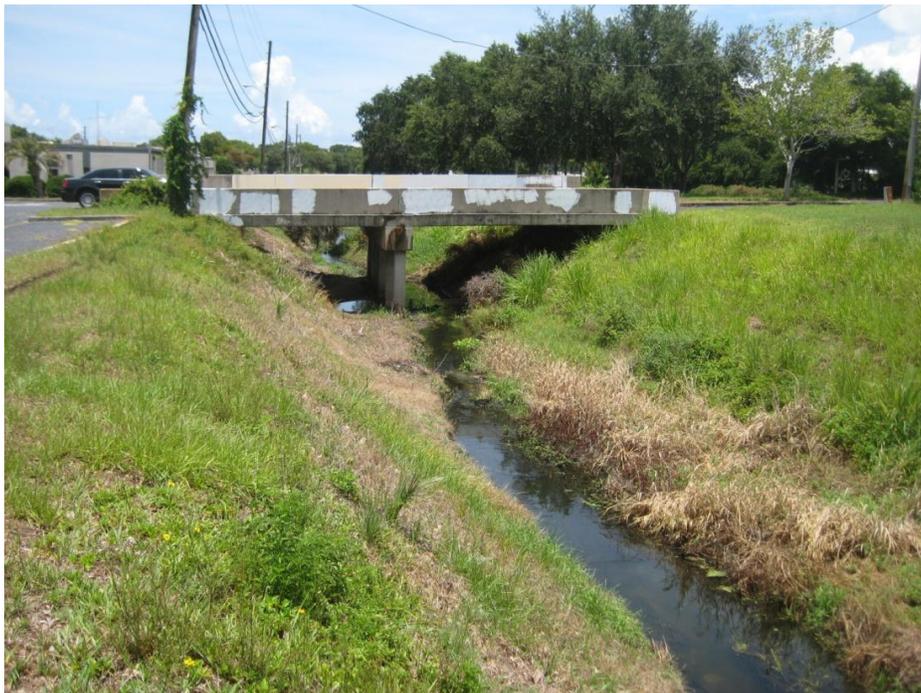
Figure 4-50. Site Spring Branch 4 looking downstream.

North of the school the creek is incorporated into a trailer park drainage system, and then continues farther east and north. Spring Branch 4 is the farthest upstream site visited, located east of Patricia Avenue and south of Cedarwood Drive (Figure 4-50). The channel is prismatic with a commonly observed trapezoidal configuration. Although the steep side slopes were grassed, isolated bank slumping was observed. The bottom contained algae mats and 1 – 2 inches of soft sand.

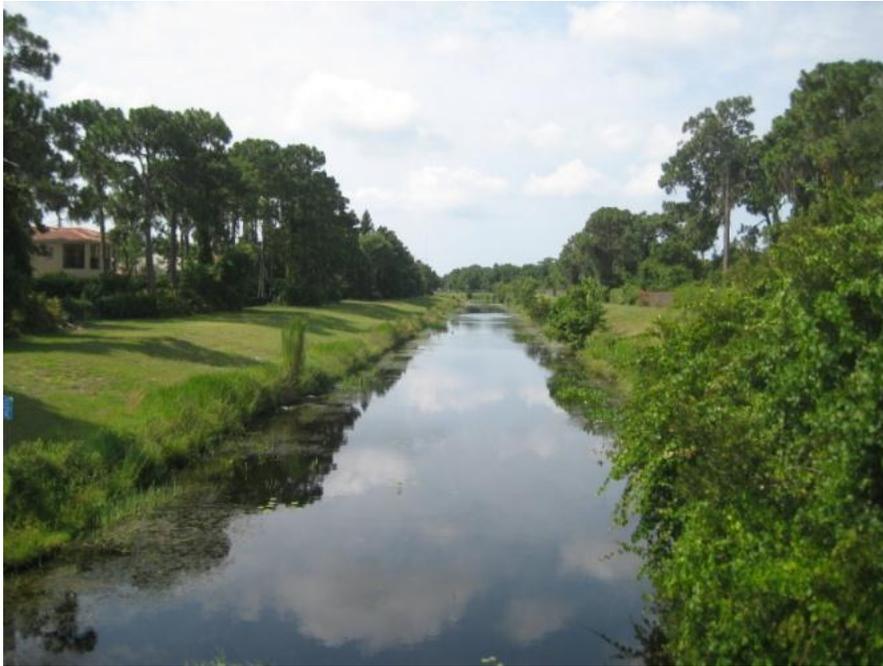
Figure 4-53. Site McKay 1 looking downstream.

Site McKay 1 is the most upstream site visited and is located at the crossing at 102nd Avenue. As shown in Figure 4-53 the channel south of 102nd Avenue has been dredged and is maintained. The depth of loose sand at the site averaged 6 inches. The channel bottom was relatively clean with only patchy silty and fine-grained material visible.

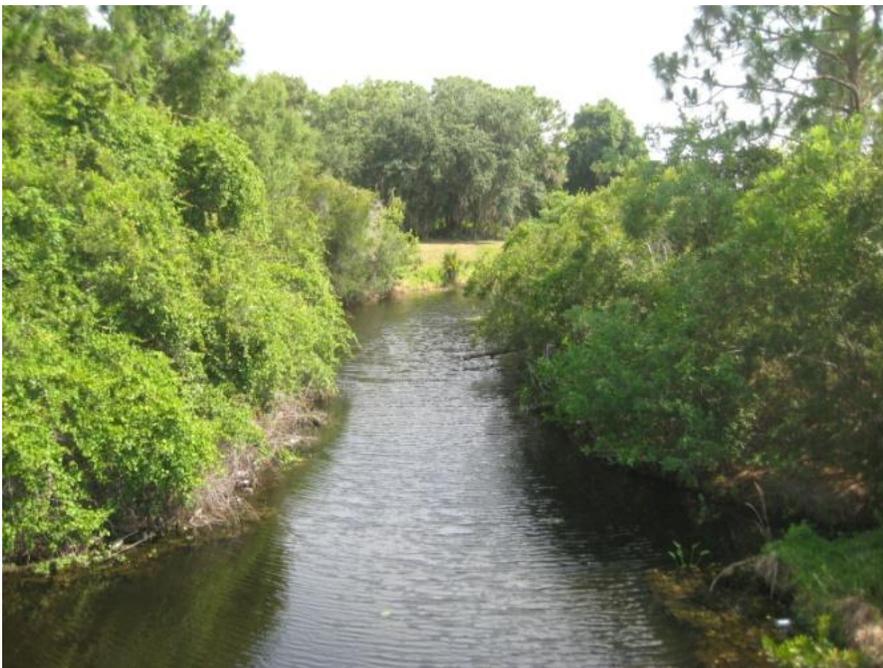
Figure 4-54. Site McKay 1 looking upstream.

In contrast, the channel south (upstream) of 102nd Avenue is much narrower and the channel sides are not so well maintained (Figure 4-54).

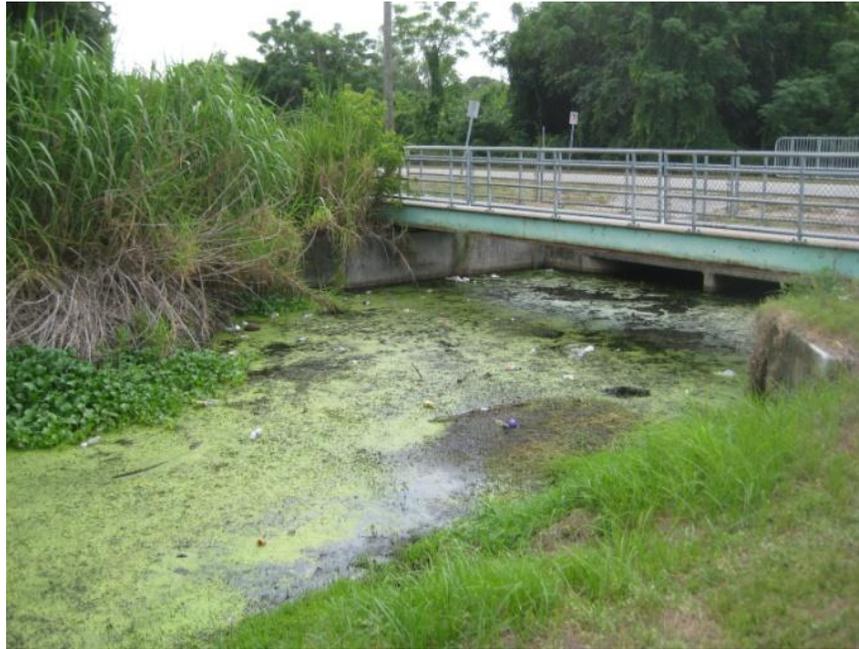
Figure 4-55. Site McKay 2 looking downstream.

Site McKay 2 is located in Heritage Park north of Walsingham Road. The creek is open water (Walsingham Reservoir) between 102nd Street and Walsingham Road. The site, which is near Pinellas County water quality monitoring site 27-10, is shown in Figure 4-55. Just upstream of the site the channel is very overgrown and had a loose sand layer with substantial fine-grained material measured to be 6 – 10 inches thick. It is likely that much of the sediment at this site is of local origin, as the upstream reservoir acts as a sediment sump.

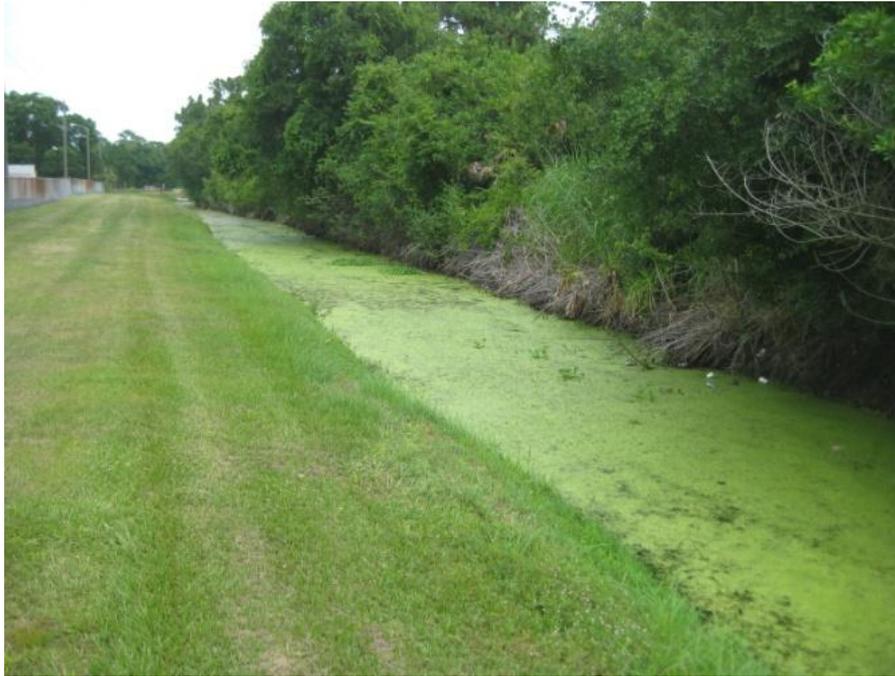
Figure 4-56. Site McKay 3 looking downstream.

Site McKay 3 is located north of 134th Avenue and west of 121st Street. As seen in Figure 4-56 the channel is maintained with a shallow grassy bank on the west side and is overgrown on the east bank. This reach had a significant fine-grained muck layer averaging 18 to 20 inches at the site. The water surface was covered with duckweed and abundant trash.

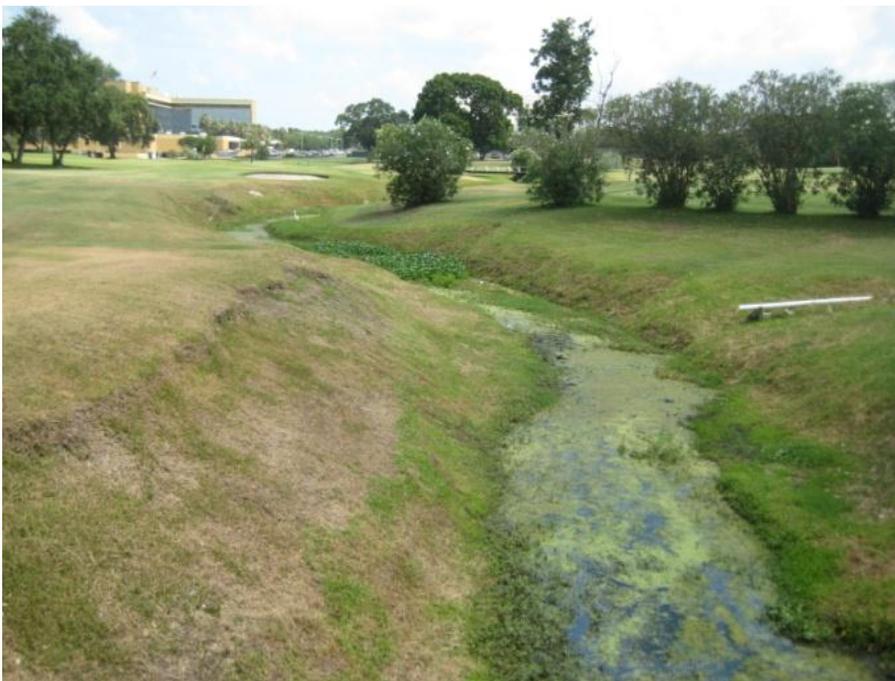
Figure 4-57. Site McKay 4 looking downstream.

Site McKay 4 is located north of 8th Avenue SW at Pine Crest Golf Course. The channel has grassy banks and crosses the golf course (Figure 4-57). A weir at the site retains water and presumably sediment upstream, as shown in Figure 4-58. Loose sand was approximately 2 inches deep below the weir and 3 inches deep above it.

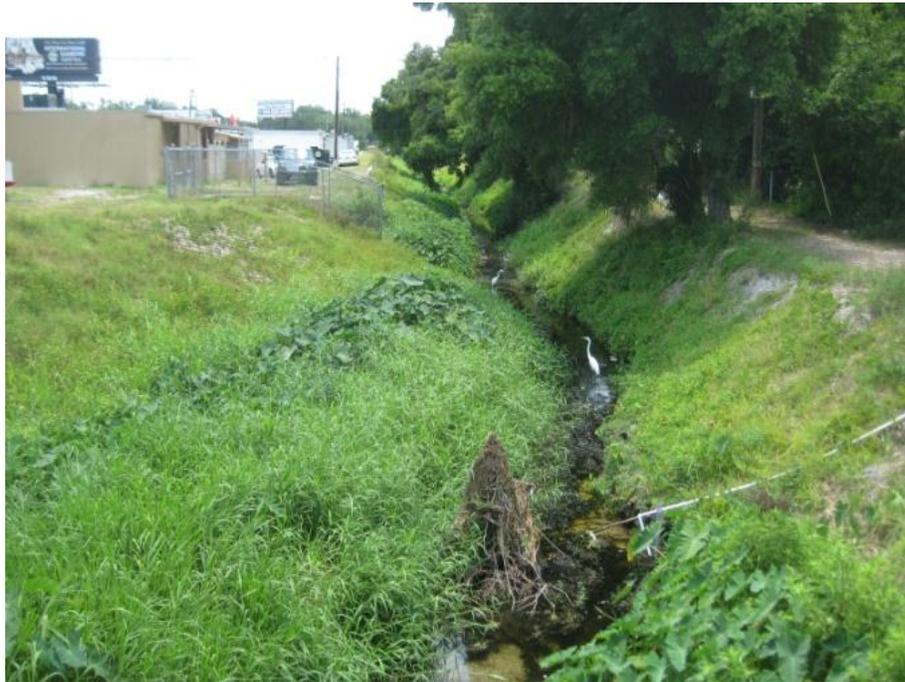
Figure 4-59. Site McKay 5 looking downstream.

Site McKay 5 is located at the 20th Street crossing south of West Bay Drive (Figure 4-59), near Pinellas County water quality monitoring site 27-09. Data indicate that the site is freshwater with salinity averaging 0.3 ppt. Whether the tide levels affect the water level in the stream at this location is unknown. This site marks the location of the channel as it turns to flow back to the south. The channel has concrete lining adjacent to the bridge and is otherwise incised with vegetated banks. The grass growing along the edges of the channel bottom supports a fine-grained layer approximately 4 inches deep. The clean channel center has a sand and gravel bottom and

minimal fine sediment was observed. This reach is narrower than several upstream reaches so flow velocities must be high at the site, leading to the scour and transport of fine grained sediments.

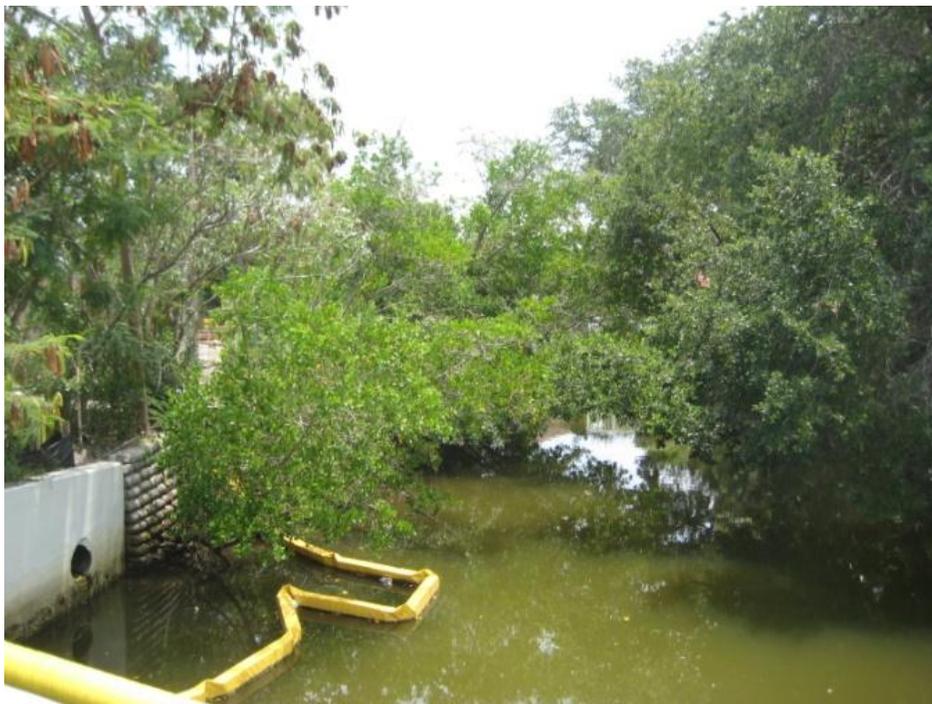
Figure 4-61. Site McKay 7 looking upstream.

Site McKay 7 is the most downstream site and is located at Indian Rocks Road. The channel is tidal and had sea walls on both sides as shown in Figure 4-61. Deep (24 inches) black anoxic fine-grained muck was observed along the seawall.

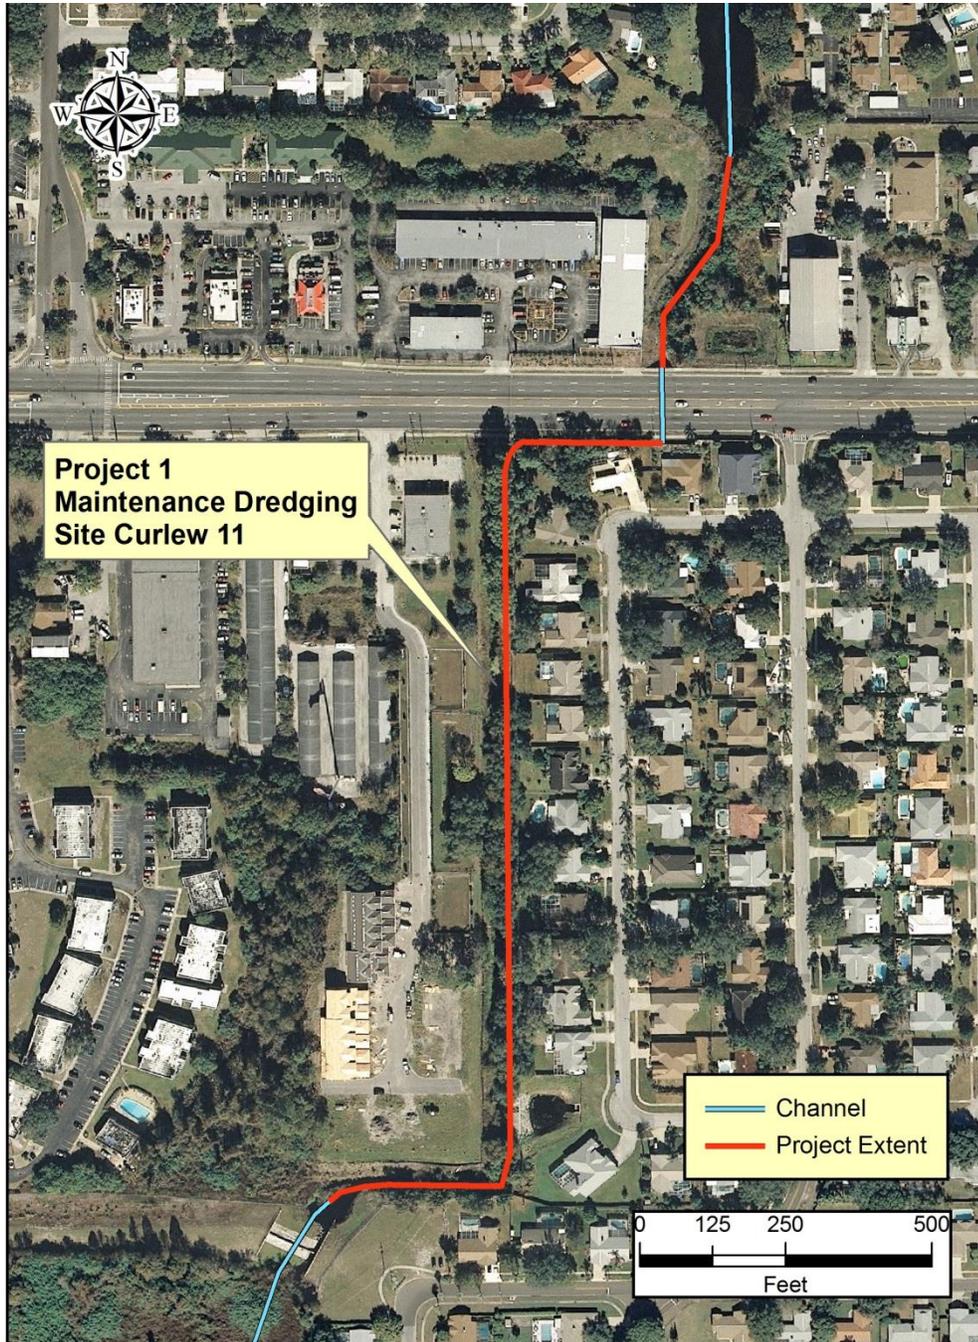
Figure 5-1. Project 1 at Site Curlew 1.

Location - Curlew Creek site Curlew 11, Jerry Branch south of Main Street (Figure 5-1)

Issues – Turbidity curtains would be required downstream of the dredging.

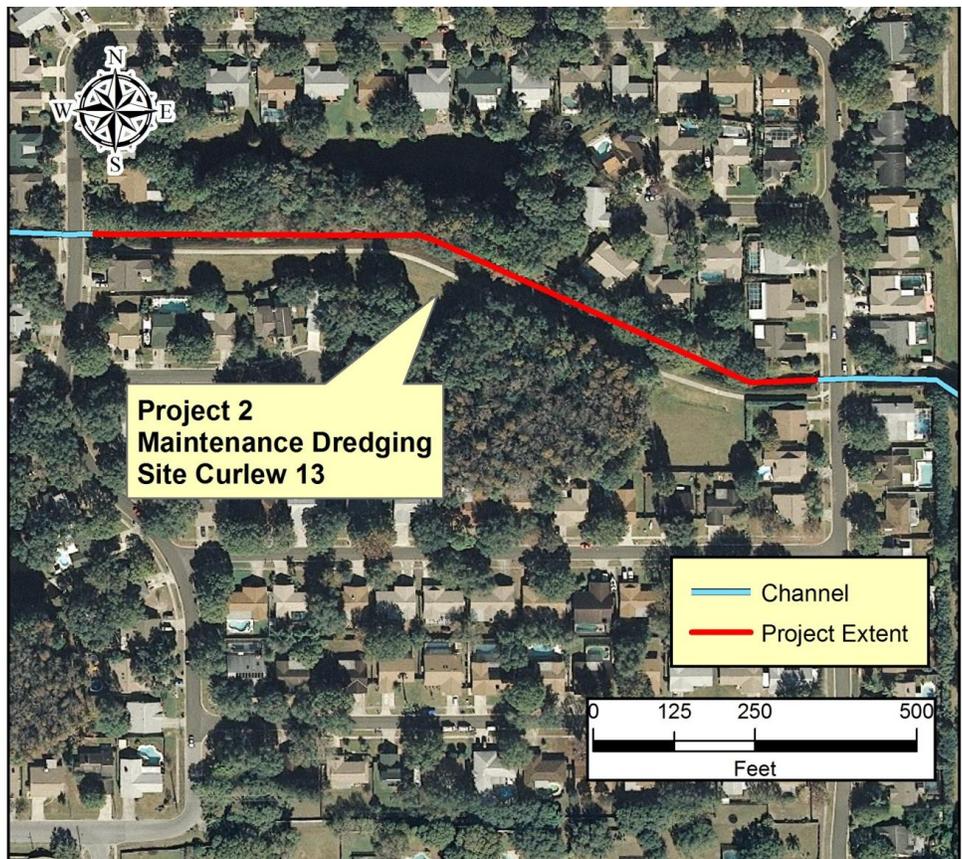
Figure 5-2. Project 2 at site Curlew 13.

Location – Curlew Creek site Curlew 13 at Cypress Point Drive west of Belcher Road (Figure 5-2)

Issues – Turbidity curtains would be required downstream of the dredging

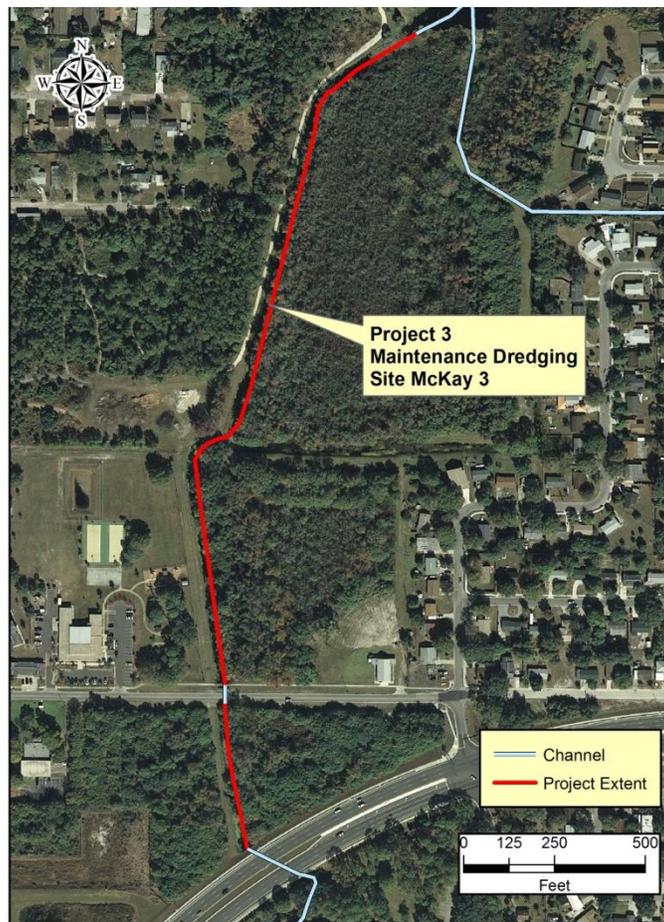
Figure 5-3. Project 3 at Site McKay 3.

Location - McKay Creek site McKay 3 north of 134th Ave near Ulmerton Rd (Figure 5-3)

Issues – Turbidity curtains would be required downstream of the dredging.

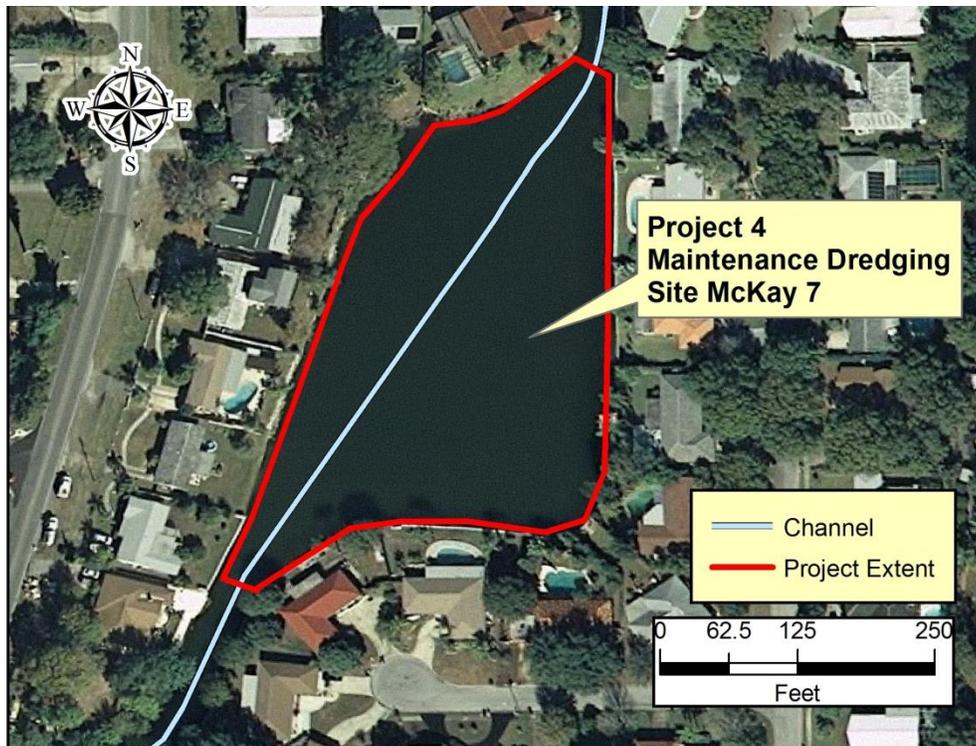
Figure 5-4. Project 4 at site McKay 7.

Location - McKay Creek site McKay 7 at Indian Rocks Road (Figure 5-4)

Issues – Turbidity curtains would be required downstream of the dredging. Environmental permitting would be necessary.
