Sediment Management Plan For the Watersheds of Clearwater Harbor and Saint Joseph Sound

Prepared for:
Pinellas County
Department of Environment
and Infrastructure

April, 2012

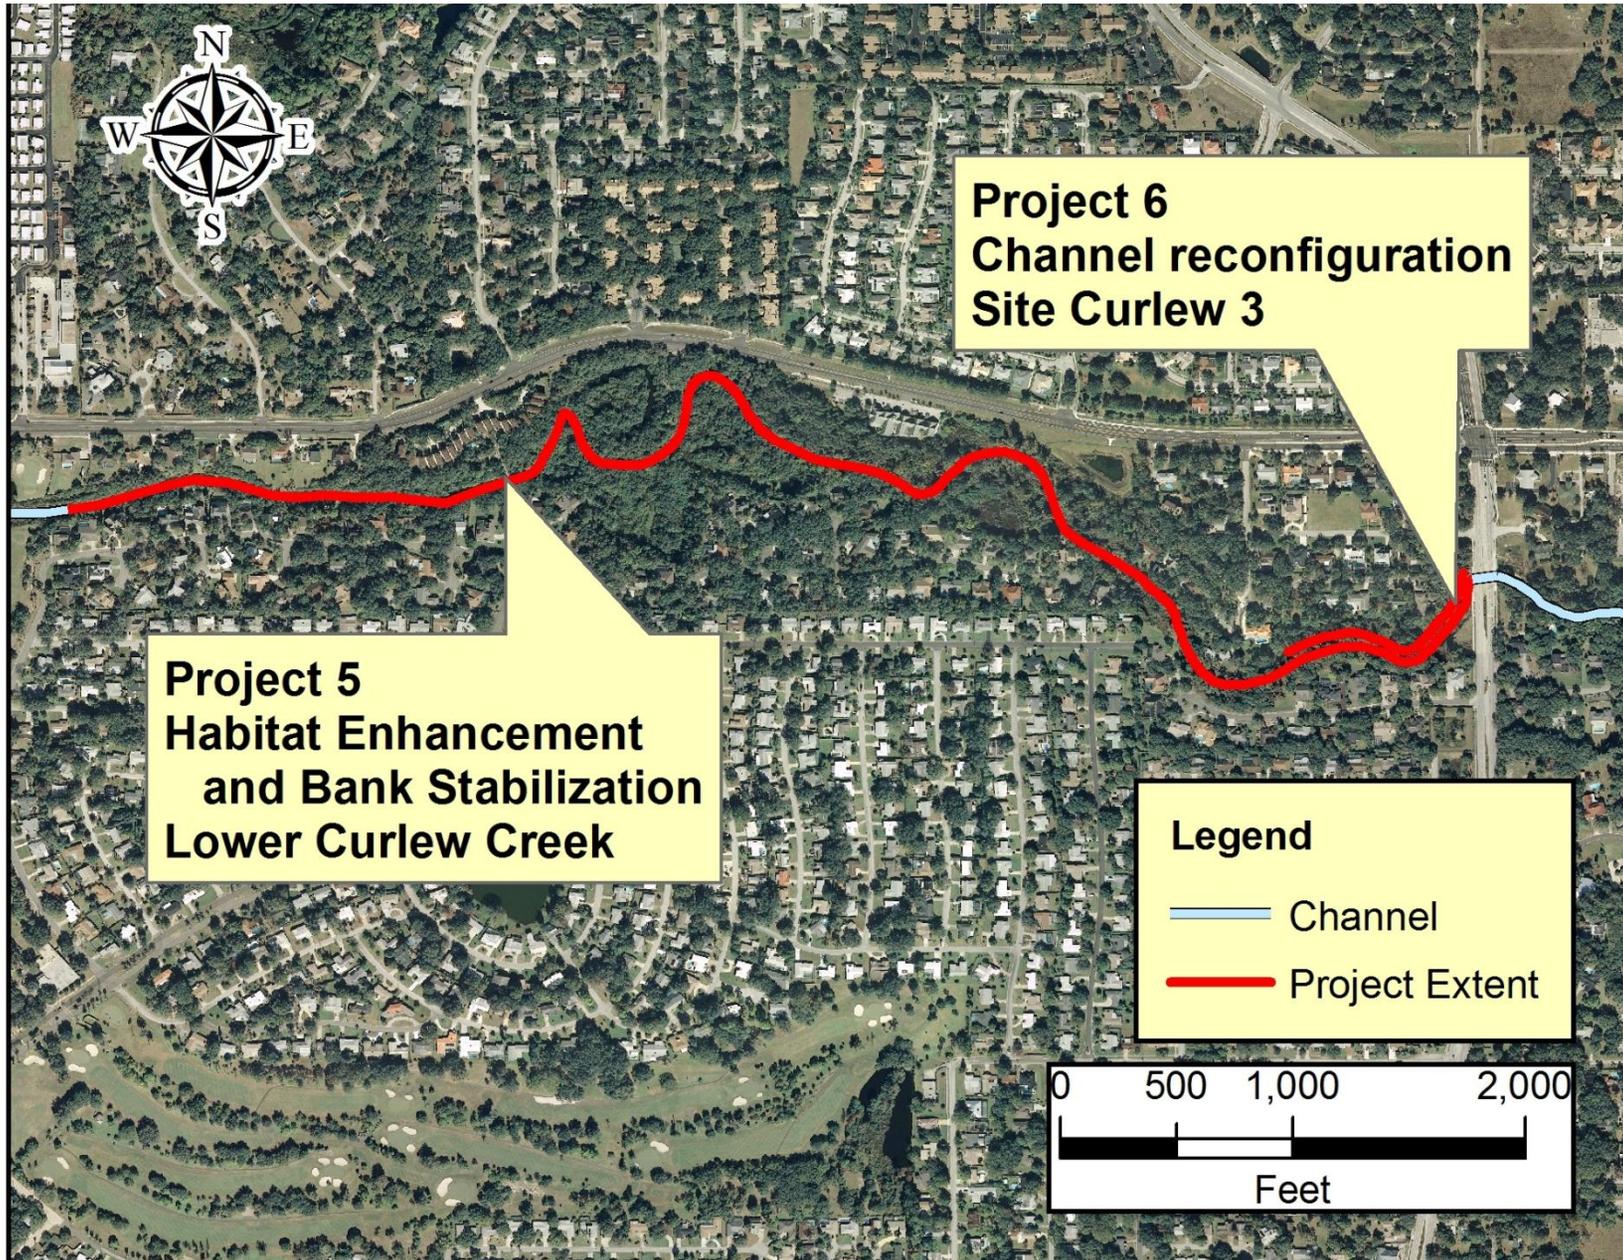
Figure 5-5. Project 5 in Lower Curlew Creek and Project 6 at site Curlew 3 (County Rd 1).

Description – Opportunities exist to enhance in-stream habitat and stabilize channel banks in lower Curlew Creek (Figure 5-5). Target areas include much of the main stem of Curlew Creek downstream of County Road 1 to the north end of St. Andrews Links Golf Course, a distance of about 6100 feet. Structural habitat including the following may be strategically placed within the channel to afford enhanced habitat for fish, benthos, and other wildlife. Sediment transport will be reduced due to lower stream flow velocities. Site-specific placement of any of these alternatives should include hydrologic modeling and engineering analysis that is beyond the scope of this work. Habitat enhancement options include:

Location – Curlew Creek site Curlew 3 west of CR1, shown in Figure 5-5 above.

Issues – Environmental permitting will be required. Structures must withstand high flows and not increase flood potential.

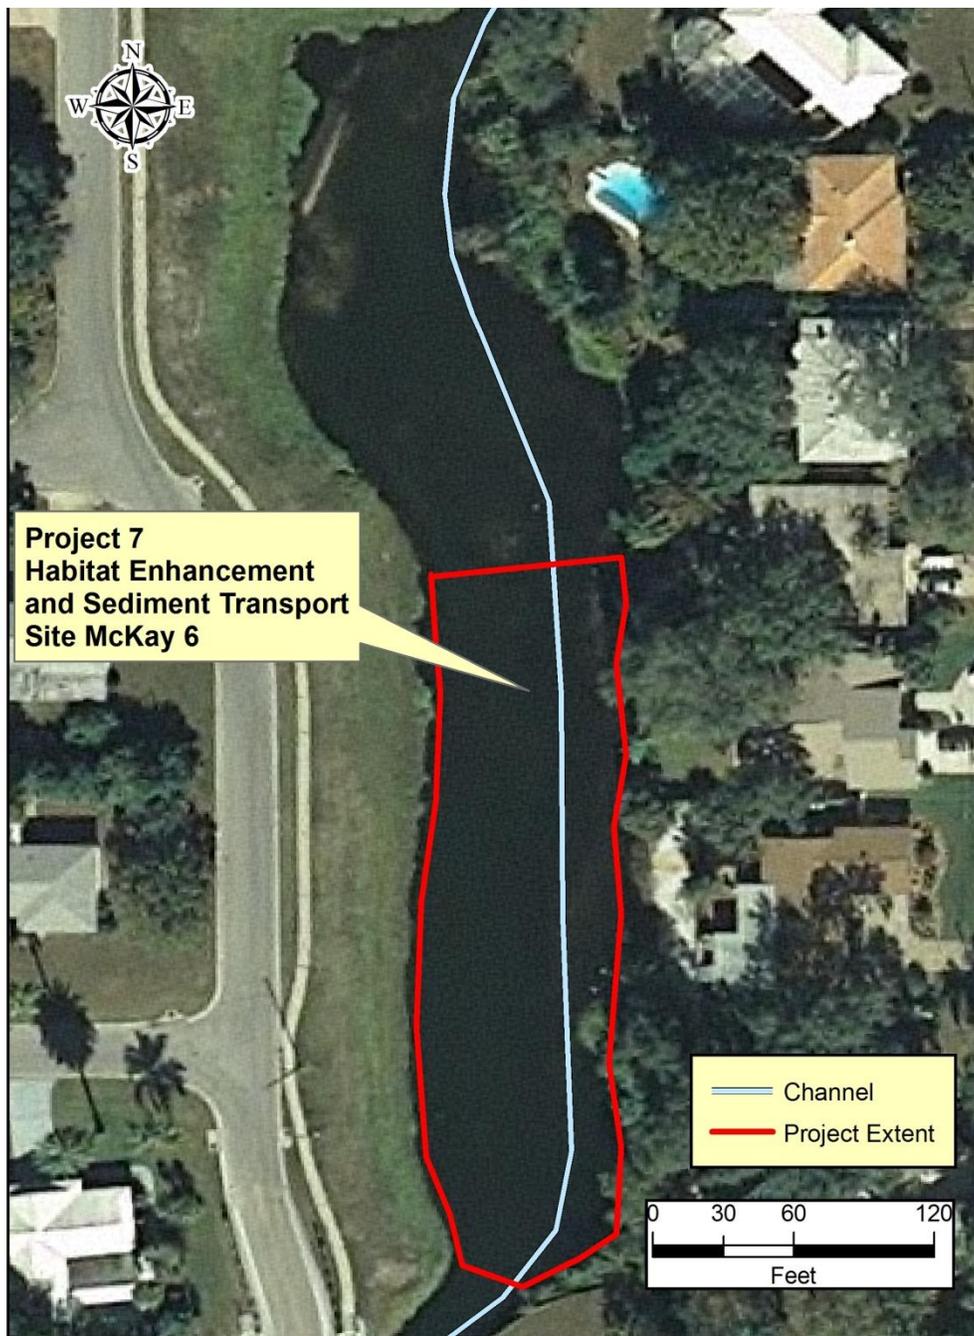
Figure 5-6. Project 7 at site McKay 6.

Location – Sediment Sump at site McKay 6, SW 8th Ave and Hickory Dr. (Figure 5-6).

Description – Opportunities exist to enhance habitat and reduce sediment transport in lower McKay Creek (Figure 5-6). The subject site now acts as a sediment sump, but only by virtue of stream flow velocity slowing in the widened channel. Excess sediment is currently dredged from the water body, but the material is not confined to a portion of the site, making effective dredging operations difficult. Additionally, the site is entirely open water surrounded by private yards on the east side and a public grassed open space on the west side.

Both this issues could be addressed by transforming the water body into a multi-cell system. The upstream cell would remain deeper open water and would serve as the sediment sump. A berm constructed across the site would act to contain the sediment in a more confined space, making dredging more efficient. The berm could be constructed to be structurally sound during all flow events, with a spillway to allow high flows to pass.

Habitat enhancements could include vegetating the berm, and making the downstream portion of the site a series of wetlands with interconnecting flow paths. A high flow channel would be maintained to convey flood waters. Woody plants could be planted along the bank or on built-up hammocks within the water body. Deeper pools would provide fish and bethic refugia.

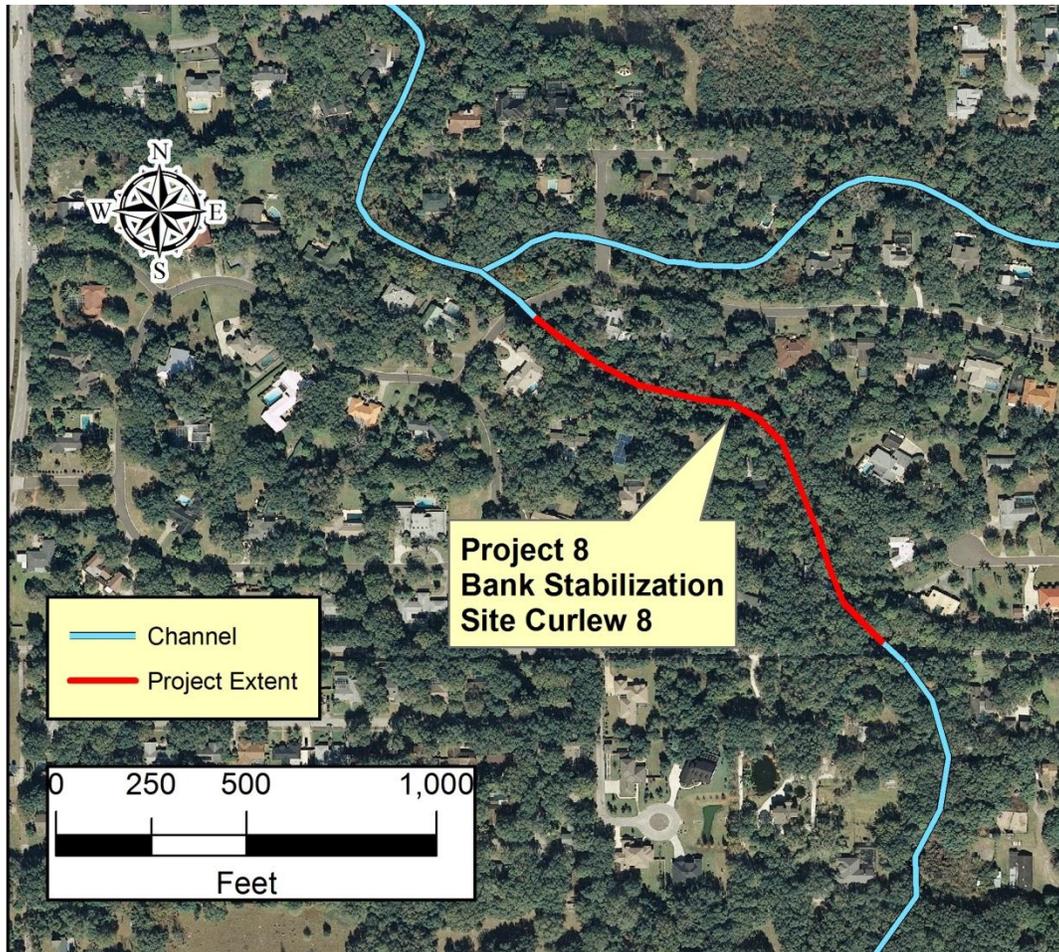
Figure 5-7. Project 8 at site Curlew 8.

Location – This recommended project is at Curlew Creek site Curlew 8, located on Brady Drive east of County Road 1 on Jerry Branch (Figure 5-7).

Issues – Environmental permitting will be required. Structures must withstand high flows and not increase flood potential.

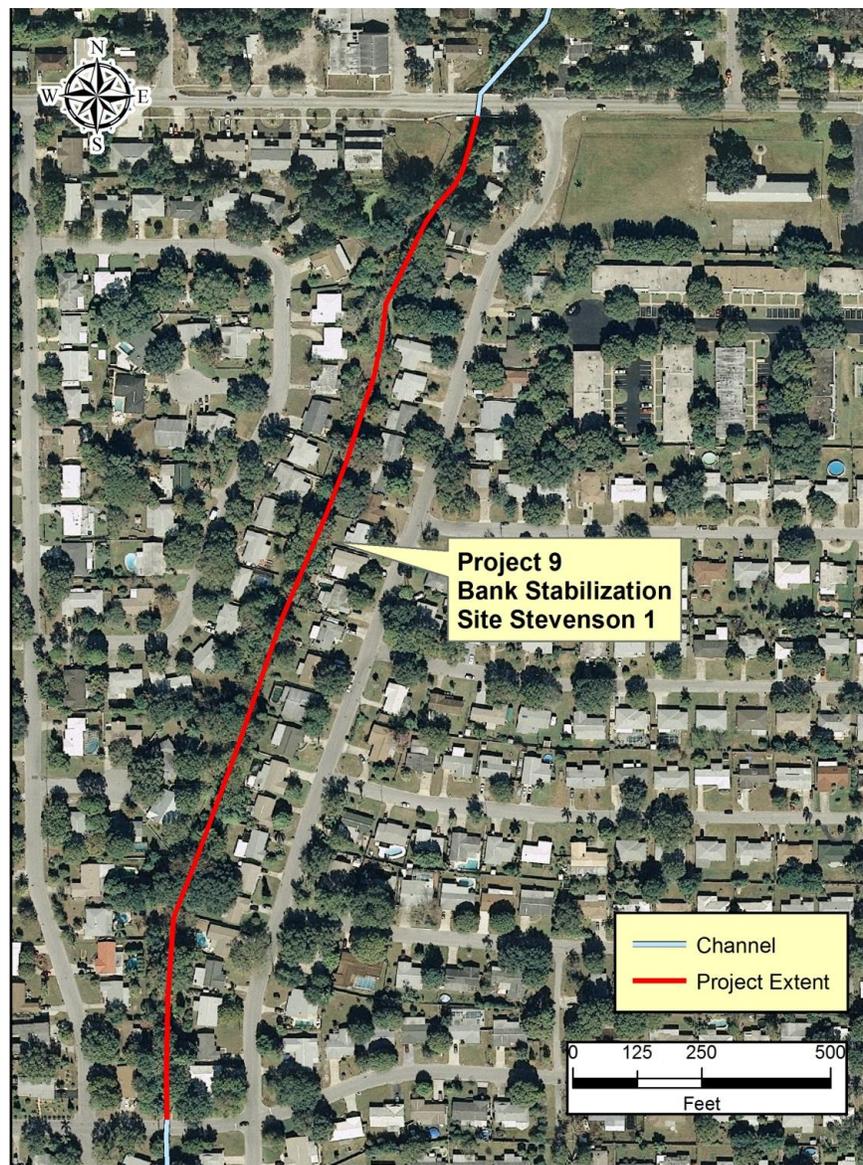
Figure 5-8. Project 9 at site Stevenson 1.

- Project 4B – Upper Stevenson Creek Stabilization (ID 25). Channel stabilization in the upper basin is necessary because of significant bank erosion, especially in the reach between Lakeview Road and Bellvue Boulevard. It is recommended to either conduct isolated fixes of problem areas as they occur, using geotextiles or gabions, or to re-configure the entire channel reach with a narrow deeper center lined with gabions and less steep higher side slopes.

Location - Upper Stevenson Creek (site Stevenson 1) downstream of Bellevue Blvd. (Figure 5-8)

Issues – Environmental permitting will be required. Structures must withstand high flows and not increase flood potential. Most of the site is not accessible to power equipment and permission from residents would be needed to access the channel.

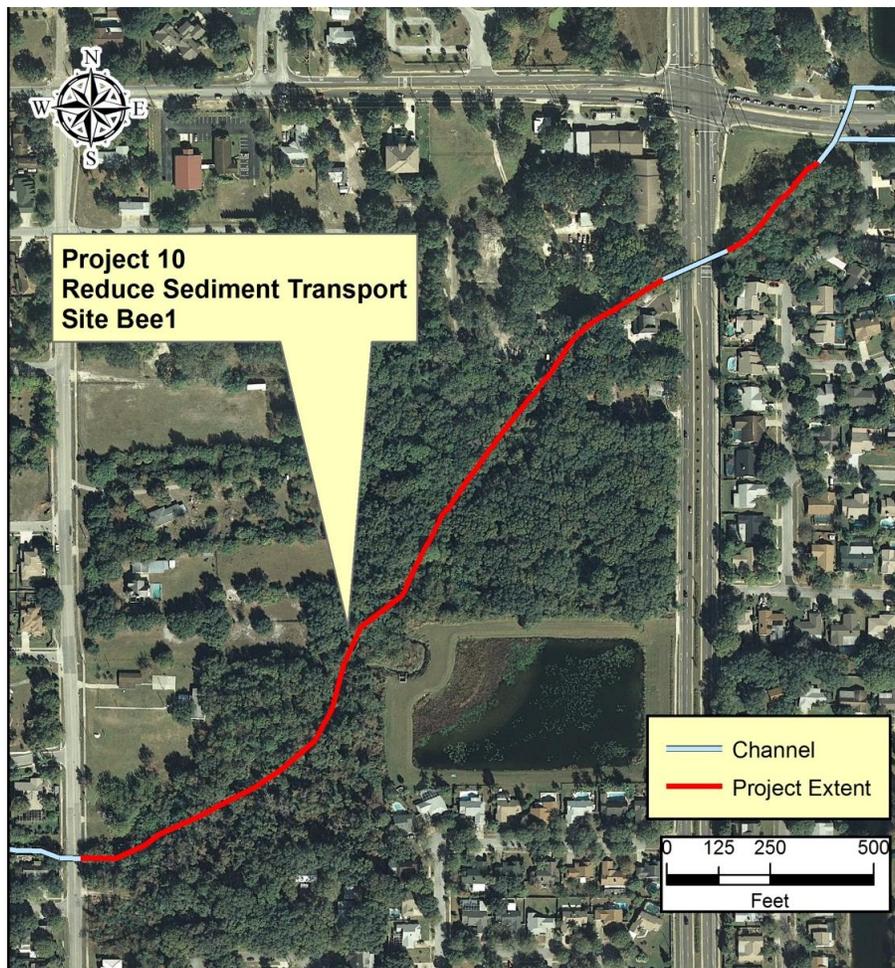
Figure 5-9. Project 10 at site Bee 1.

Location - Bee Branch site Bee 1, located near Belcher Road south of Nebraska Ave. (Figure 5-9).

Description - Shoaling and bank erosion were observed at this site, which is in an area not affected by the County's current capital projects. Although several stormwater ponds are located nearby, these appear to be designed to capture roadway or residential runoff and not intercept stream flow. The reach is bounded by undeveloped oak woods. Although preservation of the trees is desired, it may be feasible to widen or meander the channel to slow flows and reduce sediment transport. Alternate channel sections should account for tree protection.

Relative cost – Work involved would include clearing existing debris from the banks, smoothing the banks, and the manual placement of rip rap in the channel. Costs are expected to be moderate to relatively high for the benefit.
