The lake assessments are created in partnership with Hillsborough County and the Florida Center for Community Design and Research
LAKE ASSESSMENT DOCUMENT

Lake Cedar East 7/13/99 Watershed: Curiosity Creek

I. Physical Data – Area, Depth, Volume, & Bottom Contours

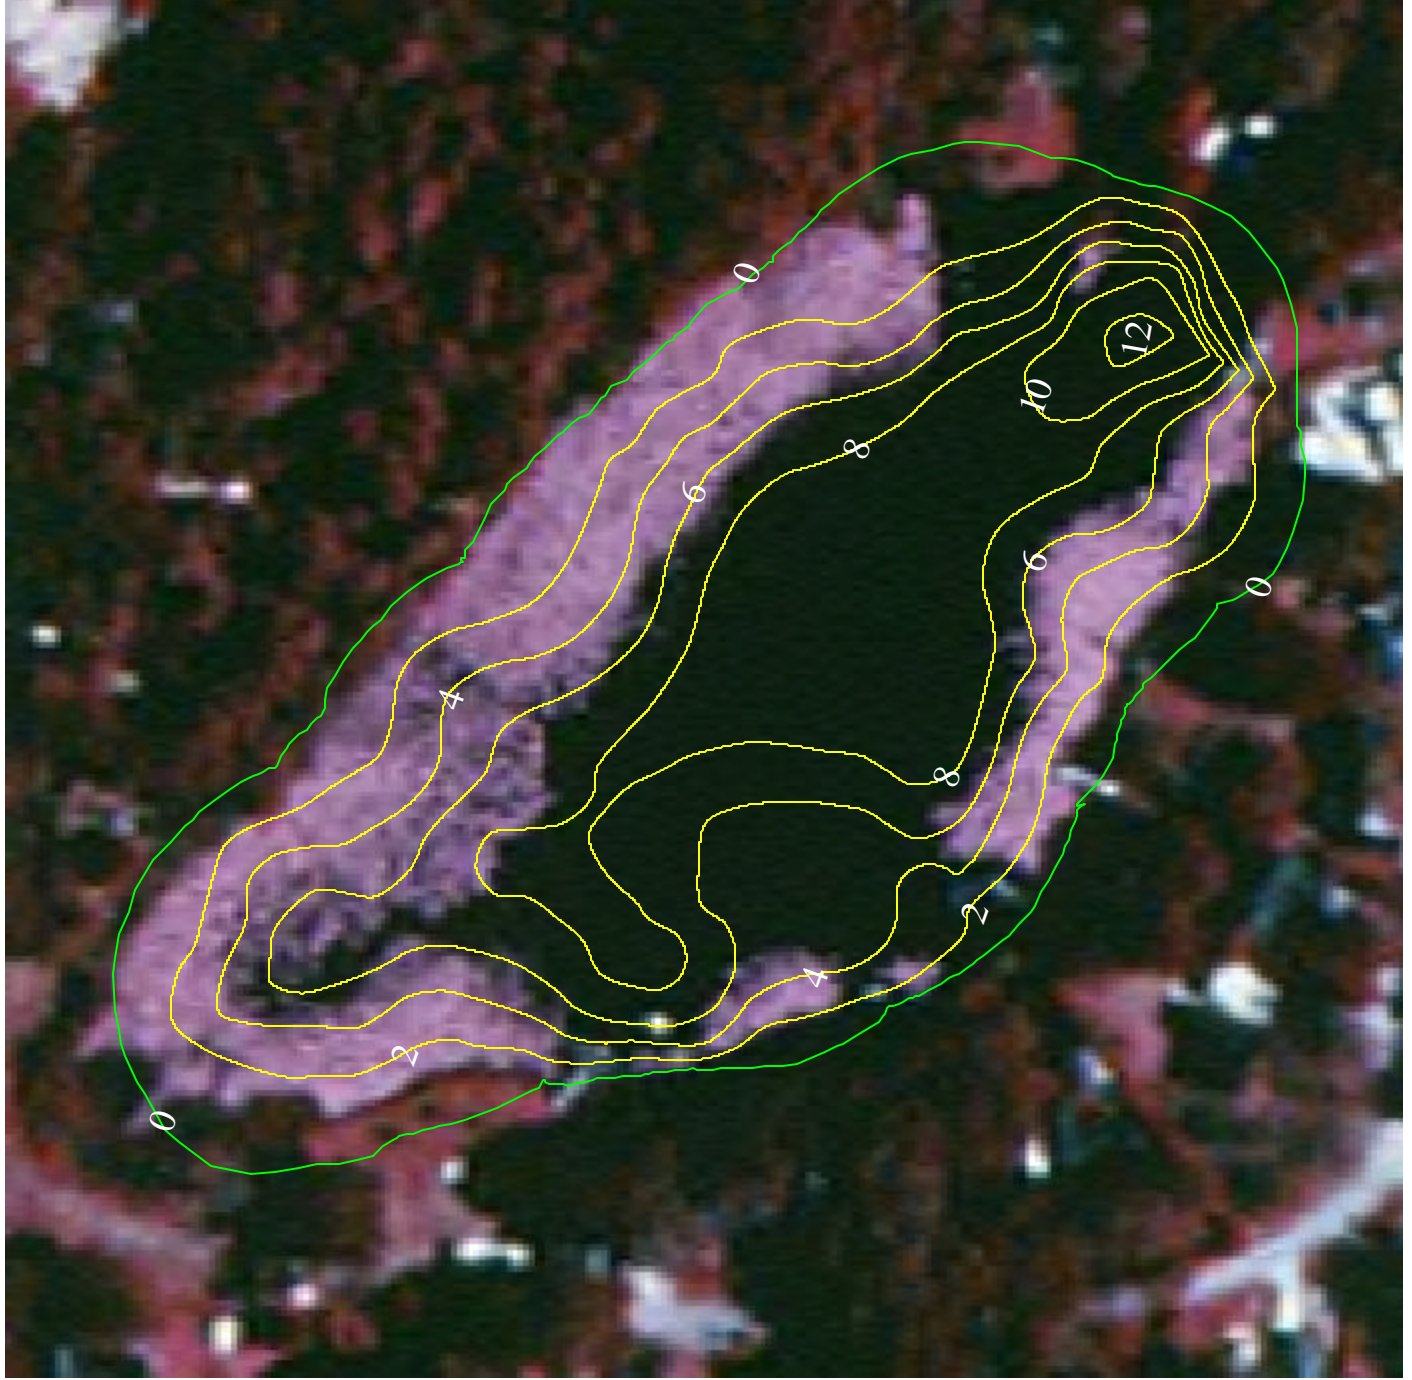
Lake Cedar East

- Contour Lines Expressed in 2-Foot Intervals
- Lake Perimeter Ground Level

Survey Date July 13, 1999.

Staff gage water level is currently unavailable for this lake. Contours are expressed in absolute depth below this level.

Digital orthophotos by United States Geological Survey. All contours generated by Florida Center for Community Design and Research based on survey data provided by the Hillsborough County Lake Management Program.

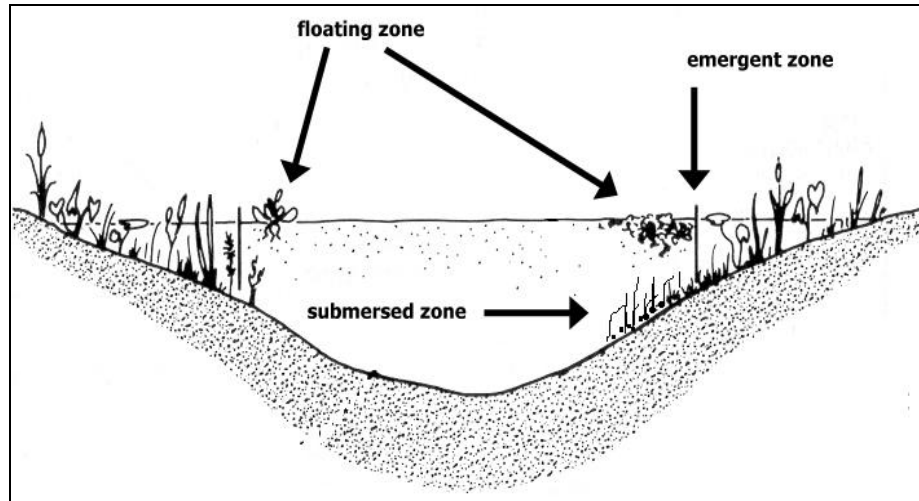
In addition to an overall survey of the types of plants on a lake, an estimate of the standing crop (biomass) of the lake has been obtained for many lakes. This was done by calculating the average weight of the vegetation within a quarter-meter square quadrat tossed haphazardly into three zones (see Figure) at each sampling site around the lake: (1) the emergent zone, (2) the floating zone and (3) the submersed zone. The average weight of the plants (Table 4) from all sampling sites and the dominant type of vegetation (Table 5) are provided. If data tables are not shown, no standing crop estimates were obtained for this lake.
