The lake assessments are created in partnership with Hillsborough County and the Florida Center for Community Design and Research
LAKE ASSESSMENT DOCUMENT

Lake Pine

6/8/99

Watershed: Curiosity Creek

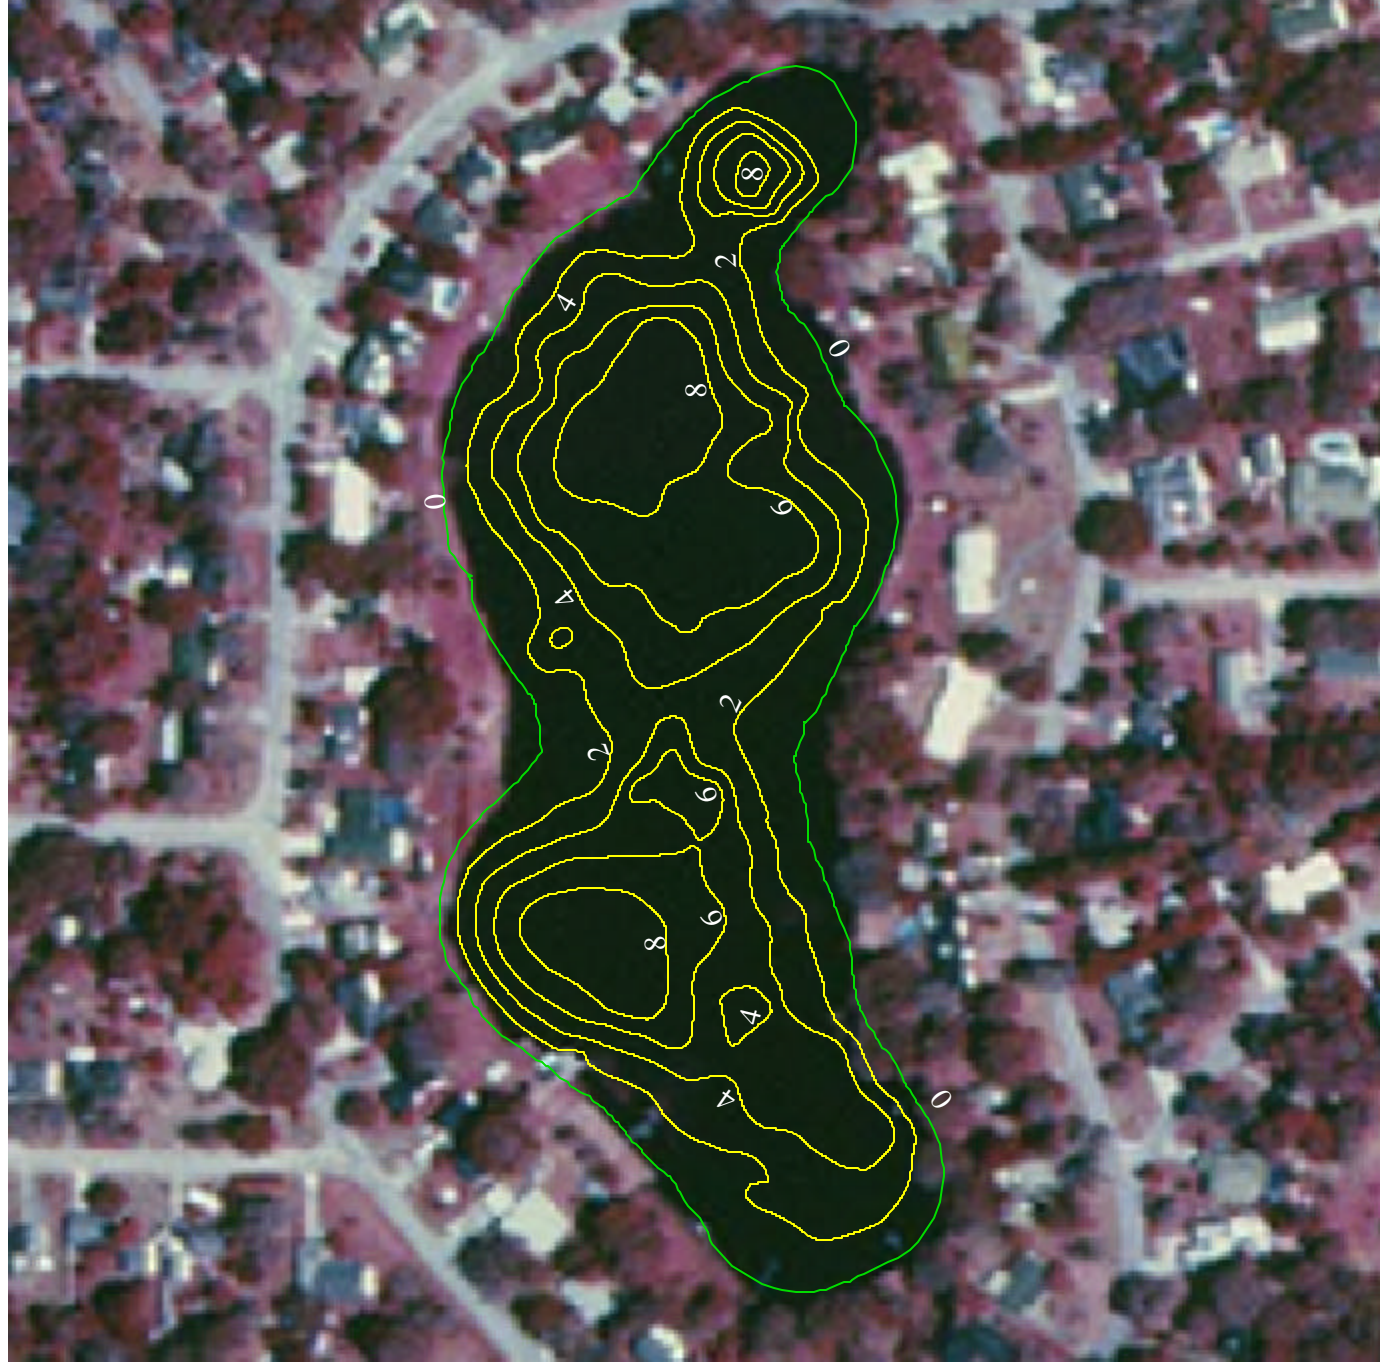
Lake Pine

Contour Lines Expressed in 2-Foot Intervals
-

Survey Date: June 7, 1999

Lake water level was not available when the lake was surveyed. Contours are expressed in absolute depth below this level.

Digital orthophotos by United States Geological Survey. All contours generated by Florida Center for Community Design and Research based on survey data provided by the Hillsborough County Lake Management Program.

The first section of the report provides the results of the bottom mapping effort: a contour (bathymetric) map of the lake, area, volume and depth statistics, and the water level at the time of assessment (if available).

The bottom of the lake was mapped using a sophisticated Global Positioning System (GPS) to determine the boat’s position, and a depth-finder to provide depth associated with that measured position. The result is an estimate of your lake’s area, mean and maximum depths, and volume (Table 1) and the creation of a bottom contour map.
