The lake assessments are created in partnership with Hillsborough County and the Florida Center for Community Design and Research
LAKE ASSESSMENT DOCUMENT

Lake Wastena 7/14/99 Watershed: Brooker Creek

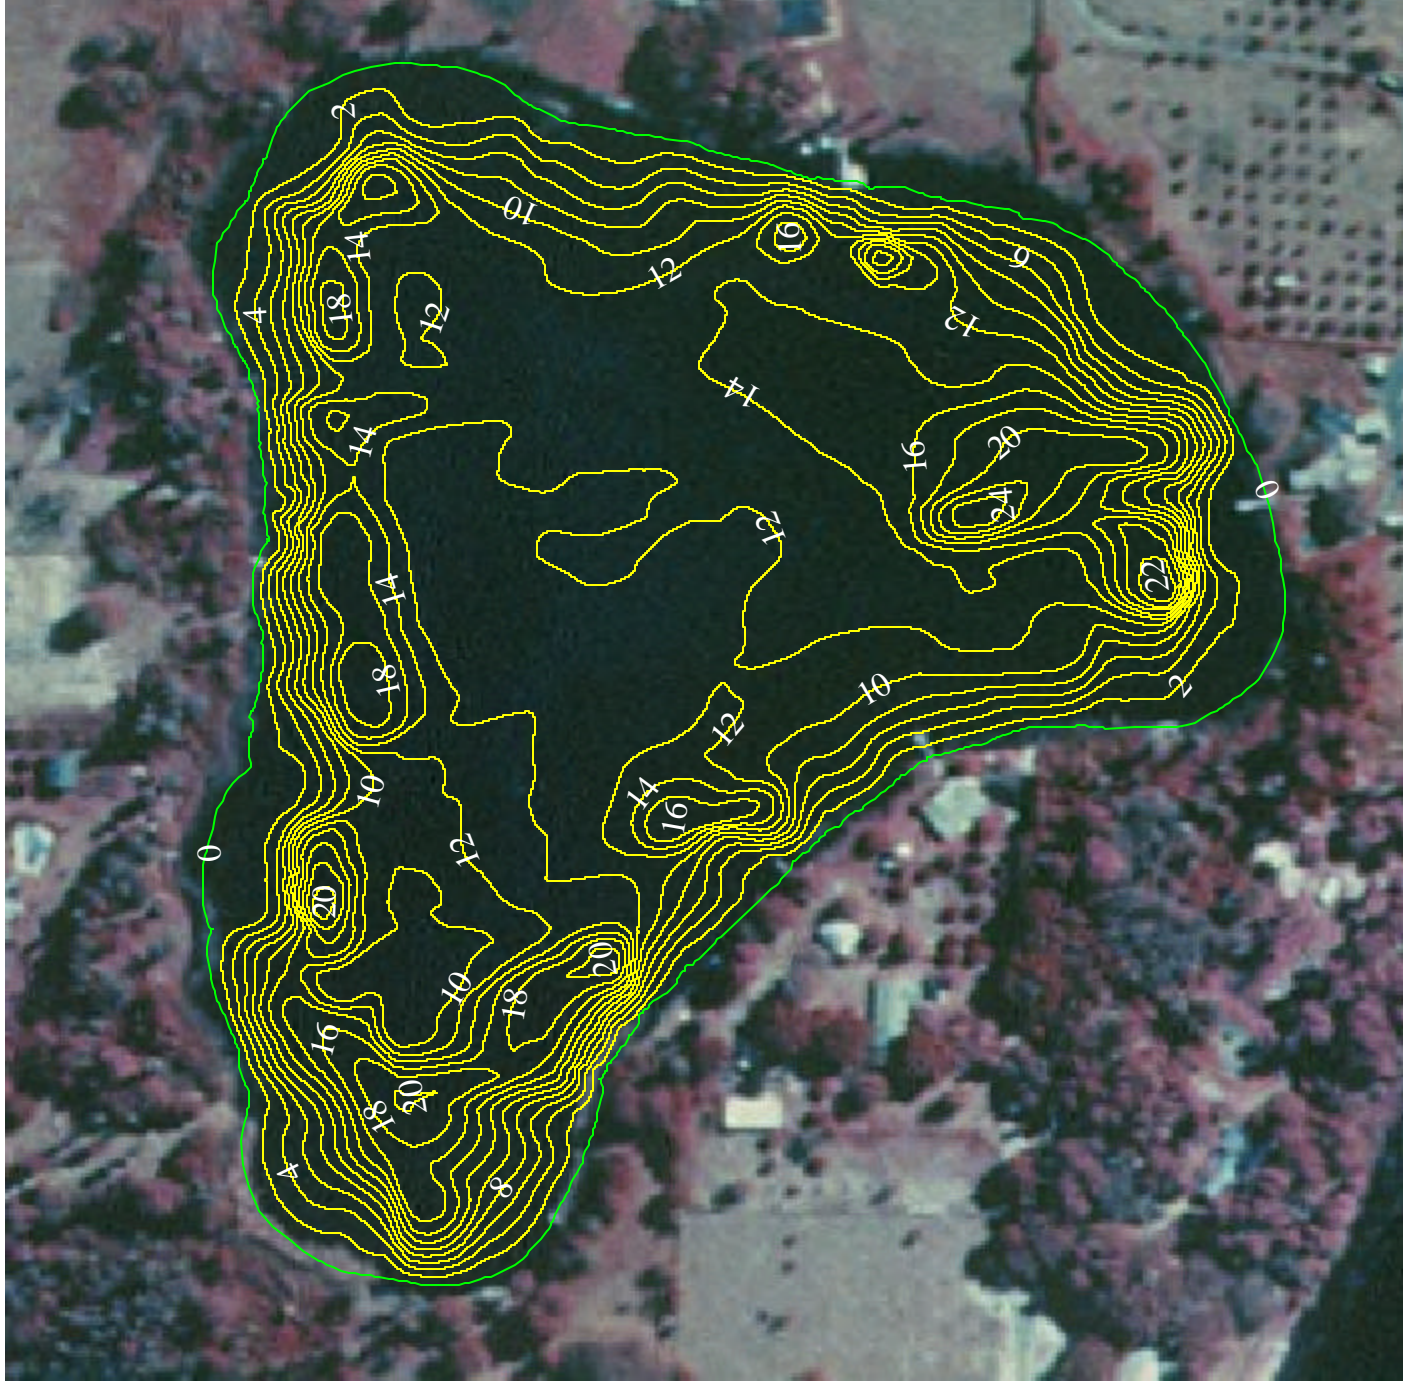
Lake Wastena

- Contour Lines Expressed in 2-Foot Intervals
- Lake Perimeter Ground Level

Staff gage water level is currently unavailable for this lake. Contours are expressed in absolute depth below this level.

Digital orthophotos by United States Geological Survey. All contours generated by Florida Center for Community Design and Research based on survey data provided by the Hillsborough County Lake Management Program.

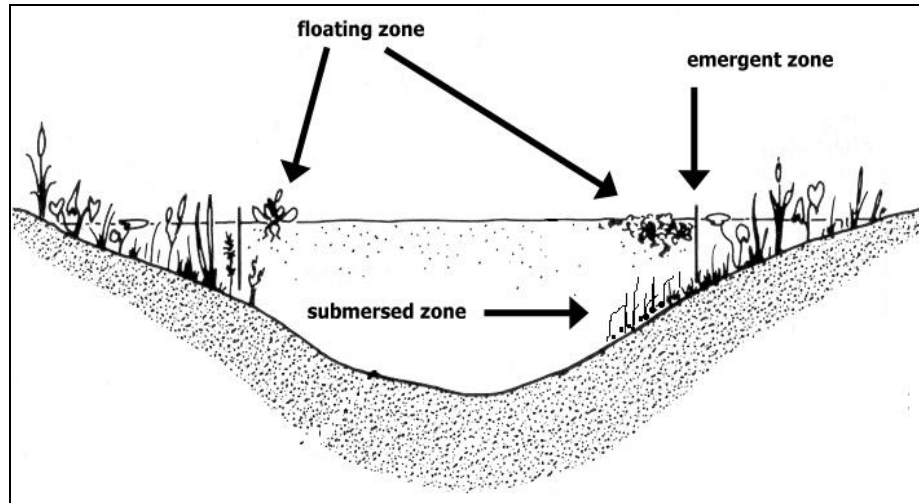
In addition to an overall survey of the types of plants on a lake, an estimate of the standing crop (biomass) of the lake has been obtained for many lakes. This was done by calculating the average weight of the vegetation within a quarter-meter square quadrat tossed haphazardly into three zones (see Figure) at each sampling site around the lake: (1) the emergent zone, (2) the floating zone and (3) the submersed zone. The average weight of the plants (Table 4) from all sampling sites and the dominant type of vegetation (Table 5) are provided. If data tables are not shown, no standing crop estimates were obtained for this lake.
